Structural investigation of the Plasma Transferred Arc hardfaced glass mold after operation

Abstract: The paper presents the results of research aimed at detecting the causes of premature wear of molds for glass shaping, manifesting the formation of pits in the Plasma Transferred Arc pad-welds in which the working surface of the mold was shaped. The weld microstructure was tested, the chemical composition was determined in the pad-weld's cross-section, linear and surface chemical distributions were made in the pad-weld's cross-section, the surface morphology in damaged areas, and the chemical composition of surface inclusions were examined. The too high temperature of formed glass associated with wettability of the glass of the mold was indicated as the primary cause of premature mold wear.

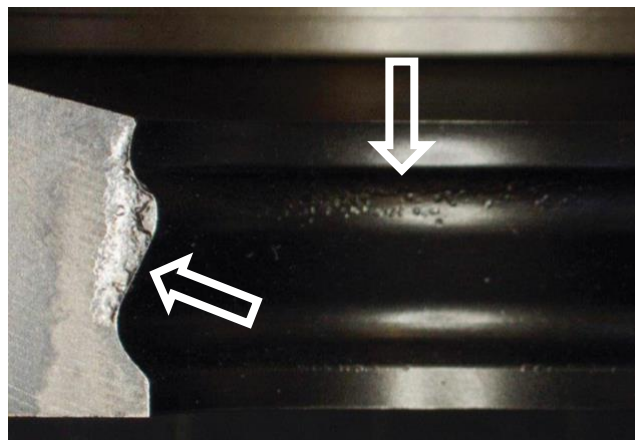
The tests consisted of observation of the outer surface and microstructural tests in the cross-section of the coating-substrate. In the first stage, pitting was located in part of the pad-weld's surface and partly in the mold division plane. The location of erosive damage on the working surface is indicated by arrows in Figure 1, they are located only on the surface of the narrowing of the hole (along its entire perimeter) in the mold (a fragment of the surface remaining the longest in contact with the glass) and partly on the surface of the mold division. The intensity of the occurrence of defects was highly comparable for all examined cases, which indicates that the cause of the defect is repetitive and systematic. Leaking glass onto the mold surface indicates a dangerously low contact angle (high wettability) of the mold surface with liquid glass. In the analyzed conditions, this dangerous phenomenon may occur as a result of a decrease in surface tension at the liquid glass-gaseous environment interface (atmosphere) and at the interface between the liquid glass-mold material, due to too high glass temperature.

Fig. 1. Location of pits in the working part of glass molds

Pitting clusters located in the mold's opening (Fig. 1) are shown in figure 13, their morphology and intensity of occurrence indicates high surface sensitivity to the factor causing wear. The dimensions of the pits are in the range of a few μm to 1 mm. Figure 13a shows a view of the surface with pits, which have a smooth geometry without clear sharp edges, and their morphology and distribution in no way correspond to the microstructure of the pad-weld. The pitting profile is gentle, indicating a gradual movement of the destruction front. At the bottom of the pits, a resident foreign body was observed, which was identified in the next stage.

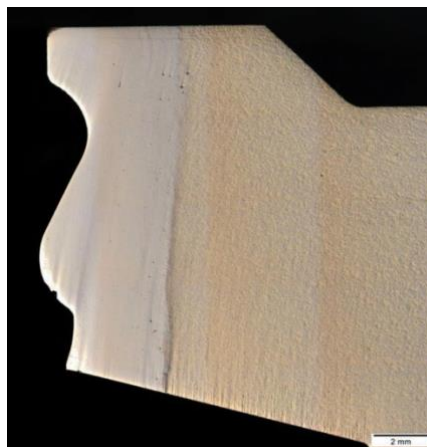
Tests of the pad-welds microstructure were carried out in order to check the correctness of their structure and chemical composition, on cross-sections made in the direction of the mold's radius. The preparations were collected by mechanical cutting with liquid cooling. In all cases, the sanding was performed on abrasive papers with the gradation of 100; 180; 320; 500; 800; 1000; 2000, then polished with an aqueous Al_2O_3 suspension. In order to reveal any non-metallic inclusions, the structure of the pad weld-substrate system without etching was examined (Fig. 2). Observations on the microscope were carried out in the bright field. No non-metallic inclusions significant for the durability of the mold were observed in the obtained images, the degree of purity of the pad-weld is relatively high, characteristic for the surfacing process carried out in laboratory conditions.

Fig. 2. Cross-section of the pad-weld along the radius of the form, image without etching

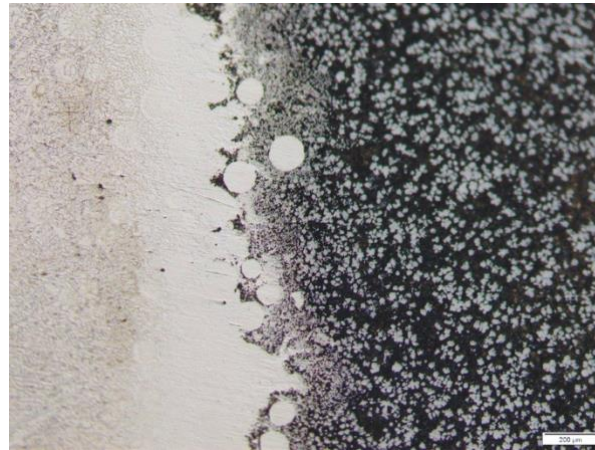
In order to reveal the structure of the microstructural boundary of the coating penetration into the substrate (glass molds), the samples were etched with Nital (Fig. 3). Microscopic observations have shown that the coating is well bonded to the substrate, but without mixing the substrate and coating too much. The low level of mixing indicates that there is no risk of dilution of the coating material with the substrate material, which indicates that the protective potential of the coating material has been maintained at a level comparable to the nominal.

Fig. 3. Microstructure of the fusion border, pad-weld – left side, substrate – right side

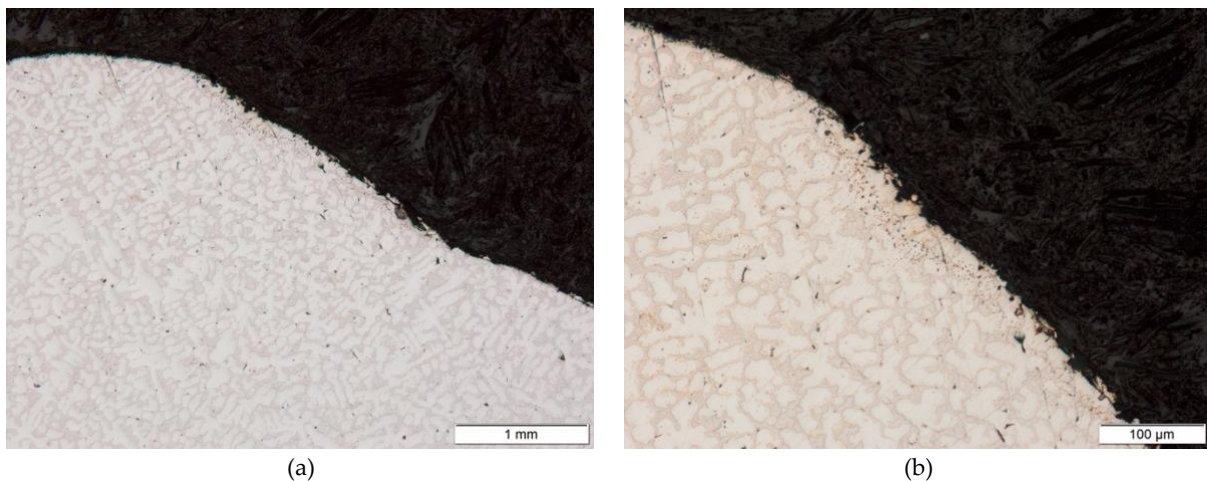
Figure 4 shows the microstructure of the pad-weld in cross section, in the area of the mold's working surface and the occurrence of pits. The structure is characteristic for a plasma pad-weld. No heterogeneity or directivity of properties that could be associated with the occurrence of pitting revealed on the surface was recorded. The structure is almost cellular in nature, without a clear direction of crystallization, which means that the thermal cycle of surfacing was relatively mild. The molds were previously heated to a sufficiently high temperature to reduce the cooling rate to a safe value.

The recorded images (Figs. 4 and 5) clearly indicate that the coating's structure is not related to the pitting location. In the area of pits, no heterogeneity, segregation or other imperfections were recorded in the structure. The front of erosive destruction of the surface moved from the direction of the formed glass, and its cause was the aggressive action of oxides (the main component of the glass), which adhered too well to the surface of the mold during operation (too high wettability). In figure 4b, a characteristic condition was observed for the gradual extraction of single crystals from the mold's surface. Some of them are partially ripped and the grain boundaries have been damaged (grain inconsistency). No structural defects were observed in the vicinity of pits. Figure 5 shows the pad-weld's microstructure (cross-section) in the working surface area, observed on a scanning electron microscope (SEM). No structural imperfections were observed during surfacing that could be related to the occurrence of pitting. The grain size does not change in the direction of the pad-weld's thickness. The structure indicates a properly carried out surfacing process.

Fig. 4. Microstructure of the pad-weld in cross section at the pitting site, etched by Nital

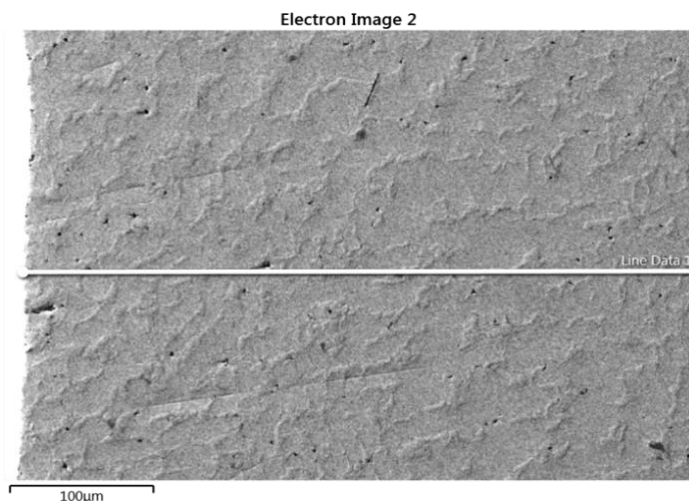
Fig. 5. The microstructure of the pad-weld in cross section near the pitting in the working surface (left side of the picture), SEM electron microscope

For the randomly selected area depicted in Figure 5, surface distributions of elements were made (Fig. 6). The distribution of iron, aluminum, copper, silicon and nickel is even. Observed chromium clusters are desirable in the structure of chromium carbides, performing the function of precipitation strengthening. In the place of occurrence in the structure of carbide precipitates, a study of the linear distribution of elements was performed (Fig. 8), the scanning line was marked in Figure 5. In the areas of precipitates, a sharp decrease in nickel concentration (Figs. 7 and 9) (the main constituent of the pad-weld's matrix) was observed, with a simultaneous increase in chromium concentration (Figs. 7 and 8). The concentration of all matrix components except the area of local carbide precipitates is even. This state indicates the homogeneity of the structure without signs of directional changes in the chemical composition. The pad-weld's material is chemically resistant to the heat cycle and high glass forming temperatures. The thermal cycle of glass pressing does not cause local depletion in elements responsible for heat resistance.

Figure 10 shows the SEM image of the pad-weld's structure with a much larger magnification compared to figure 5. The study was performed with particular regard to the area of the precipitates (marked as no. 1) and the gray phase (marked as no. 2) with morphology different from the matrix. The study of linear elemental distributions was carried out to determine the integrity of the precipitates with the matrix.

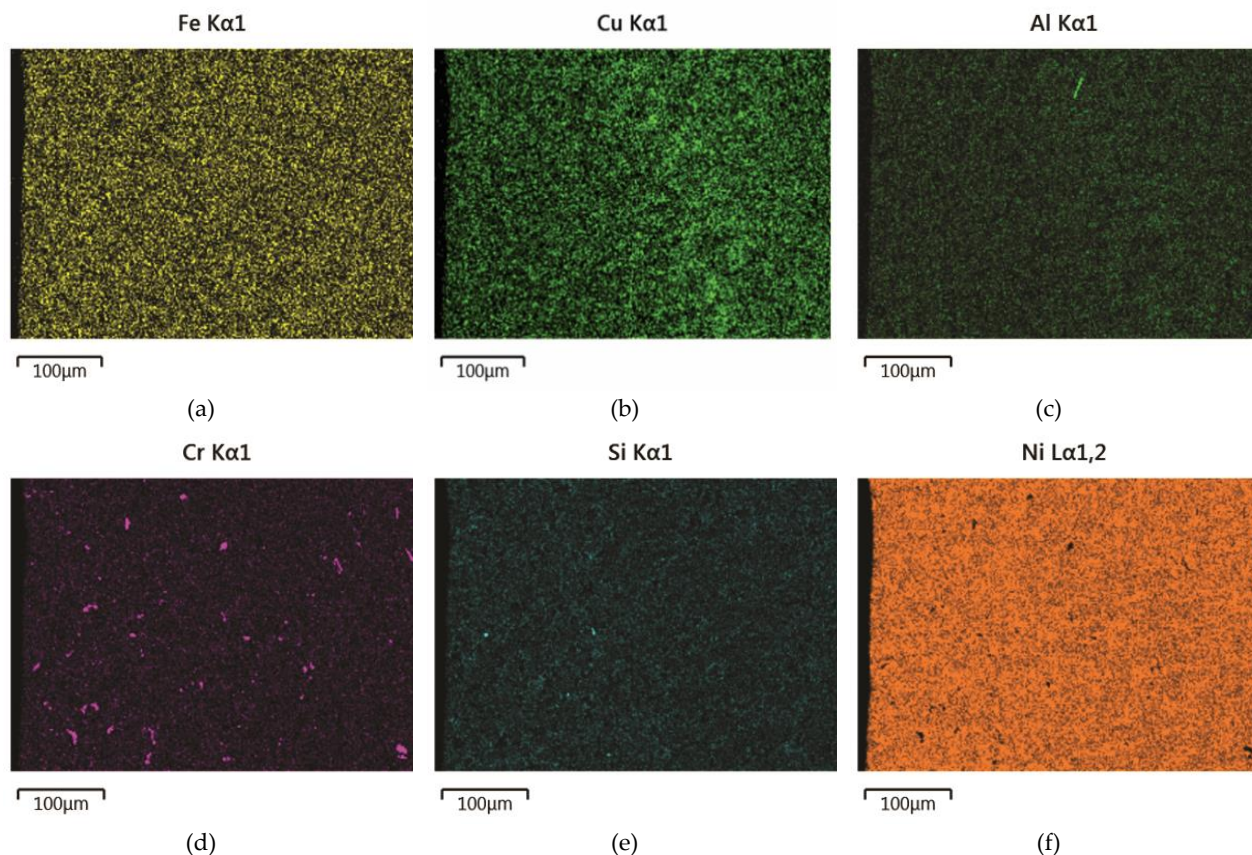
Fig. 6. Surface distribution of elements: a) Fe; b) Cu; c) Al; d) Cr; e) Si; f) Ni, made for the area from fig. 5

The graph in figure 11 uniquely identifies the precipitates as chromium carbides, in the place of separation an abrupt increase in the concentration of chromium and carbon was recorded. The presence of chromium carbides with a dispersion as in figures 6, 7 and 10 has only a positive significance for the properties of the pad-weld, constituting the basis of the mechanism of the precipitation strengthening of the pad-weld.

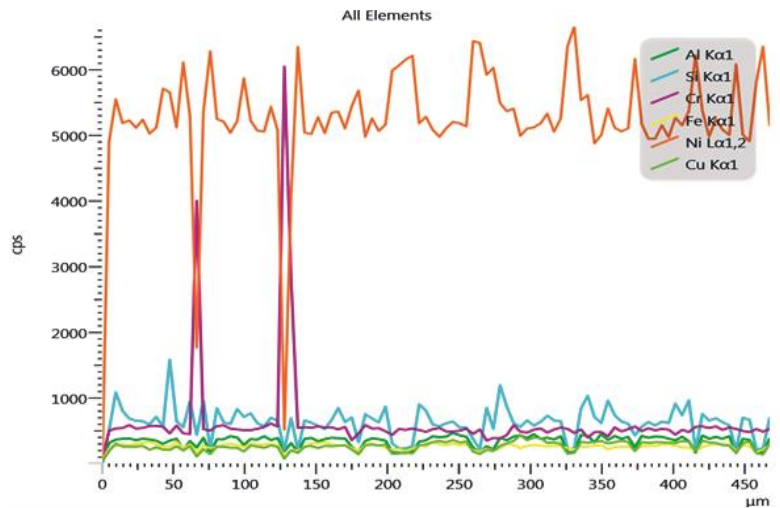
Fig. 7. Linear distributions of the elements Al, Si, Cr, Fe, Ni, Cu in the area of precipitation

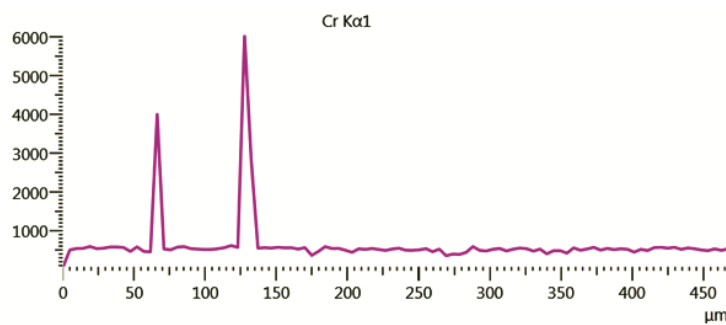
Fig. 8. Linear distribution of the Cr in the area of precipitation according to fig. 5

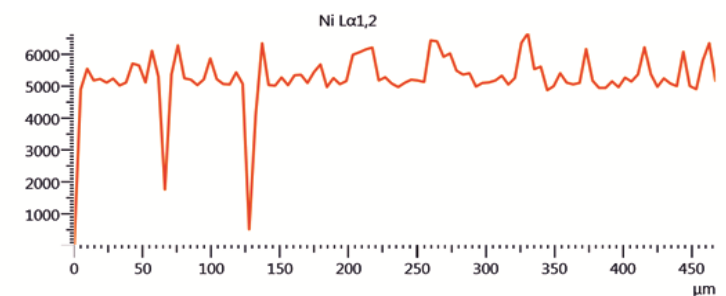
Fig. 9. Linear distribution of the Ni in the area of precipitation according to fig. 5

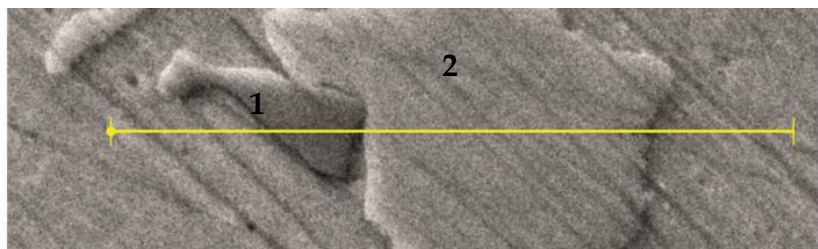
Fig. 10. Microstructure of Cr precipitation (1 gray phase) with a chemical composition scanning line

The linear distribution of elements from figure 11 also shows the presence of a third phase (marked 2 in figure 10) with a higher nickel content than the matrix, at the expense of other components of the alloy tested.

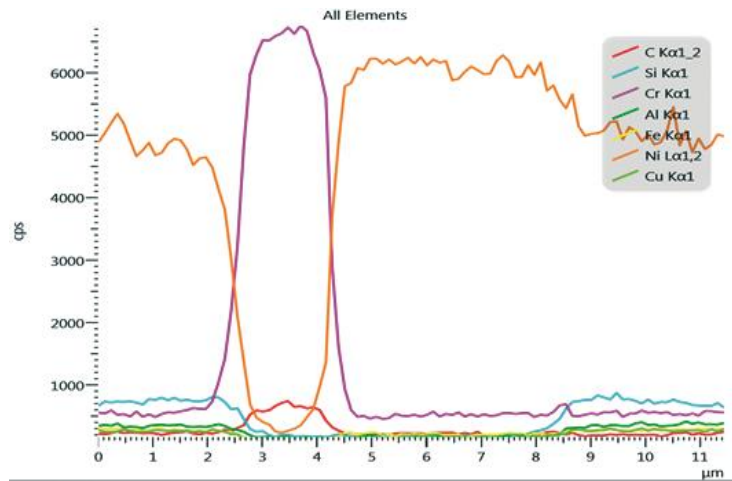
Fig. 11. Linear distribution of elements Al, Si, Cr, Fe, Ni, Cu, in the pad-weld

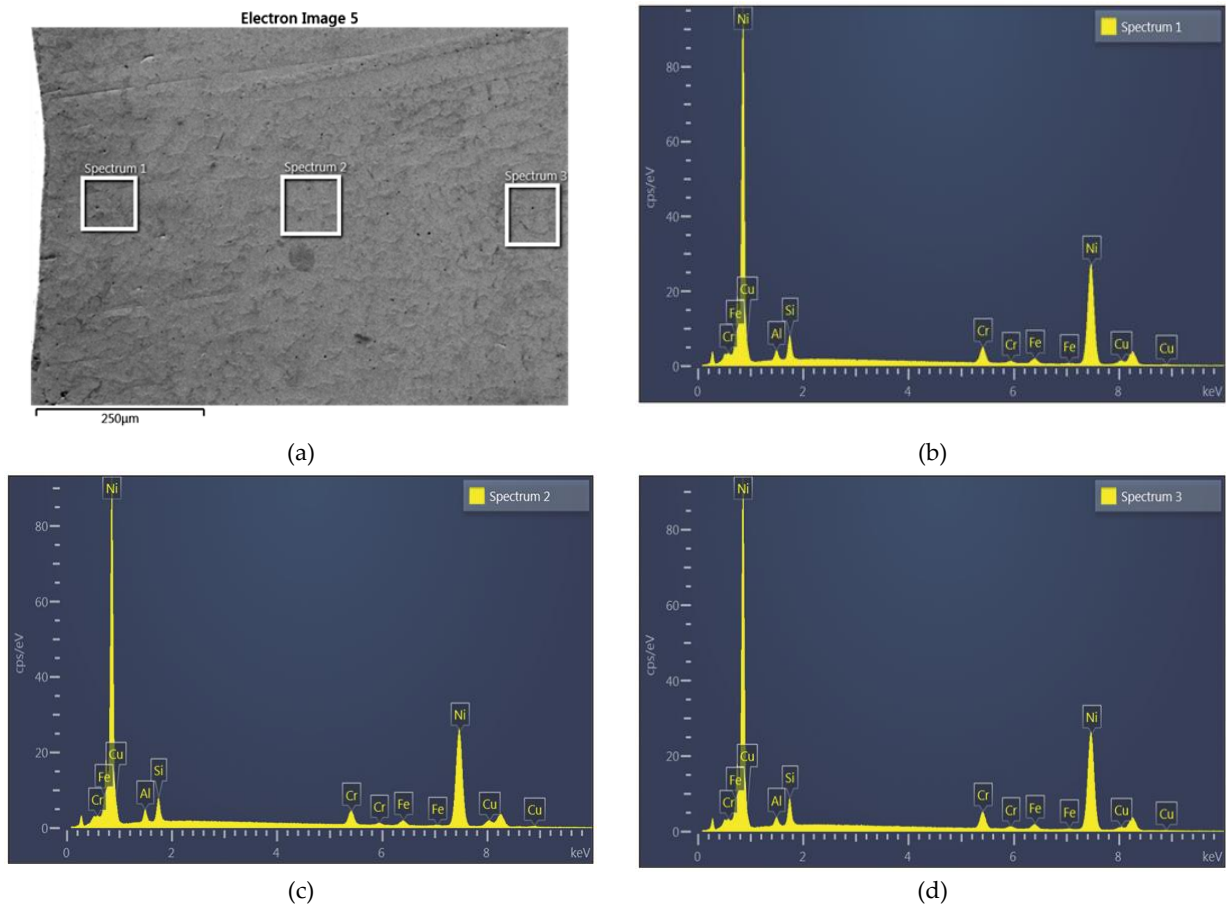
Figure 12 shows the results of EDS spectral analysis. Tests of the chemical composition of the pad-weld (table III) carried out in the three areas marked in figure 12a indicate uniformity of chemical composition, which clearly demonstrates the high quality of the plasma pad-weld. The chemical composition corresponds to the composition of the powder used for surfacing, taking into account the effects of remelting and partial mixing with the base material [17]. The low value of the standard deviation from the average value of the concentration by weight of individual elements confirms the homogeneity of the pad-weld's material.

Fig. 12. EDS spectrum qualitative analysis of the chemical composition in coating: a) SEM picture in cross-section of the pad-weld, b) EDS spectrum 1 close to working surface, c) EDS spectrum 2, d) EDS spectrum 3

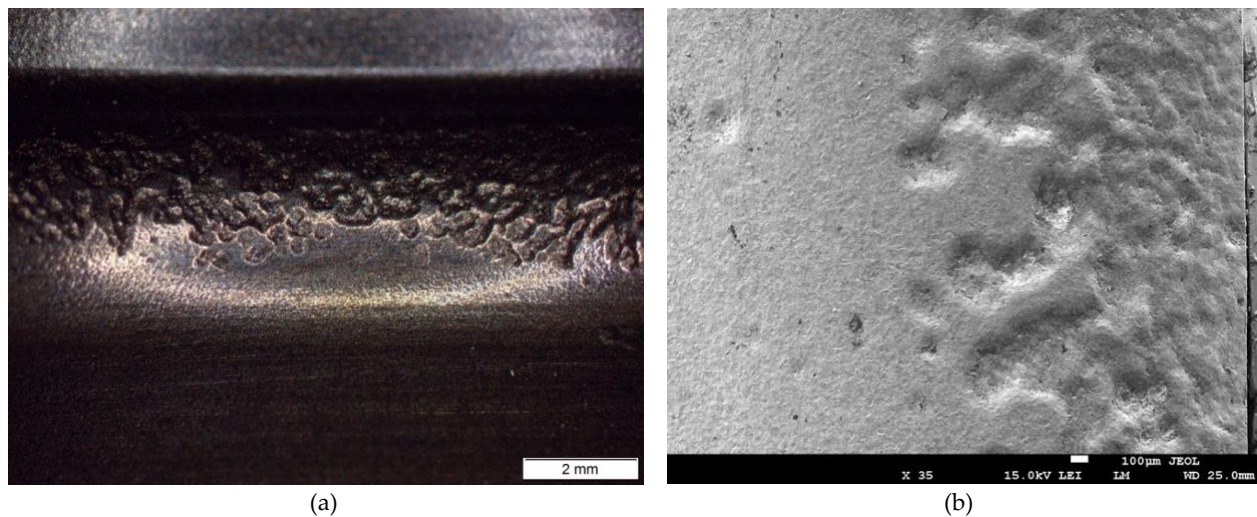
Fig. 13. Surface with pitting, a) optical microscope picture, b) SEM picture

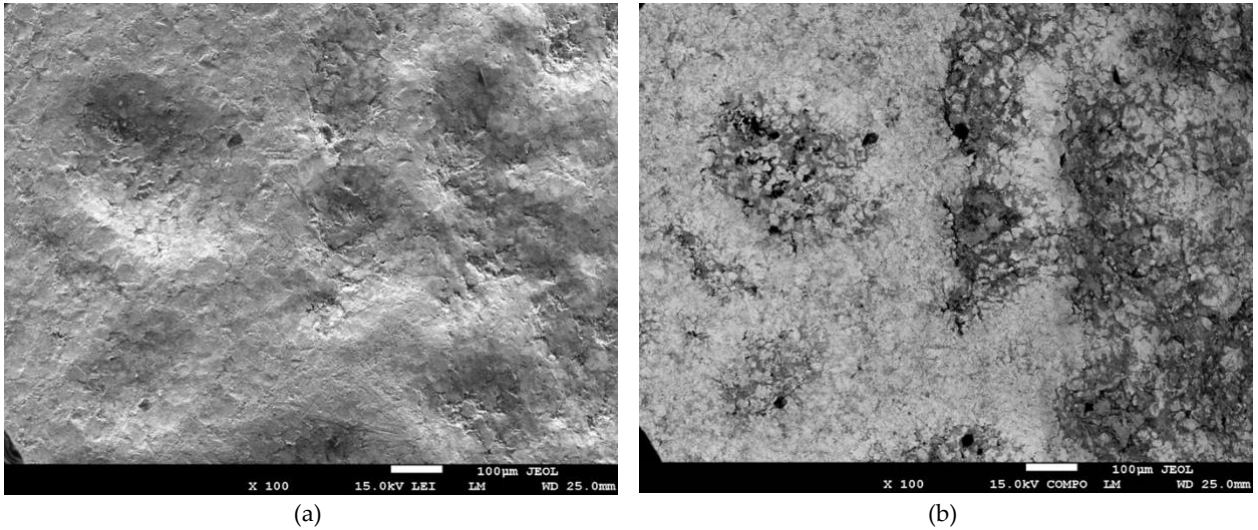
Figure 14b shows the surface image recorded using a BSE (backscattered electrons) detector to obtain a material contrast image, based on which it is possible to show the qualitative phase/chemical differentiation of the sample's surface. The electron backscattering factor strongly depends on the atomic number of the tested material. Areas of fields containing nuclei of high Z elements, scatter back more electrons, thanks to which they are mapped on BSE images as brighter places (nickel matrix of the weld). In BSE images, the contrast is the result of the difference in the average value of the atomic number between individual points of the sample. Light elements identified in the surface image (Figs. 14b, 15) as dark island areas concentrated in pitting interiors are non-metallic substances. These are glass inclusions that moistened the mold's working surface. Figure 16 continued to observe (at higher image magnification values) pitting morphology and glass filling. At the border of the glass stuck on the surface of the mold and the pad-weld's material (Fig. 15), developing cracks were observed as a result of the stress state generated under the conditions of the thermal cycle at the border of substances with extremely different physical properties [18,19] such as: thermal conductivity and expansion coefficient. The cracks developing on the surface in the glass-warp interface are the basic mechanism shaping the phenomenon of erosion and pitting in the working surface of the glass forming mold.

Fig. 14. Surface image with pitting, a) from the SEM electron microscope, b) from the SEM electron microscope made in material contrast using the BSE detector

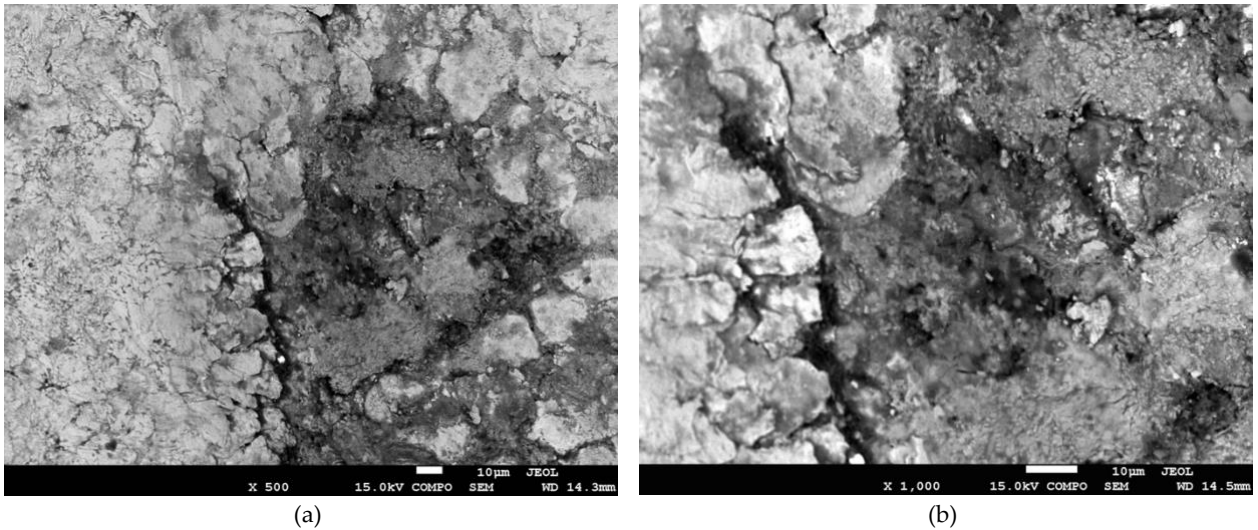
Fig. 15. SEM (BSE) image of the pitting zone

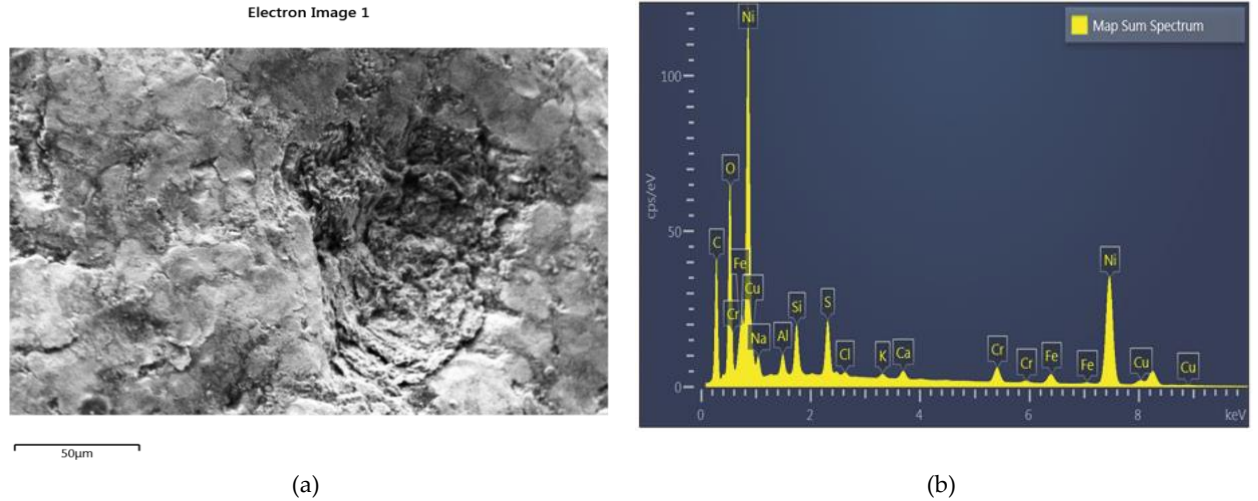
Fig. 16. a) SEM electron microscope image of the pitting surface for which EDS spectra and surface distribution of elements were taken; b) EDS spectrum for pitting area and its close surroundings

Figure 17 shows the surface distributions of selected elements that are the basic constituents of the matrix and elements included in the glass in the area illustrated in Figure 16a. Quantitative and qualitative tests of the chemical composition within the pitting prove that the pitting bottoms are filled with glass. There is a concentration of O and Ca (basic glass components) in these areas with a simultaneous depletion of the concentration of the matrix components of the pad-weld, i.e. Ni, Cr, Al and Fe. This result indicates that the basic factor generating the mechanism for the formation and development of pits on the mold's working surface is the adhesion of glass during its formation in the metallurgical process.

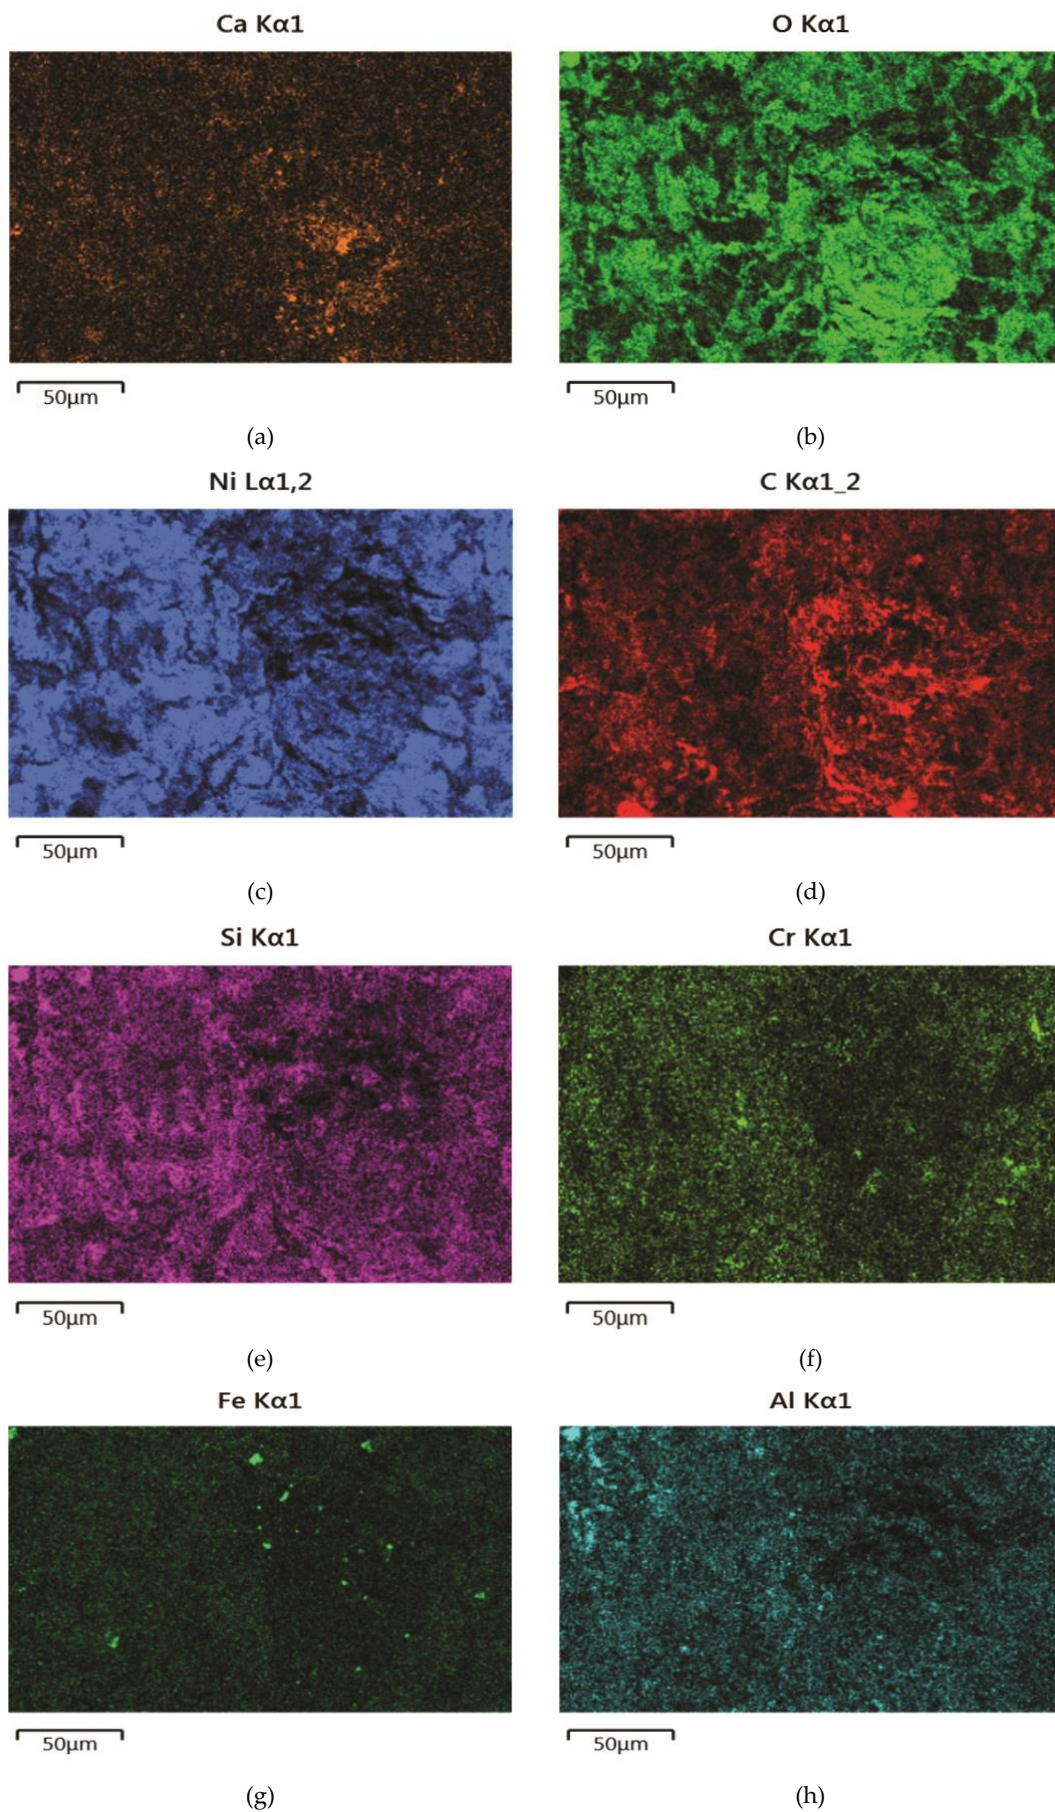
Fig. 18. Surface distribution of elements: a) Ca; b) O; c) Ni; d) C; e) Si; f) Cr; g) Fe; h) Al, made for the area of pitting and its close surroundings from Fig. 14a

3. The bottom of all pits is filled with glass, which indicates that the glass surface of the working surface of the glass mold is too wet.
4. Too high wettability is associated with many factors driving the surface tension system at the contact point of three phases (atmosphere, liquid glass and mold surface). In the context of the case under consideration, the most important variable is the temperature of the formed glass or the surface temperature of the mold.
5. In order to reduce the wear of the working surface of the pad-weld, it is necessary to lower the glass temperature (or increase the intensity of cooling the mold) to obtain a safely low wettability with liquid glass of the mold surface during the molding process.
