Mykola Orlenko\*

Ivan Buzin\*\*

## Stylistic peculiarities, features of the use of building materials and structures in buildings of the latter half of the nineteenth century and the early twentieth century, and methods for their restoration (evidence from Ukraine)

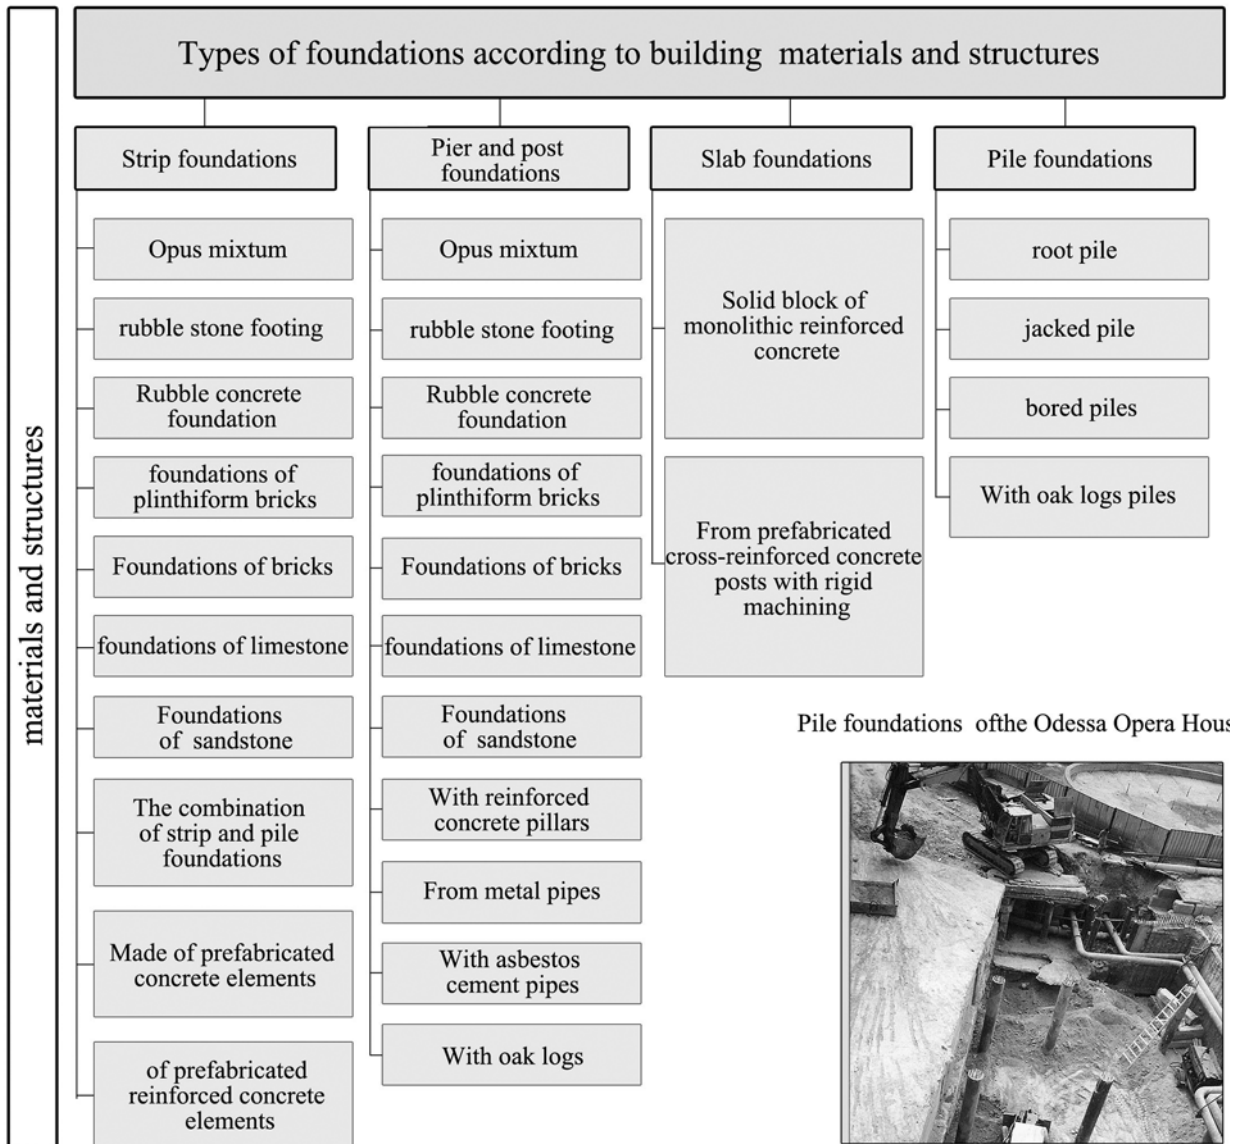
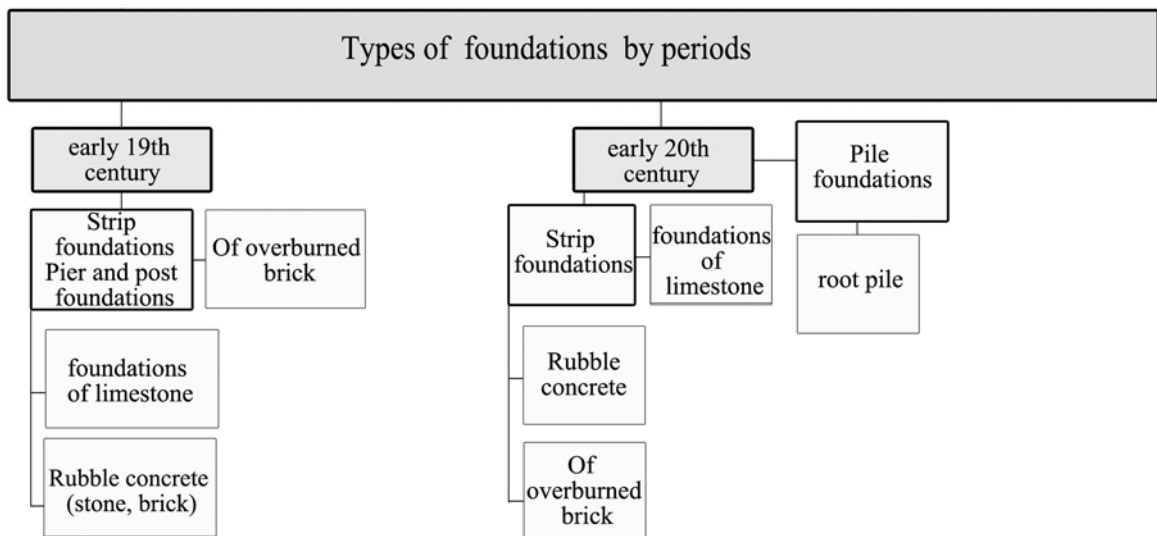
Fig. 1. Types of foundations and methods of their strengthening

## Types of foundation of restoration objects by materials and structures

## Types of foundations of restoration objects by periods

tion – building” system, the loss of which leads to its emergency state. At all periods, except for the beginning of the twentieth century, strip and pier footings were used. In the second half of the nineteenth century there were foundations made of over burned bricks or of limestone and rubble concrete (stone, brick) foundations. At the beginning of the twentieth century with the invention of the pile system, besides the strip foundations made of limestone, of over burned bricks and rubble concrete foundations, the foundations of bored piles were used. Thus, we can conclude that the most significant changes in the development of the “footing-foundation” system occurred at the beginning of the twentieth century, and in other periods, already existing foundation systems were practically spread and improved. Yes, this includes limestone and sandstone foundations, rubble concrete foundations, and footings for wooden and stone buildings made of oak logs. Some types of foundations – like the foundation of the “opus mixtum” type – disappeared after the Tatar-Mongol invasion, some – like foundations made of over burned bricks – emerged only in the seventeenth century. At the end of the nineteenth and at the beginning of the twentieth century, a combination of strip and pile foundations was introduced (“House with Chimaeras”, the Roman Catholic Church of Saint Nicholas in Kyiv) Fig. 1.

Most of the causes of the emergency state of the vaults and ceilings are based on a change in the hydro-geological conditions of the footings and foundations, as evidenced by the emergency condition of the structures of the Odessa Opera Theatre, caused by flooding of its footings and foundations, subsidental phenomena through the bulk soils, karst phenomena; overweight of additional technical equipment of the stage box; errors in the use of the system of strip foundations of various widths and depths for the building of the significant weight, the ineffectiveness of the works on silicatization of footings [13, pp. 191–192] Fig. 1–2.

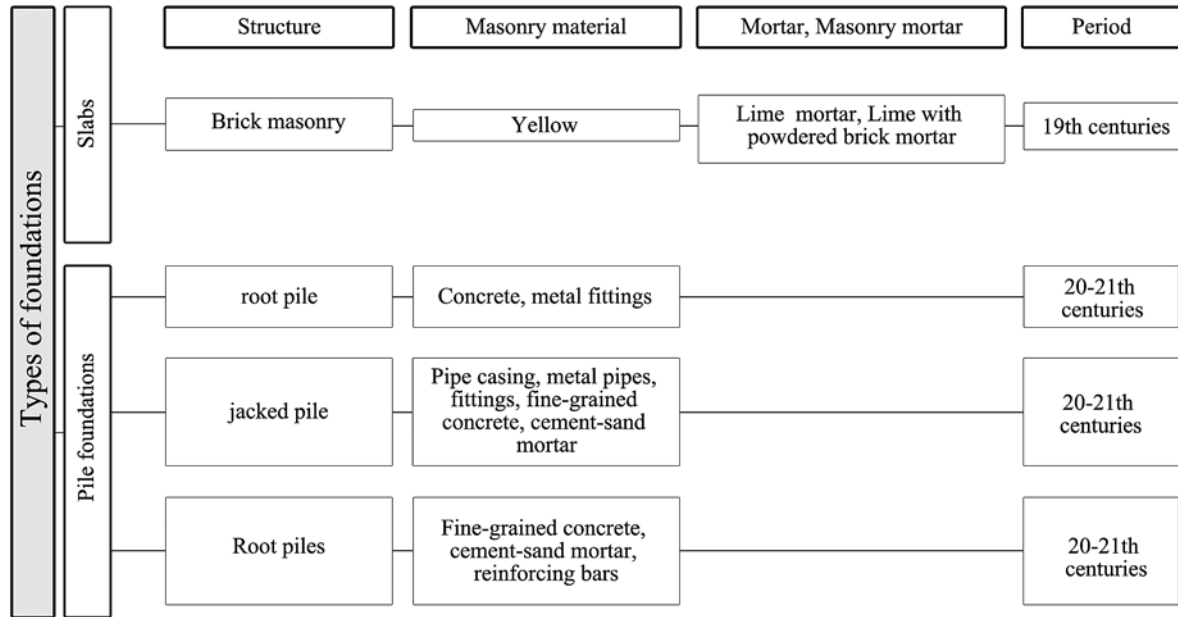
## Types of foundations by building materials and periodization

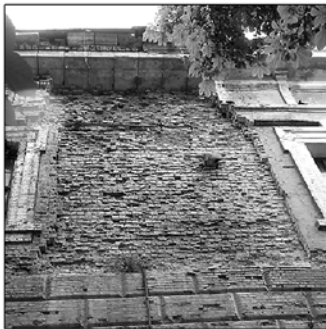
Coursed masonry of red brick of the 19th century (Mystetskyi Arsenal)

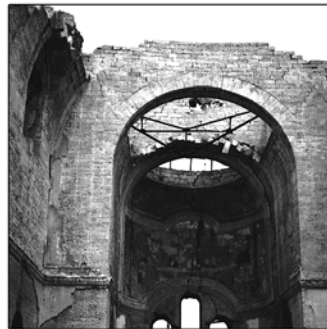
Coursed masonry of yellow brick of the 19th century ( St. Volodymyr's Cathedral in Chersonese)

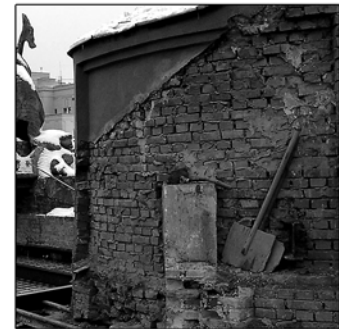
Coursed brick masonry of the early 20th century (The House with Chimaeras)
