**OPERATION-ORIENTED STUDIES ON WEAR PROPERTIES OF SURFACE-HARDENED ALLOY CAST STEELS USED
IN MINING IN THE CONDITIONS OF THE COMBINED ACTION OF DYNAMIC FORCES
AND AN ABRASIVE MATERIAL**

This paper presents the results of wear tests of shot-peened and not shot-peened cast steels used in the mining machinery industry, in particular in the construction of chain drums for armoured face conveyors. Wear tests were carried out in the conditions corresponding to the real operating conditions of armoured face conveyors during drifting work in rocks such as sandstone. The operating factors subjected to the analyses included the presence of quartz abrasive and the impact of external dynamic forces. On the basis of the wear tests as well as the microhardness and microstructure examinations performed, it has been found that the action of an additional dynamic force has a synergistic impact on the process of abrasive wear in loose quartz abrasive. It has been further found that the value of abrasive wear of chain wheels operated in the conditions of a combined action of abrasive and a dynamic force depends on whether the area of mating of wheels with the chain was shot-peened or not before the

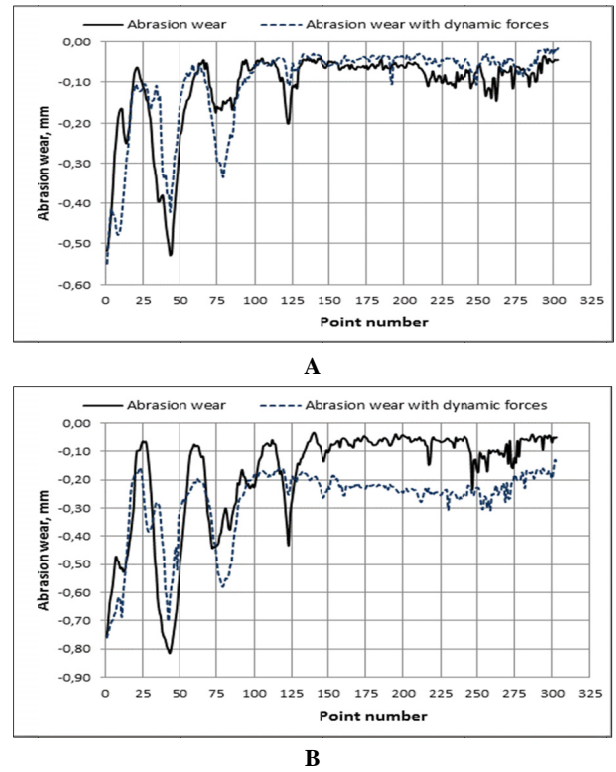
Fig. 17. Graphs of the value of averaged wear of the i -th point of the measuring route δ_{i_AVG} determined for the chain wheel made of the L35GSM cast steel, A – wheels not subjected to shot peening, B – wheels subjected to shot peening
