## AEROPHYTIC CYANOBACTERIA AS A FACTOR IN THE BIODEGRADATION OF TECHNICAL MATERIALS ON EXTERNAL BUILDING WALLS

The study conducted at the Institute of Environmental Engineering, UZ was aimed at demonstrating which species of aerophytic cyanobacteria in the biofilm caused the biodegradation of the external building wall.

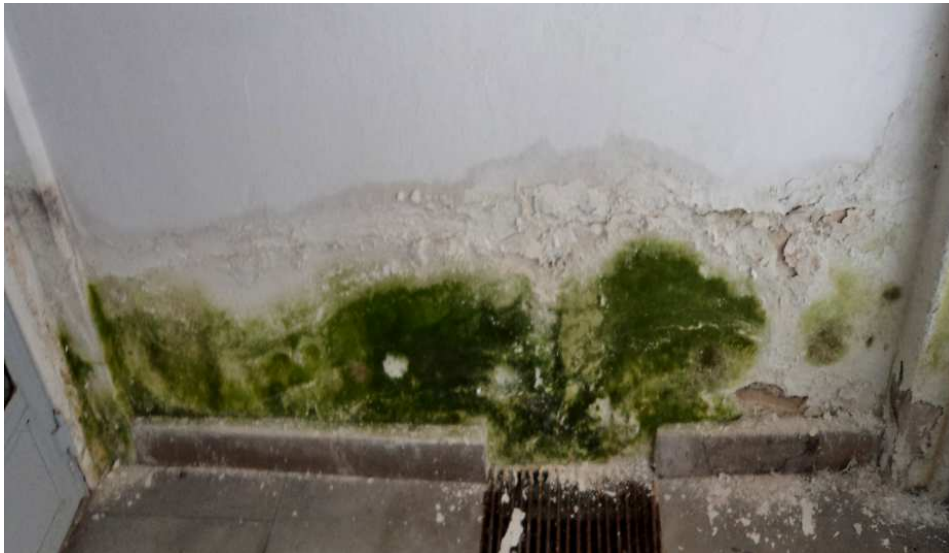
The external wall of the former UZ canteen was selected for research due to its perceptible biodegradation. On the wall there was visible discolouration and signs of structure degradation: cracking, scaling and crumbling of the technical material (Photo 1.). At present, the building is not used and it is ready for renovation. The wall selected for the study is located in a shaded canteen hall, exposed to moisture due to the leaking roof. The partition selected for research is built from solid bricks and covered with lime-cement plaster.

Photo 1. The external building wall with visible biocorrosion on the building of the former UZ canteen

The external building wall discussed in the paper provided conditions conducive to the colonization and growth of organisms causing biocorrosion. The degradation of technical material was very clear and it was characterized by surface discolouration and the destruction of the structure by numerous cracks and layer separation. During the research high moisture was detected in the areas with biological blooms. In the biofilm on the elevation aerophytic cyanobacteria were detected. Four species of cyanobacteria were identified. They all contributed to the creation of biological bloom on the wall and the initiation of biodeterioration processes of the technical materials.

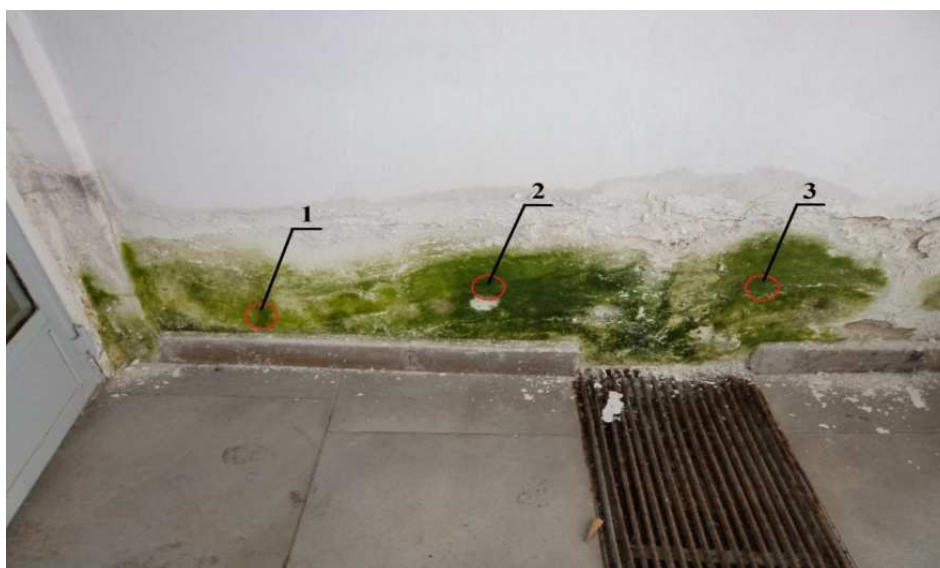
The material from the wall was sampled in April 2013. A fragment of biological material intended for laboratory growth and microscopic observations was taken off the wall with a sterilized scalpel. The samples were taken at three places of the bloom-covered wall (Photo 2).

Photo 2. The three sampling points (marked 1,2,3) on the biodeteriorated external building wall

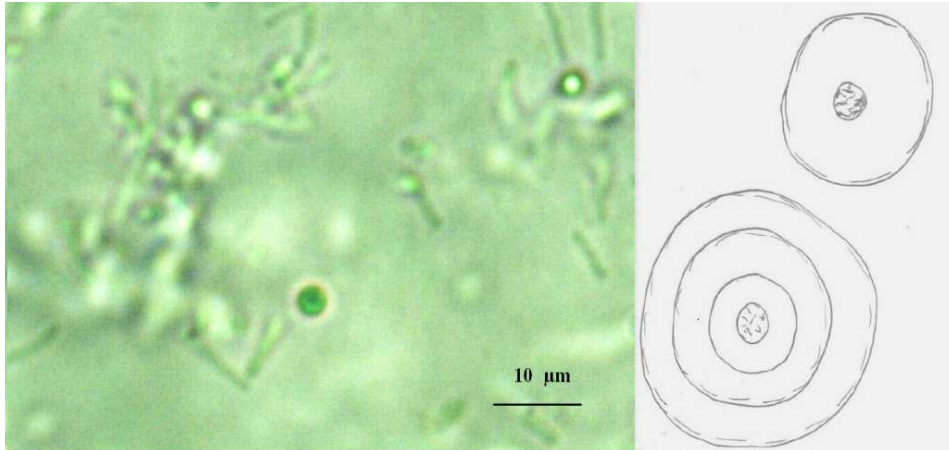
- *Gloeocapsa montana* Kützing (Photo 3) frequently occurs on moss, moist rocks and walls. Spherical or slightly elliptical cells, usually enclosed in broad, colourless, delicately concentrically layered coatings [17].

Photo 3. *Gloeocapsa montana* Kützing (on the left: microscopic image, on the right: sketch of view)

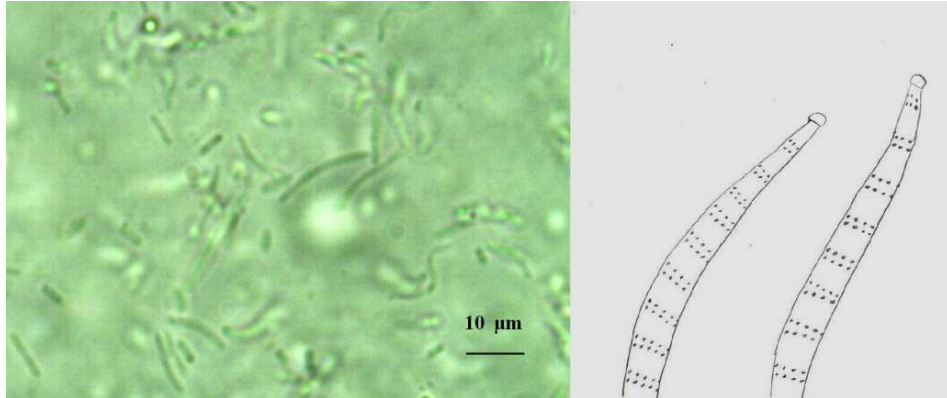
- *Phormidium calcareum* Kützing (Photo 4) occurring on damp limestone. Layered, light blue and green, leathery thalli. The cell tip sharply conical, sometimes with capitate, nearly spherical formation on top [17].

Photo 4. *Phormidium calcareum* Kützing (on the left: microscopic image, on the right: sketch of view)

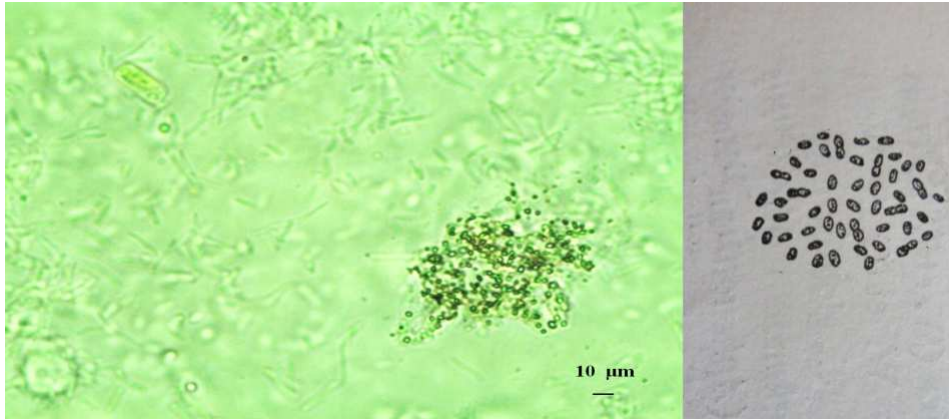
- *Aphanothece saxicola* Nägeli (Photo 5) occurs on moist rocks and walls. Microscopic spherical colonies blending into shapeless gelatinous thalli, pale blue and green, occasionally yellowish or violet in colour. Long, cylindrical cells, single or in pairs.

Photo 5. *Aphanothece saxicola* Nägeli (on the left: microscopic image, on the right: sketch of view)

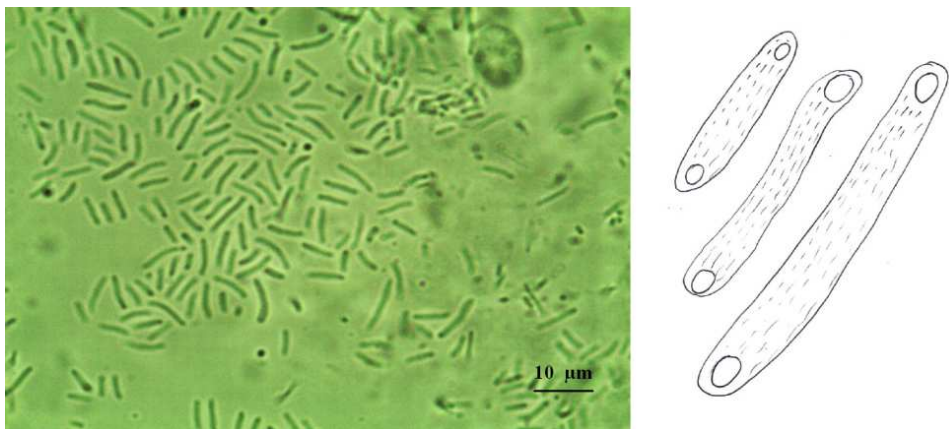
- *Gloeothece caldariorum* (P.Richter) Hollerbach (Photo 6) also occurs on moist rocks and walls. Broadly spread gelatin coatings consisting of single or double cells with a single glossy grain at either end [17].

Photo 6. *Gloeothece caldariorum* (Richter) Hollerbach (on the left: microscopic image, on the right: sketch of view)
