## Geotechnical Prospects and Electrical Tomography to Study Slope Instability in the Rif Alboran Sea Shoreline on the Mediterranean By-Road (Northern Morocco)

**Keywords:** landslide, slope instability, geotechnical, electrical tomography, mediterranean by-road, Northern Morocco.

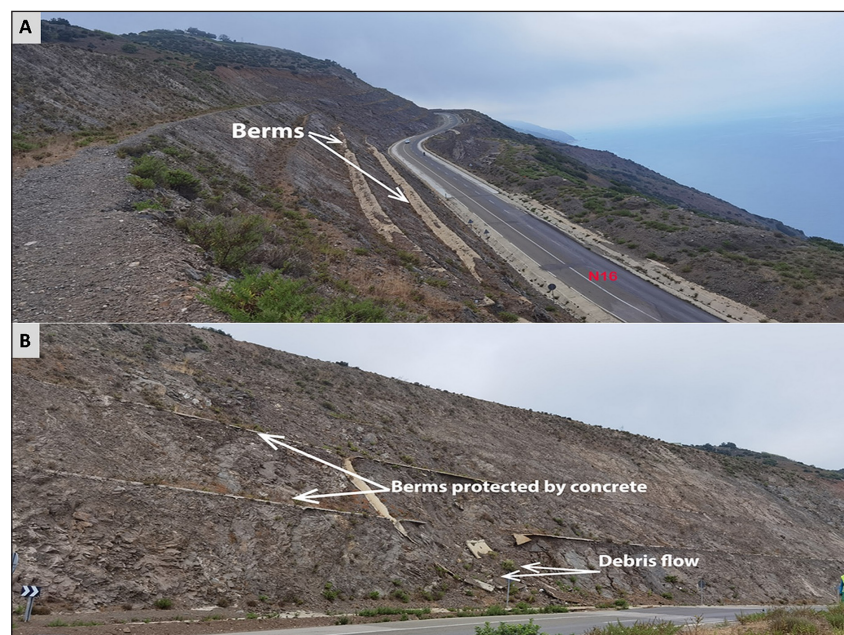
**Figure 4.** General overview of the study area

and (Fig. 5). The roadway and the shoulders that cross the landslide area are marked by subsidence and intense cracking, the guardrails are detached and damaged (Fig. 5), which explains that the observed landslide is still active and moving towards the sea. The roadway in this landslide area has collapsed and the hydraulic structure is damaged (Fig. 5.D). The vegetation layer still visible in places on the crest is very thin and is gullied by runoff during each rainfall. This further activates

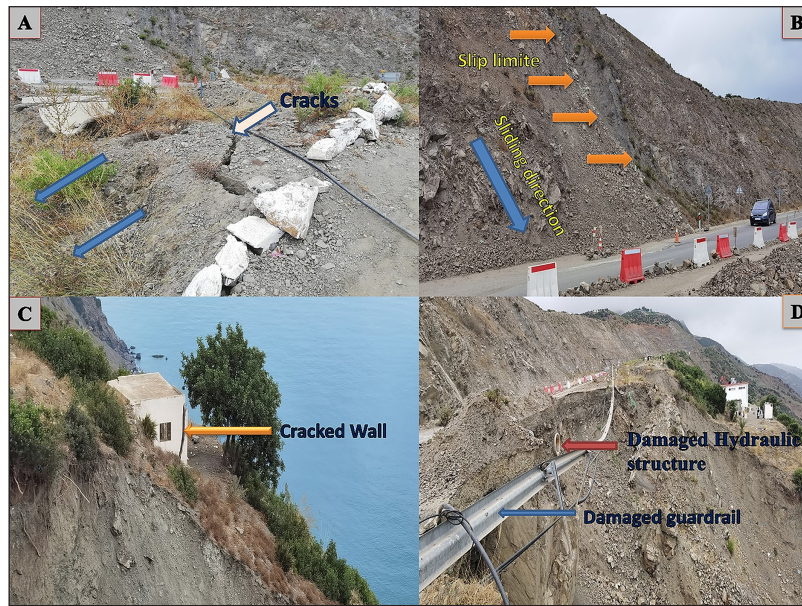
**Figure 5.** (a) Cracks and subsidence in the road sides, (b) limit and direction of the slide, (c) crack in the wall of a small house, (d) collapse of the roadway and damaged structures

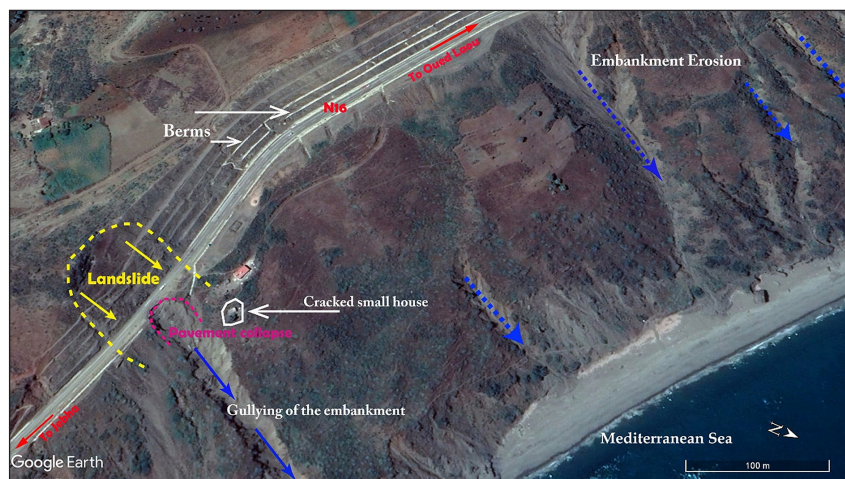
**Figure 6.** Status of the study area

The ground movements in the studied slope can be divided into two zones (Fig. 6): A large part (Zone 1) where the escarpment is subject to relatively recent and local degradation, which for the moment does not affect the road (Fig. 4). The foot of the slope in this zone is remarkably eroded (Fig. 6). A second surface (Zone 2) can be observed where the berms are clearly curved downwards with more significant degradation and scree. Moreover, this last area is limited by cracks and subsidence, suggesting the formation of a complex landslide with clearly defined boundaries (Fig. 6)

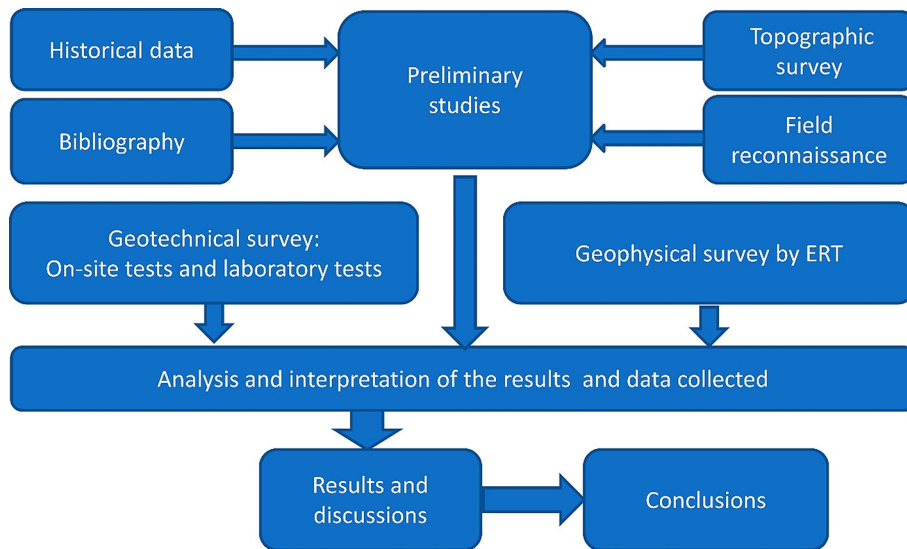
Figure 7. Process and methodology

The adopted methodology (Fig. 7) is based on a preliminary study including historical and bibliographical research completed by field surveys and a topographic survey at a scale of 1:5,000.

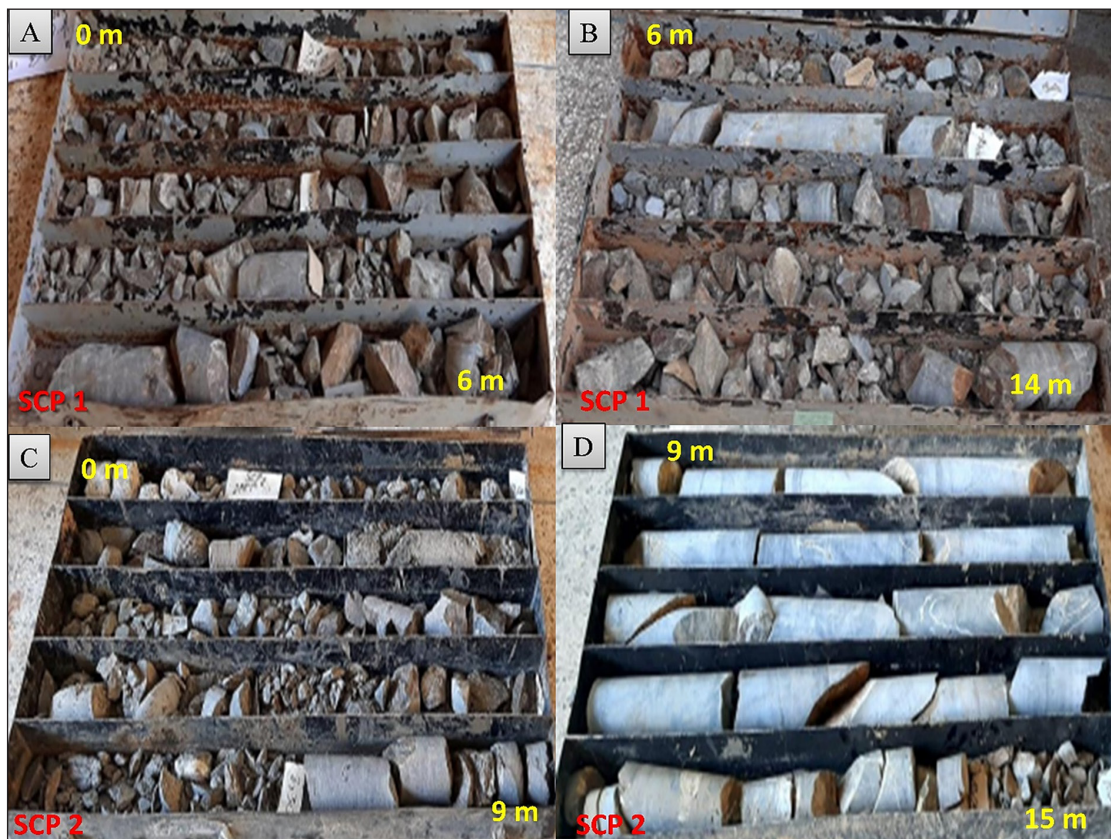
**Figure 9.** The first two core drilling plates SCP 1 & SCP 2: A SCP1 borehole from 0 to 6 m; B SCP1 borehole from 6 to 14 m; C SCP2 borehole from 0 to 9 m; D SCP2 borehole from 9 to 15 m

The analysis of the core samples from SCP1 and SCP2 (Fig. 9) and (Fig. 12), shows that at the level of the roadway, the shaly substratum is reached after about 5 meters of depth. Therefore, a mixture of shale debris and the backfill material forming the pavement body forms of the surface layer. Yet, the greyish shale in the subsoil is heavily fractured and contains whitish calcic seams. In the SCP3 borehole, which is located on the roadway next to the hydraulic structure, it can be seen that the material extracted from the cores consists of backfill material to a depth of around 9 m (Fig. 12). The shale can be identified after this depth, but it is much crushed and is embedded in a greenish or greyish silty-marl matrix. Borehole SCP4, located in the landslide right-of-way, shows a disordered stratification, confirming the structural disorder in this area due to the landslide and the dynamic activity of the slope at this location. At a depth of between 12 m and 15 m, a layer of silty marl, about 2 m thick, can be seen (Fig. 10) (Fig. 12). This layer certainly represents the landslide line and its thickness. The SCP5

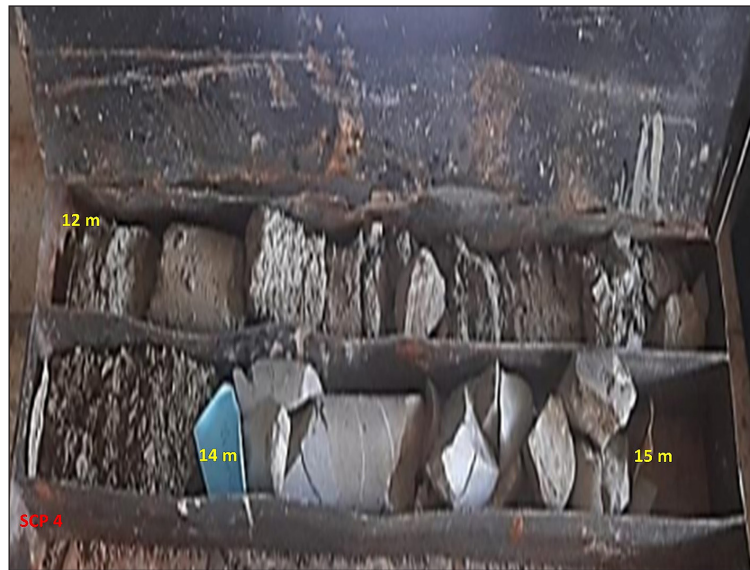
Figure 10. Core-drilling plates of SCP4 borehole between 12 and 15 m depth

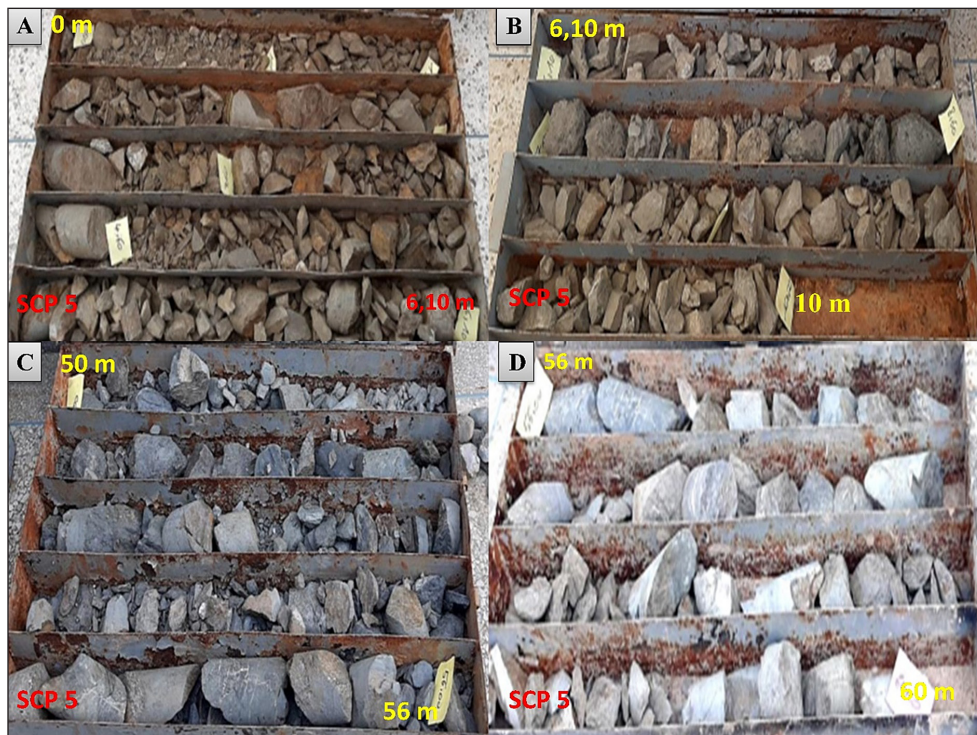
Figure 11. Core-drilling layers of the SCP 5 borehole

borehole (Fig. 11) (Fig. 12), located at the crest of the hill, confirms the small thickness of the crust, not exceeding one meter in thickness. Below this, alternating fractured schistose layers separated by greenish or greyish marl and clayey cleavage joints can be seen, sometimes crossed by white calcic seams. After a depth of about 20 meters, the shale is relatively hard with a decrease in the fracture rate with depth.
