## BUILDINGS ERECTED WITH UNCONVENTIONAL MATERIALS IN GRAJEWO AND RAJGRÓD COMMUNES, N-E POLAND: RESULTS OF FIELD SURVEYS IN 2021

Renata Adamska\*, Katarzyna Karwowska\*, Jarosław Szewczyk\*\*

### Abstract

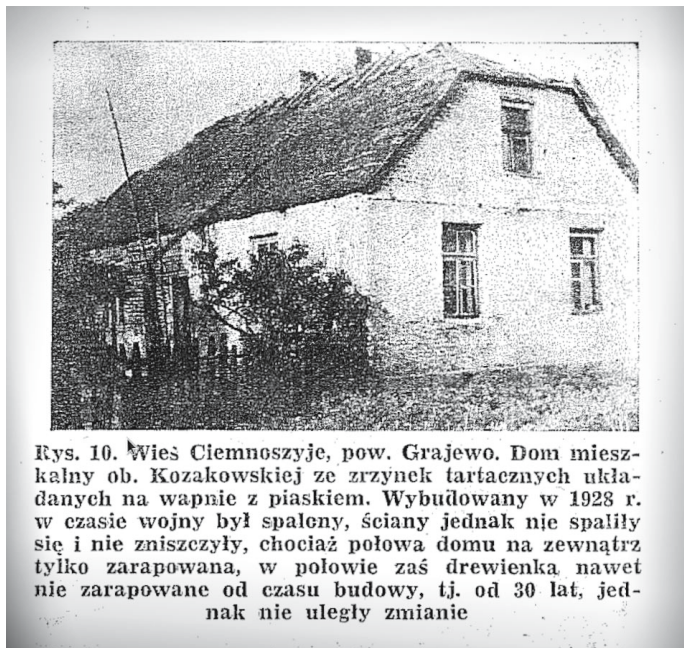
Rys. 10. Wios Ciemnoszyje, pow. Grajewo. Dom mieszkalny ob. Kozakowskiej ze zrzynek tartacznych układanych na wapnie z piaskiem. Wybudowany w 1928 r. w czasie wojny był spalony, ściany jednak nie spaliły się i nie zniszczyły, chociaż połowa domu na zewnątrz tylko zarapowana, w połowie zaś drewnienka nawet nie zarapowane od czasu budowy, tj. od 30 lat, jednak nie uległy zmianie

Fig. 2. A farmhouse made with cordwood in 1928 in Ciemnoszyje; source: M. Łukaszewicz [1958, p. 14]

In Ciemnoszyje, the commune of Grajewo, an old farmhouse was built with cordwood and lime mortar in 1928. Three decades later it was mentioned by Menandr Łukaszewicz [1958, p. 14] (Fig. 2). The authors failed to find it nowadays. Probably, the building was dismantled several decades ago.

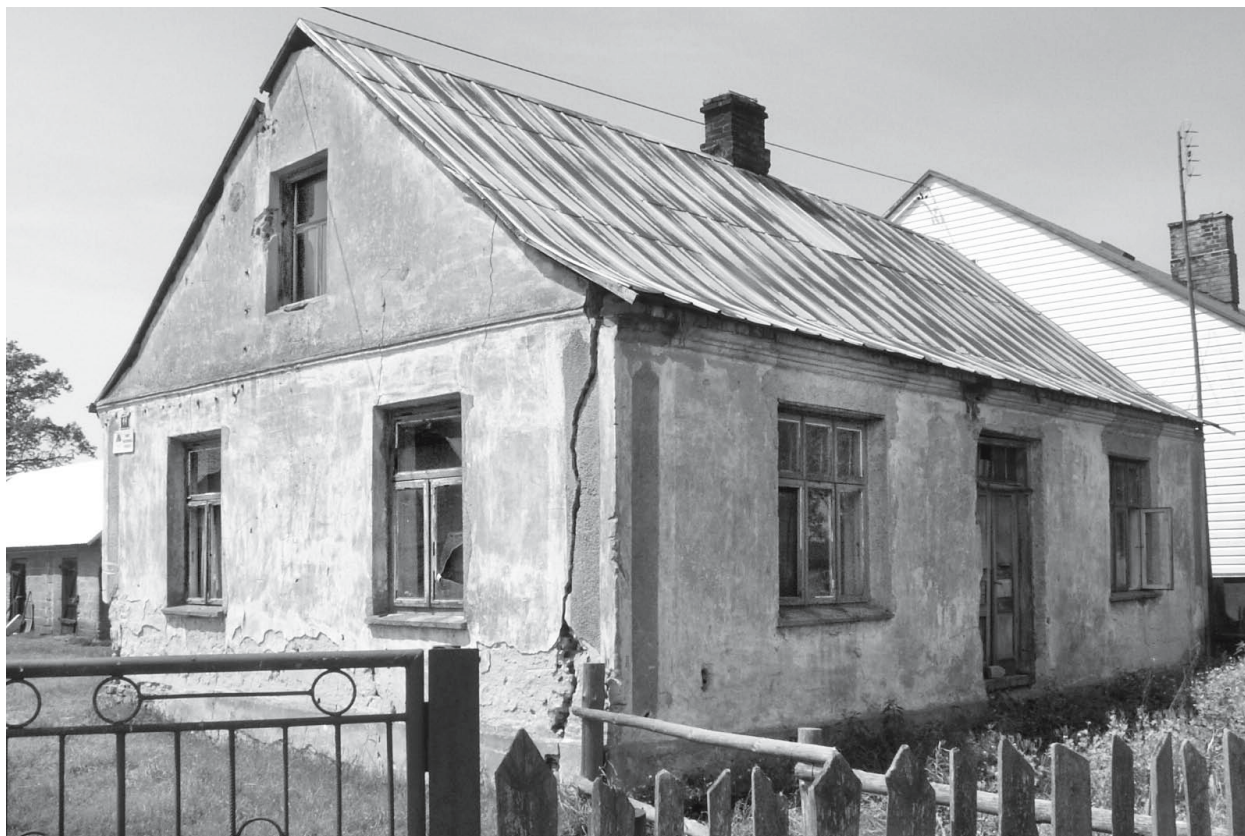
Another cordwood masonry farmhouse in Ciemnoszyje was found by Jarosław Szewczyk in 2010 [p. 359] (Fig. 3). Presumably, it was built in the 1930s. According to a villager the authors met during the survey, the building had ceased to exist a few years before.

Fig. 3. Another farmhouse made with cordwood in Ciemnoszyje; photo: J. Szewczyk, 2010

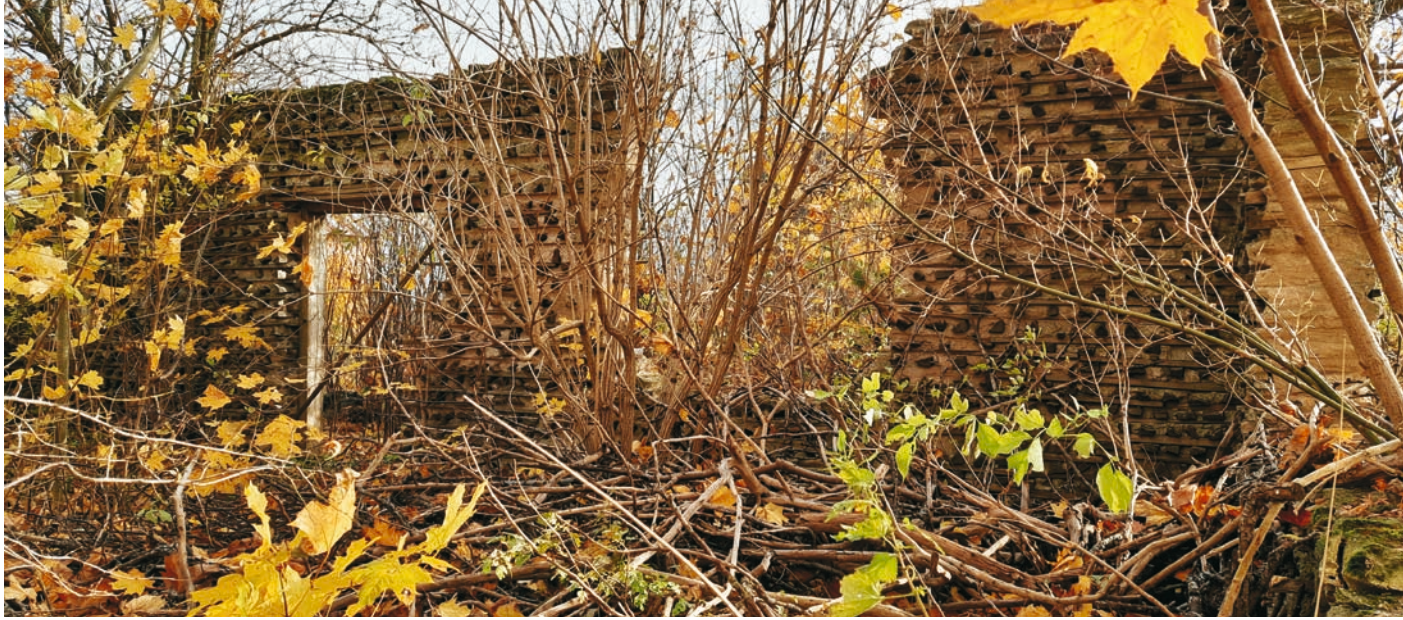
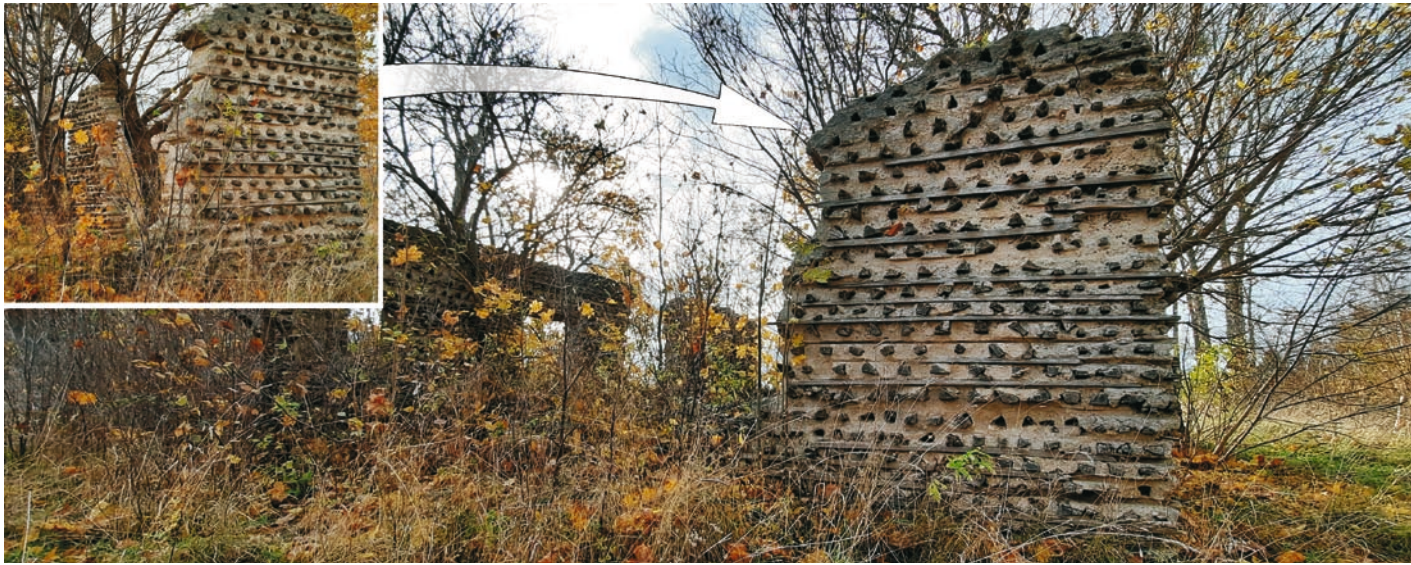
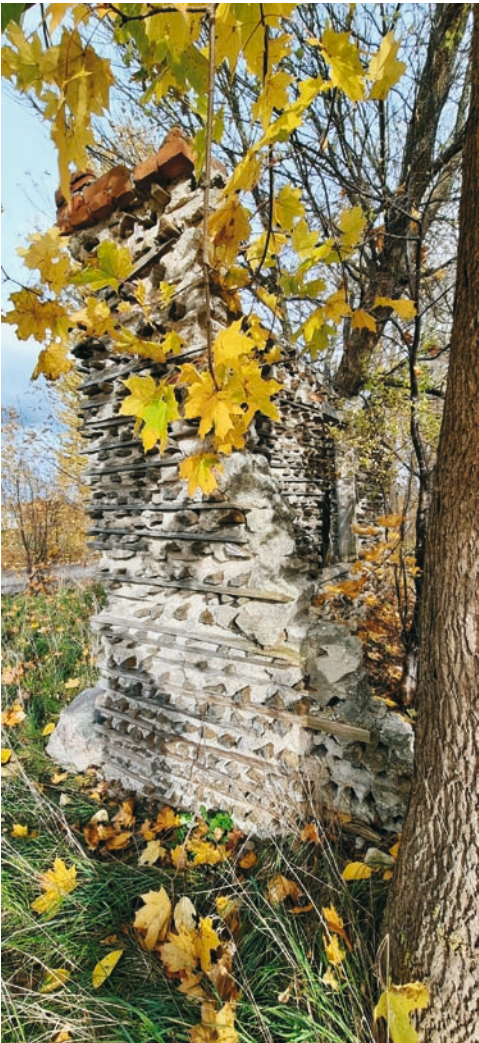
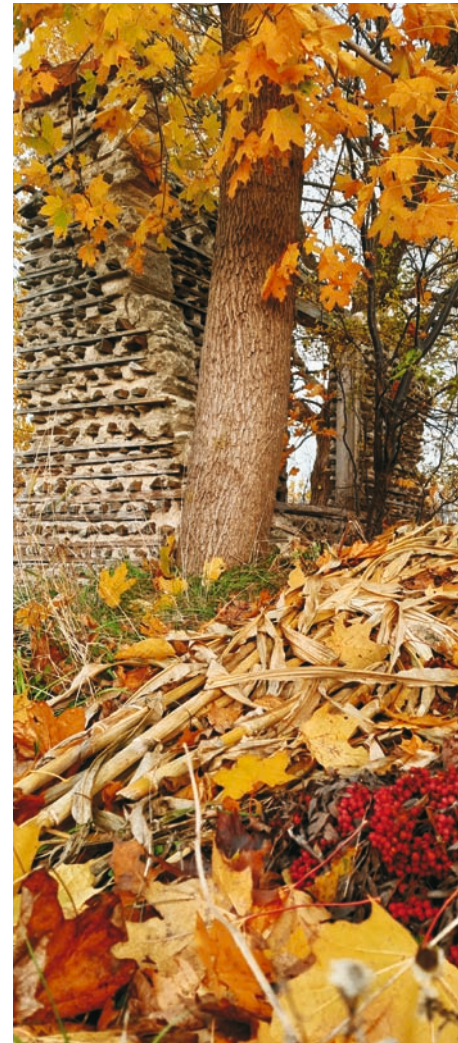
The authors also verified earlier mentions about an old cordwood masonry house in Rydzewo Kolonia, the commune of Rajgród. The house was in a ruinous state in 2010 [J. Szewczyk, 2010, p. 360-361]. Surprisingly, its ruins still exist (Figs. 4-7). No local villagers were able to provide any detailed information about the house. Assumedly, it was built in the late 1920s and inhabited for over about half a century or less.

**Fig. 4-7.** Ruins of a cordwood house in Rydzewo Kolonia; photo: Renata Adamska and Katarzyna Karwowska, 2021

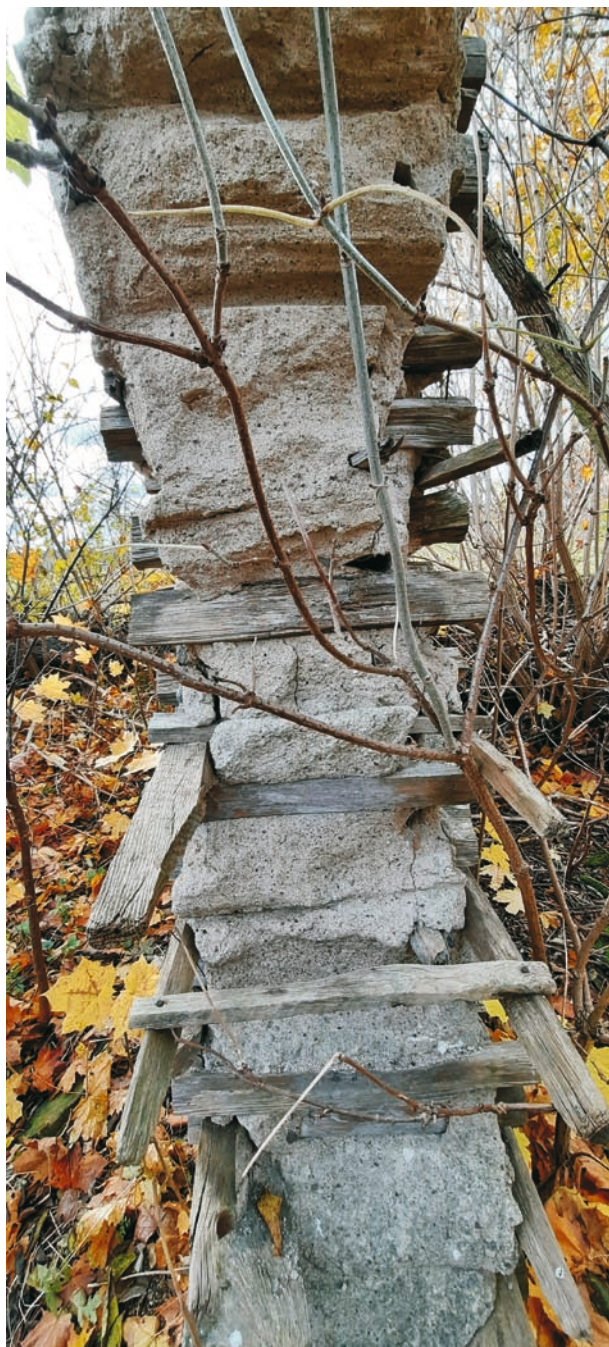
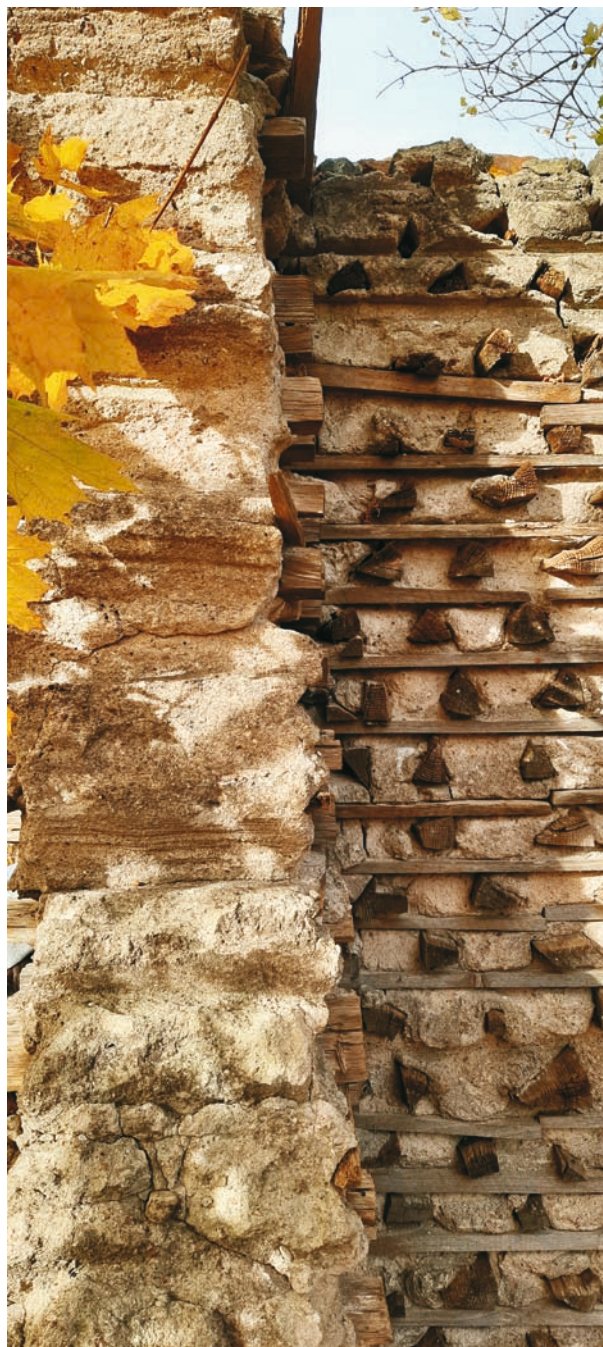
**Fig. 8, 9.** Cordwood masonry in Rydzewo Kolonia (wall details); photo: Renata Adamska and Katarzyna Karwowska, 2021

All these cordwood masonry buildings revealed the utmost workmanship perfection of their builders: brick foundations were robust, cordwood items and wooden reinforcing slats were carefully arranged and all the walls were perfectly vertical (Figs. 8-9). Window frames and jams, and door lintels were made of massive timber with their mortise tenon joints carefully carved out (Fig. 10).

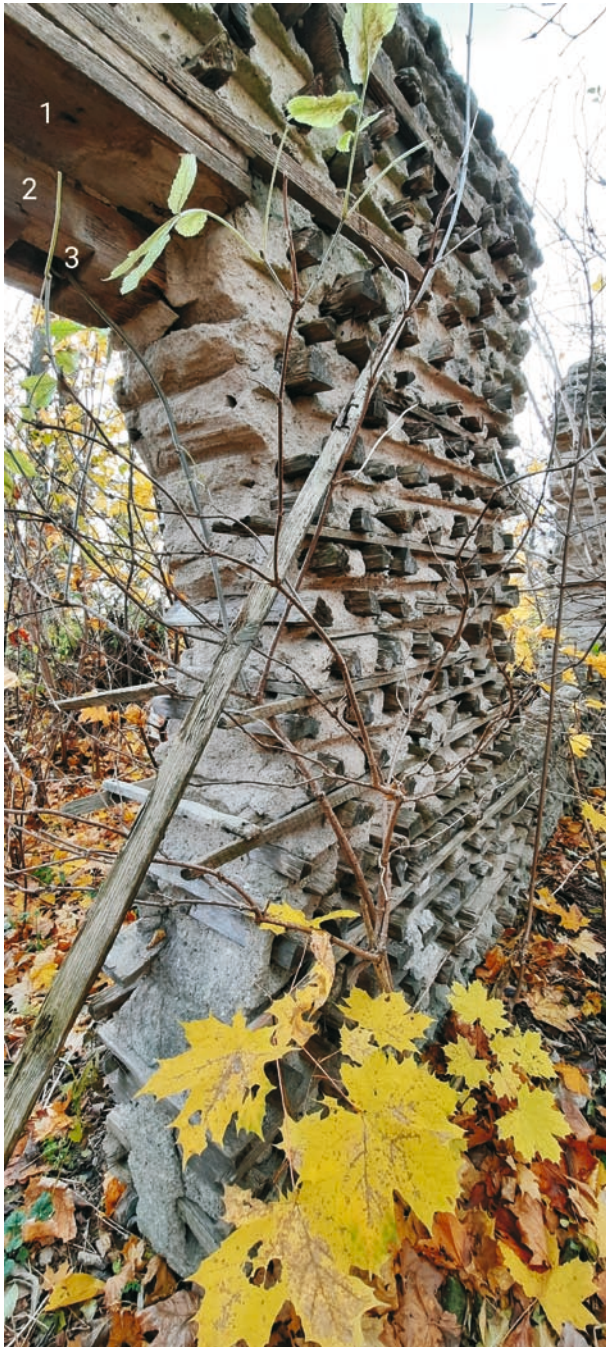
**Fig. 10.** Wall and carpentry details of the cordwood house in Rydzewo Kolonia: (1) door lintel; (2) door header; (3) mortise; photo: Renata Adamska and Katarzyna Karwowska, 2021

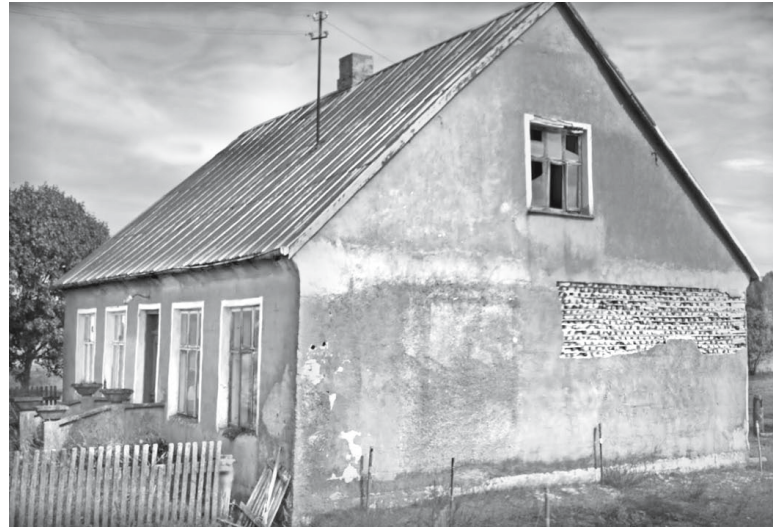
the commune of Grajewo in the mid-war period. Supposedly, a number of buildings with cordwood walls still exist, but they are difficult to find because their walls have been plastered. The authors found only one example which had not been described before, namely, a farmhouse in Pieńczykowo (Fig. 11). The building was erected in the 1920s, supposedly by a relatively rich family. Its showy front entrance stairs still witness its past relative glory, if compared to other farmhouses of that time.

**Fig. 11.** A farmhouse made with cordwood in Pieńczykowo; photo: the authors, 2018

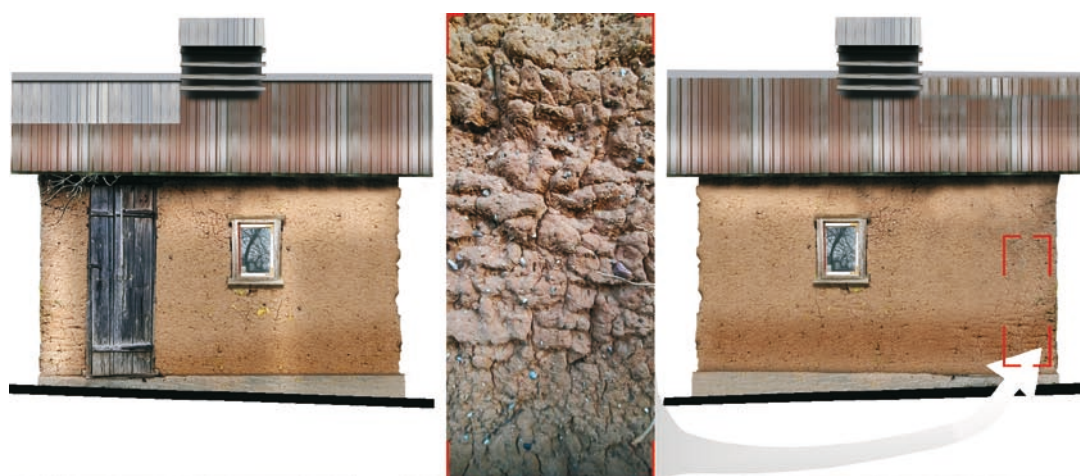
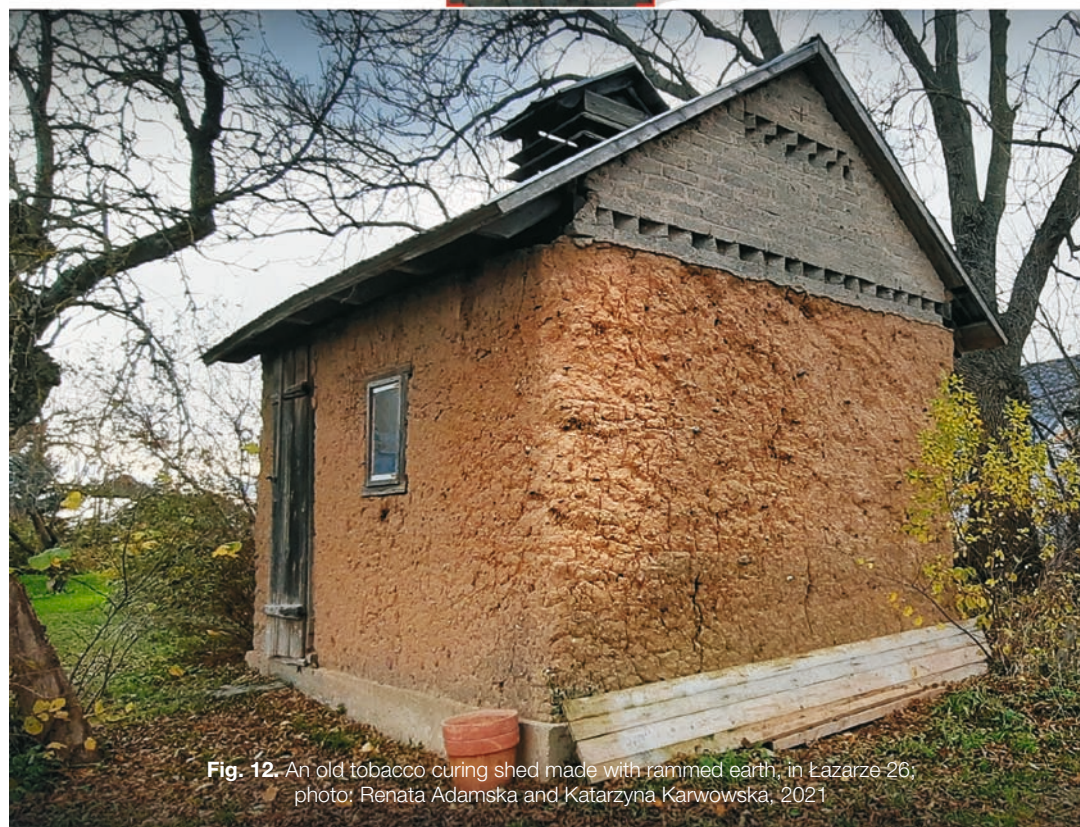
In Łazarze, the commune of Rajgród, according to locals, there were more earthen sheds in the past. They all were used as tobacco curing sheds, as the local community grew tobacco crops for tobacco industry in Augustów (from 1951). An old tobacco shed in Łazarze 26 now serves as a bakery of *sękacze* (*sękacz* is a type of *Baumkuchen* cake, claimed to be a regional cake; Figs. 12-13).

**Fig. 12.** An old tobacco curing shed made with rammed earth, in Łazarze 26; photo: Renata Adamska and Katarzyna Karwowska, 2021

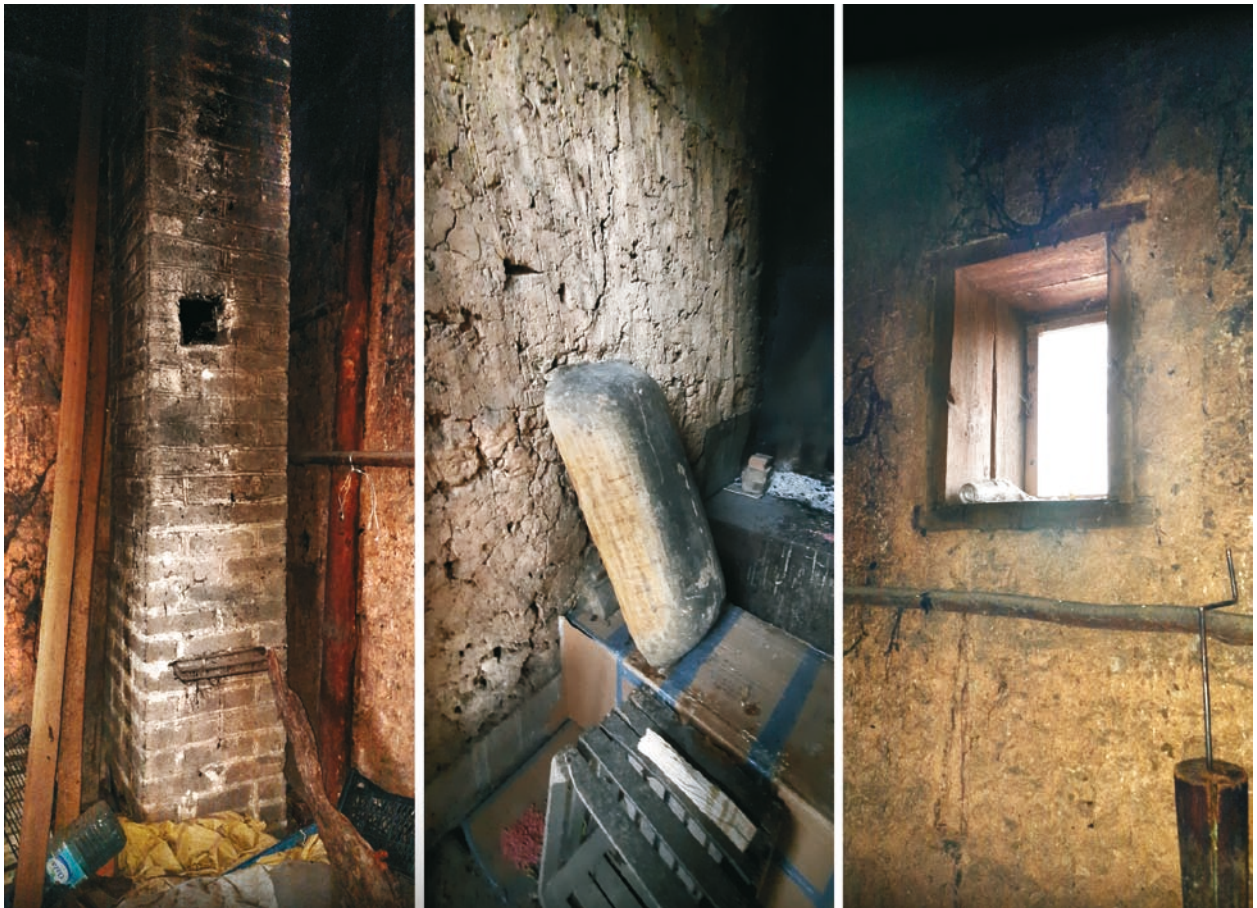
**Fig. 13.** The old tobacco curing shed inside (now a bakery), in Łazarze 26; photo: Renata Adamska and Katarzyna Karwowska, 2021

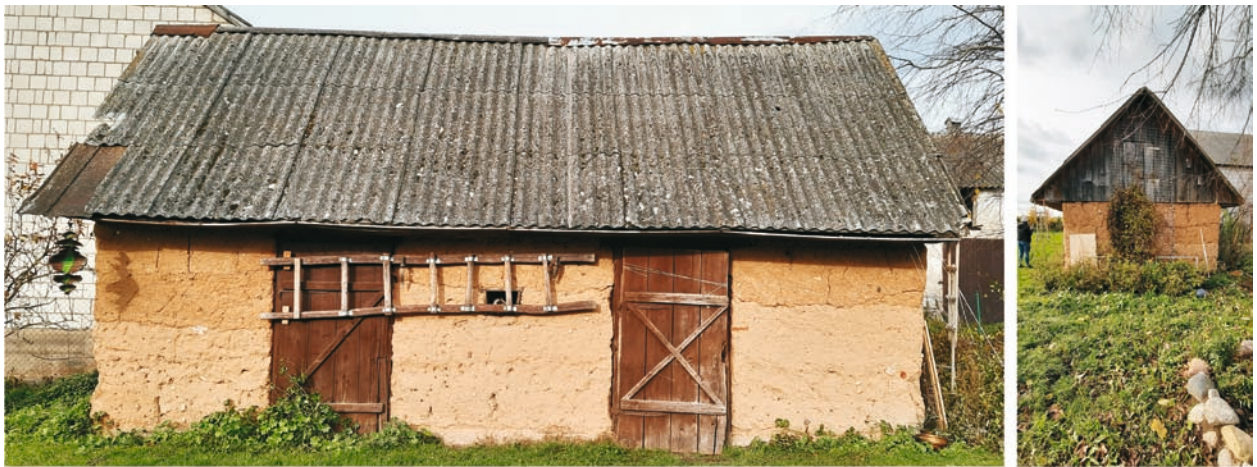
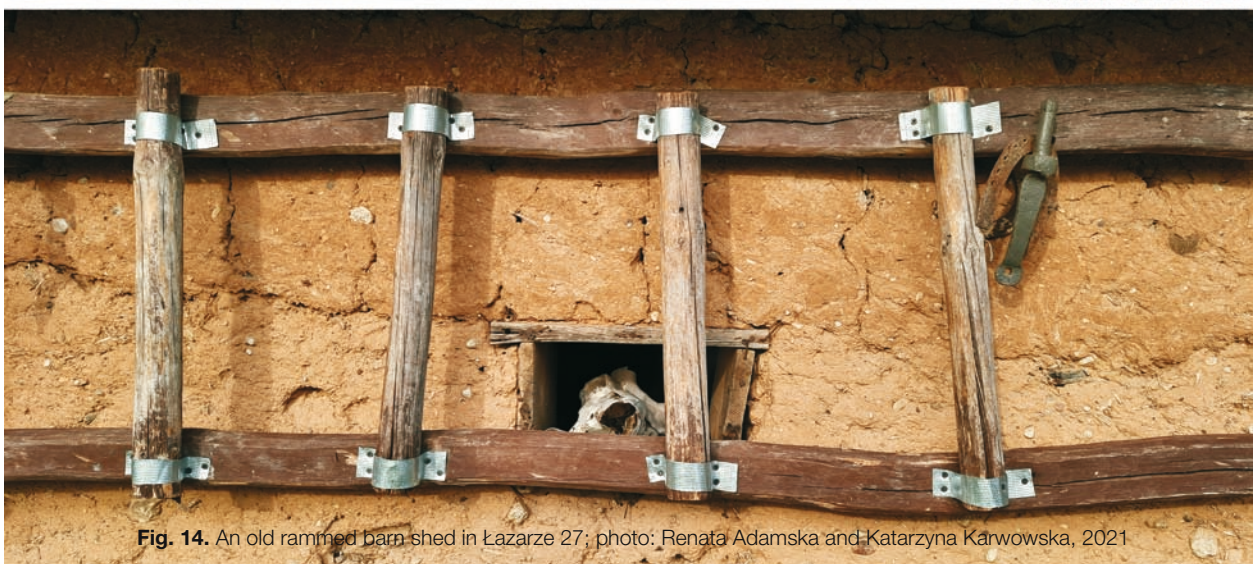
Another old earthen barn in Łazarze, although not plastered, still remains in a quite good technical condition (Fig. 14). Its walls were constructed with three to four horizontal courses of earthen mortar. The mortar consisted of substantial amount of chopped straw and earth just dug from the site with no transport needs. Both these earthen sheds were built in the early 1950s.

**Fig. 14.** An old rammed barn shed in Łazarze 27; photo: Renata Adamska and Katarzyna Karwowska, 2021

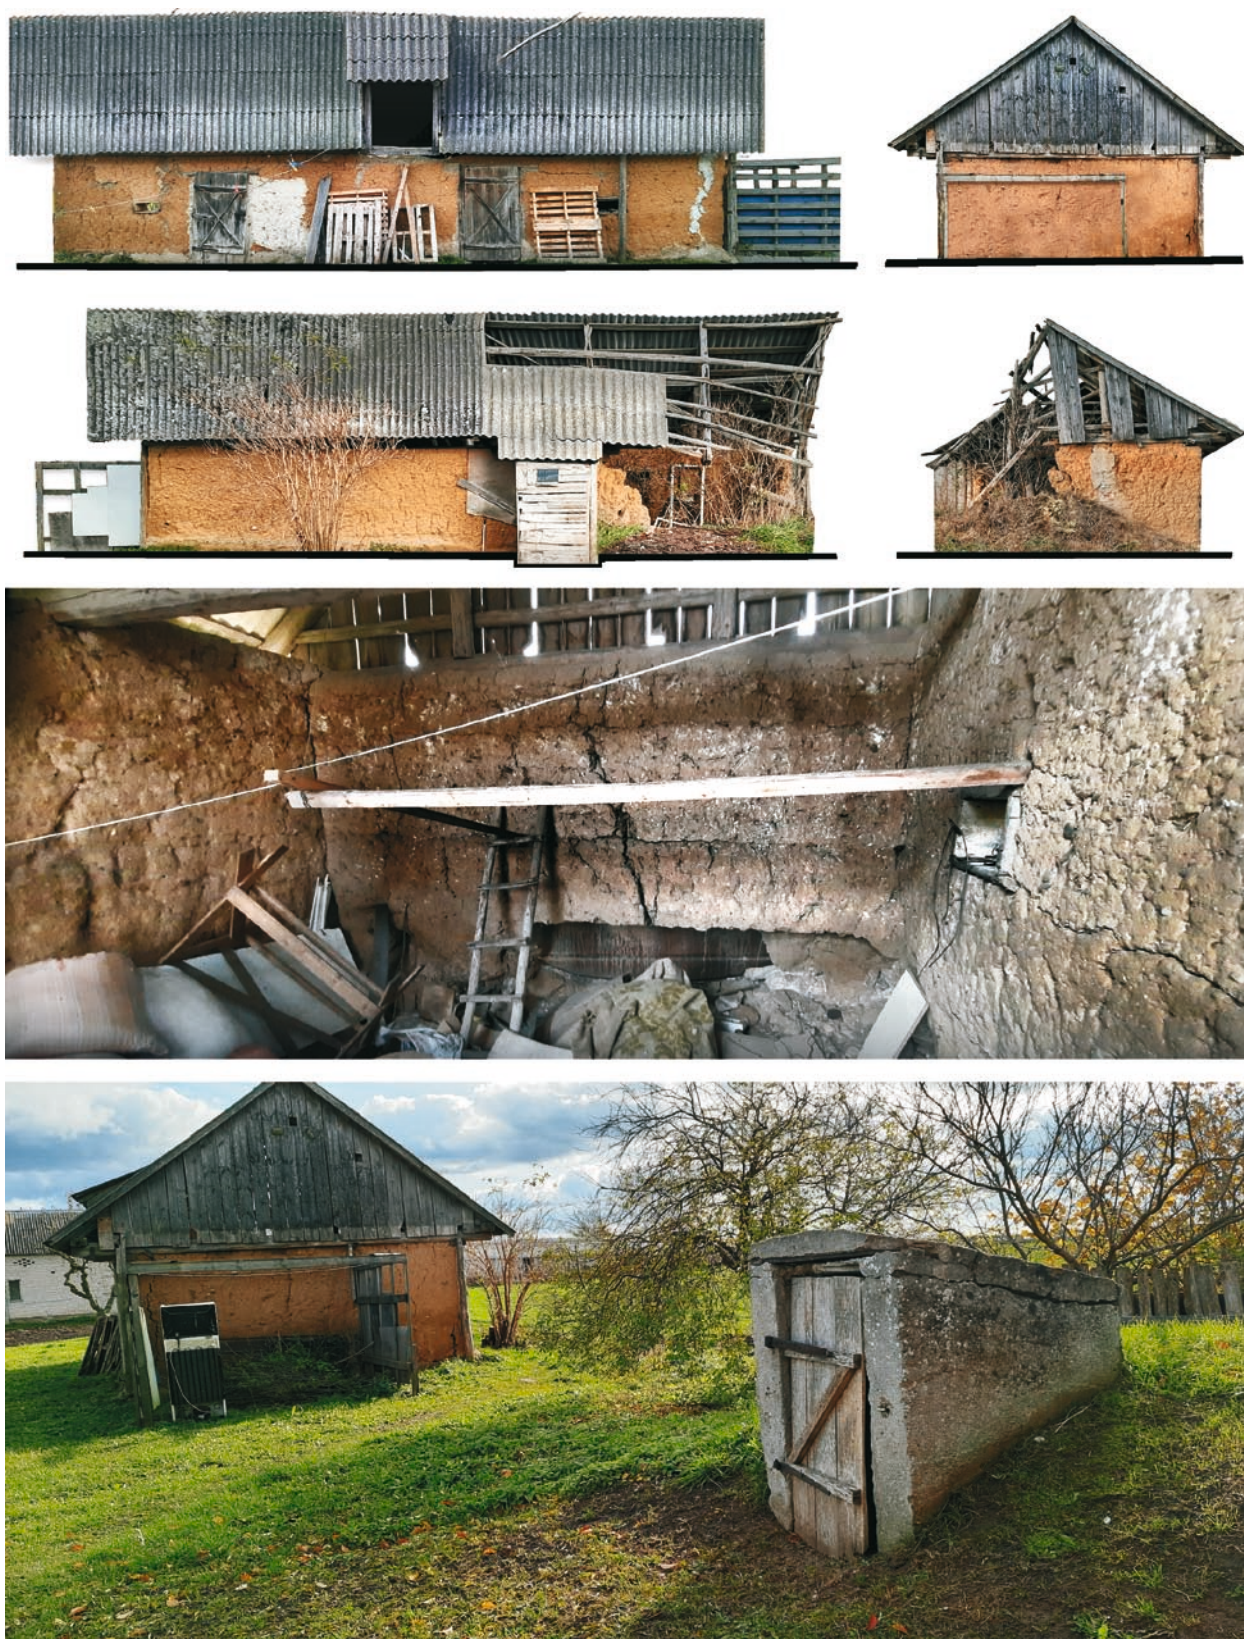
About a kilometre north-east away from Łazarze there is a small hamlet Kosify. Amongst its buildings there is another rammed earthen barn (Fig. 15), but rather in a ruinous condition. Its walls were erected in the 1950s with four courses of rammed earth mortar, each approximately 50 cm thick.

**Fig. 15.** An old rammed earth barn in Kosilų; photo: Renata Adamska and Katarzyna Karwowska, 2021

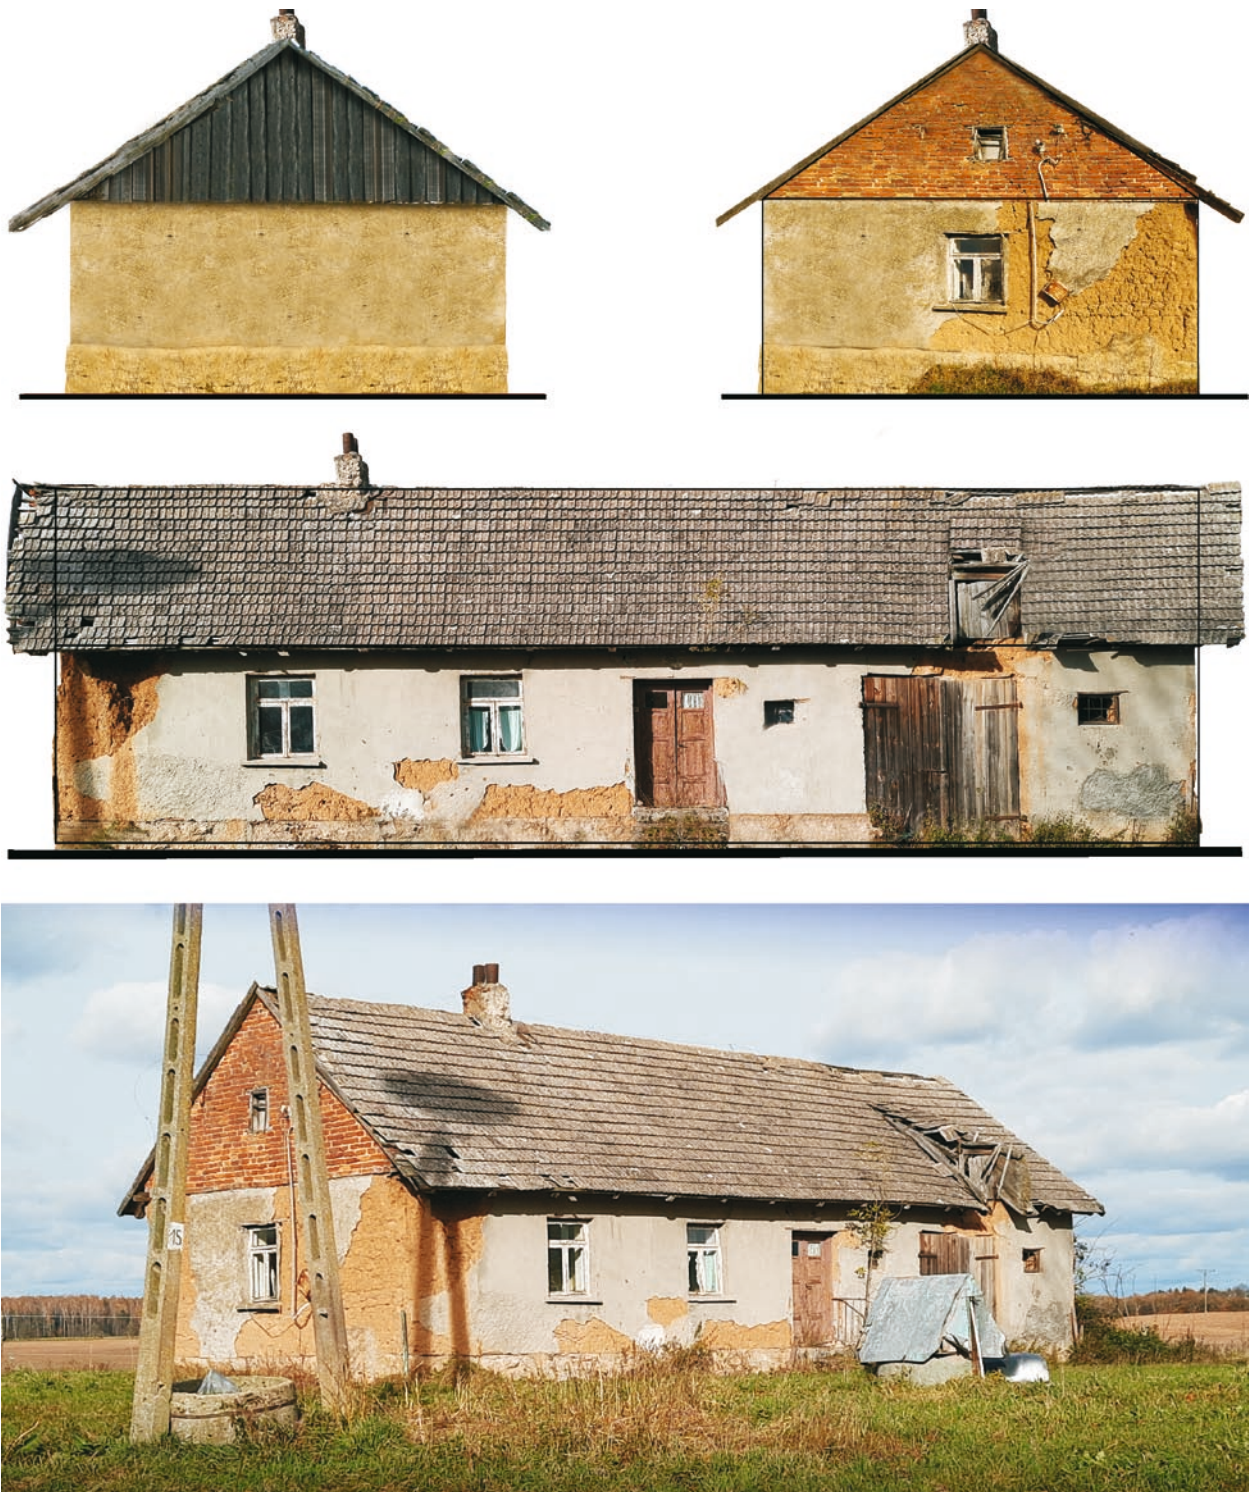
Yet another earthen barn still exists in Kołaki. Its walls are all earthen, except for the western gable wall, partly brick-masoned. Curiously, this western part of the building was used as a farmhouse in the past (Fig. 16).

**Fig. 16.** An old rammed farm building in Kolaki; photo: Renata Adamska and Katarzyna Karwowska, 2021

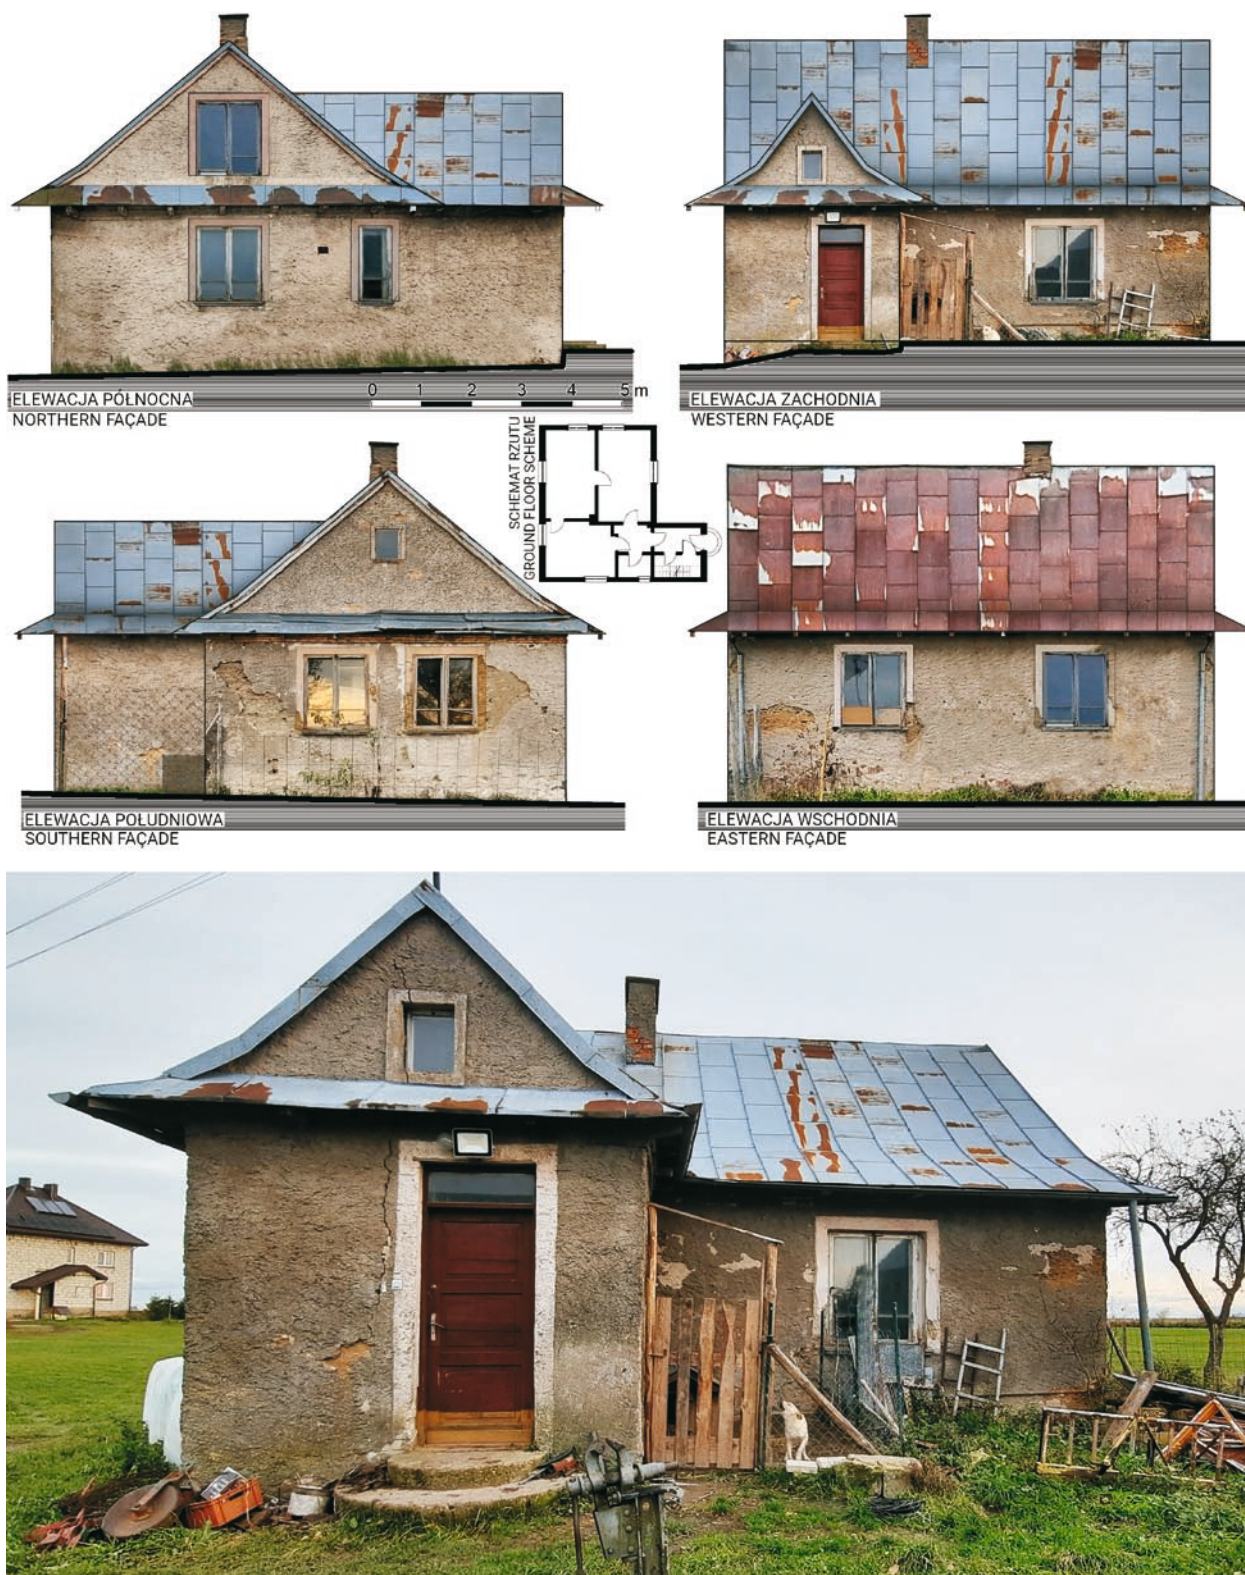
The most interesting old earthen farmhouse was found in Konopki Kolonia (Fig. 17). It is the oldest one, allegedly built in the 1930s. Currently uninhabited, it has still retained its floral stencils on some of its walls (Fig. 18). The walls were plastered in various

Fig. 17. An old farmhouse made with rammed earth, in Konopki Kolonia; source: the authors, 2021

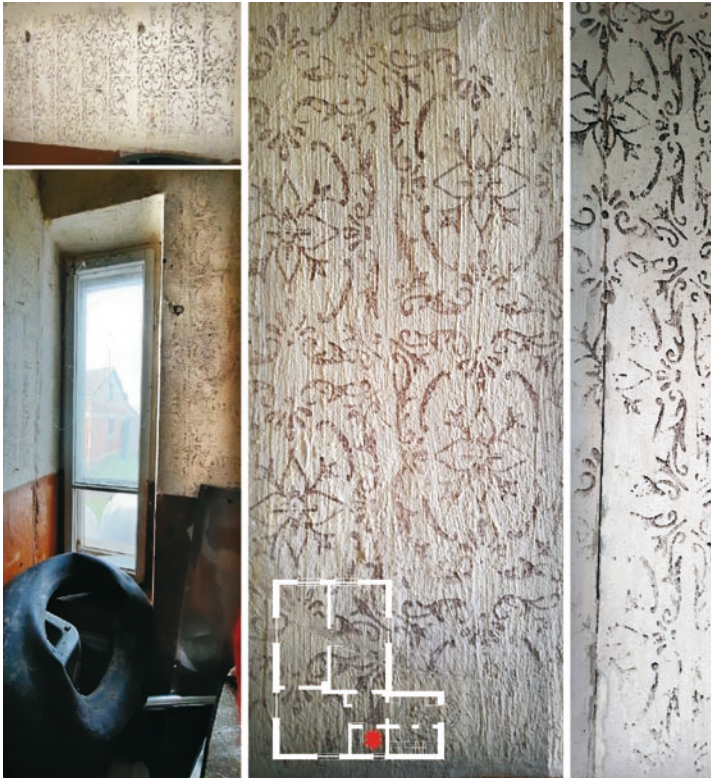
**Fig. 18.** Stenciled walls in the earthen farmhouse in Konopki Kolonia; source: the authors, 2021

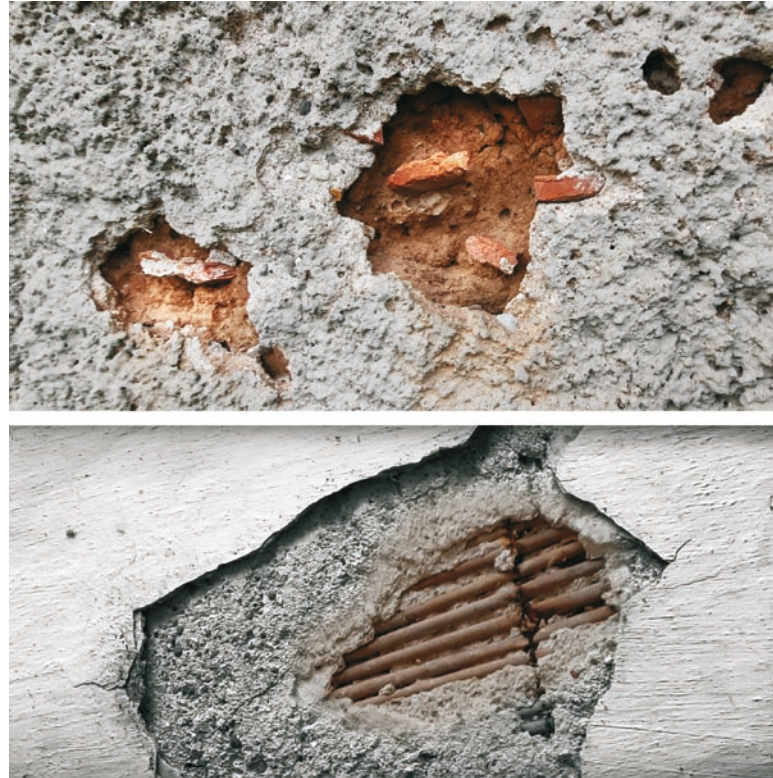
**Fig. 20.** Wall plaster in the earthen farmhouse in Konopki Kolonia (outer plaster above; inner plaster below); source: the authors, 2021

manners: the external side of the wall was plastered with thick two-layer plaster fixed with ceramic shells and stones (Fig. 20: upper photo), whilst the inside three-layer plaster was fixed with a reed mat (Fig. 20: lower photo). These days, the main room of the farmhouse in Konopki Kolonia serves as a granary (Fig. 21).

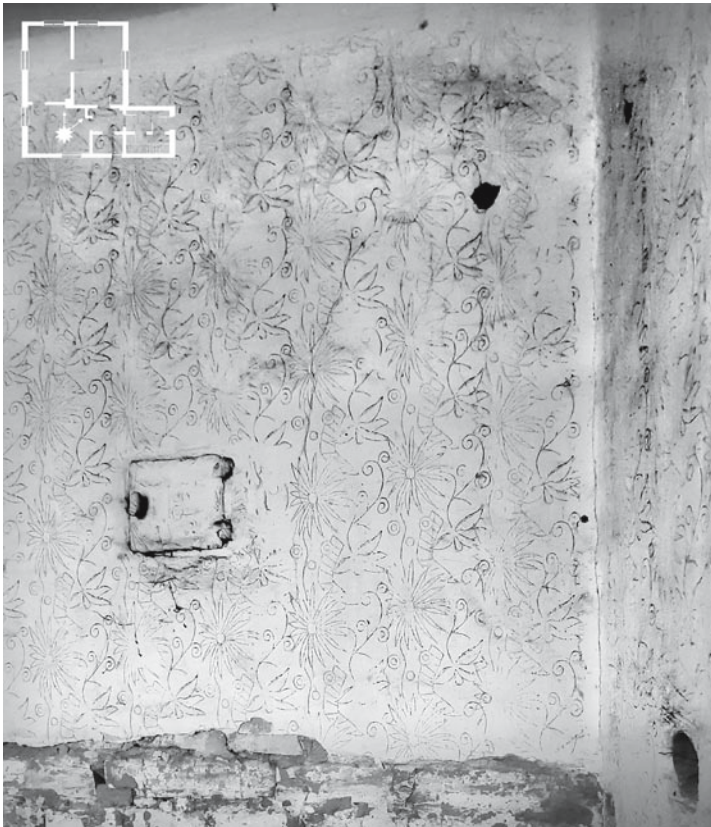
**Fig. 19.** Stenciled wall in the earthen farmhouse in Konopki Kolonia; source: the authors, 2021

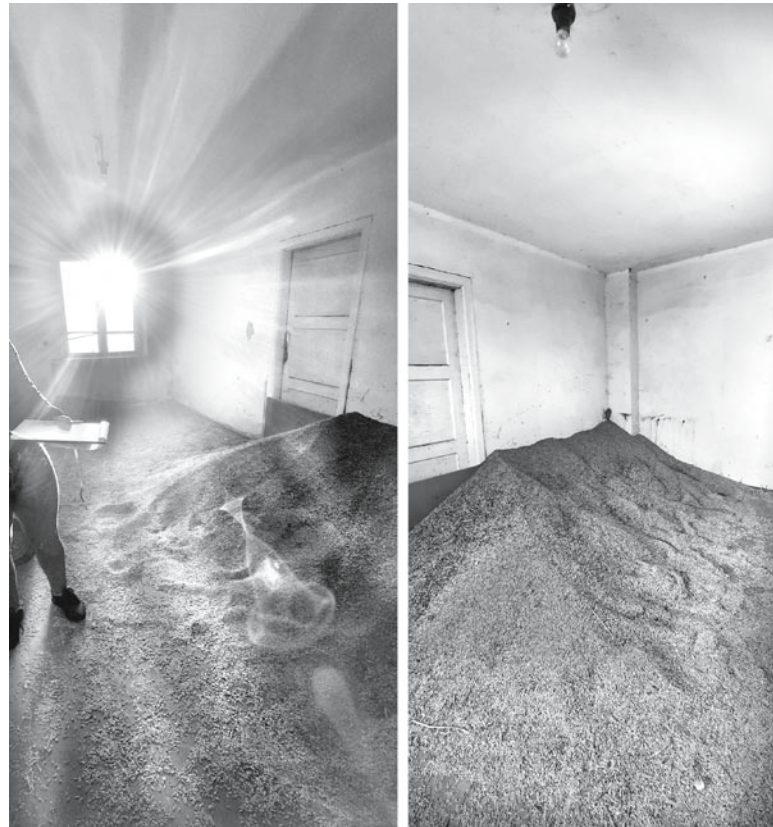
**Fig. 21.** Grain storage in the former main room in the earthen farmhouse in Konopki Kolonia; source: the authors, 2021

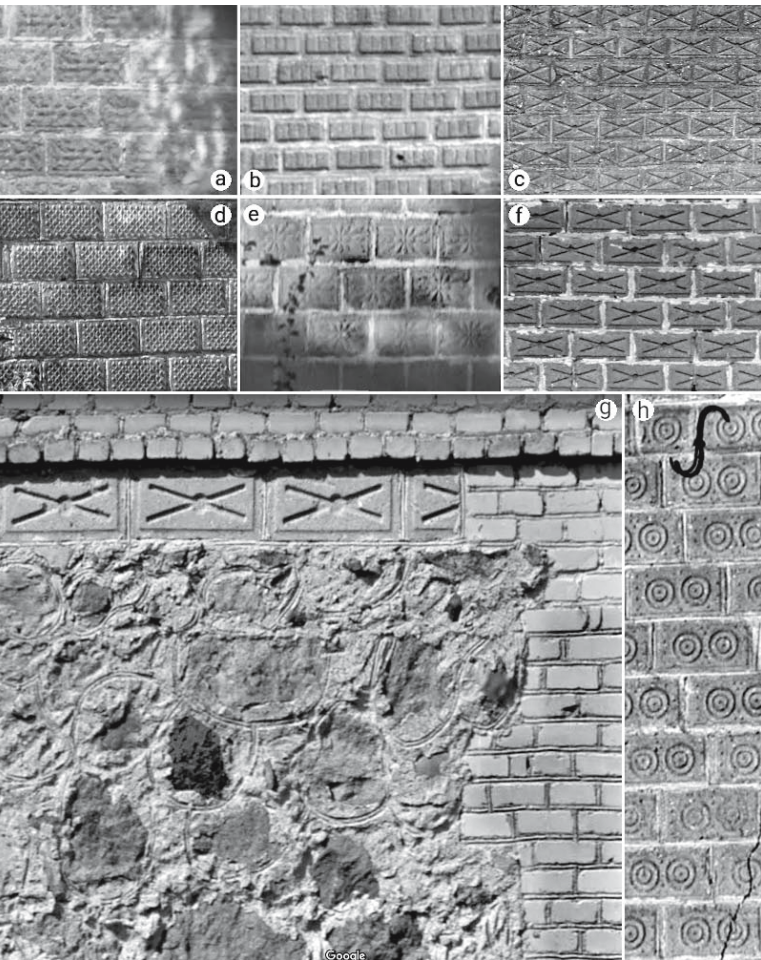
**Fig. 22.** Hollow brick walls in various villages in the communes of Grajewo and Rajgród: Brzozowa Wólka, Łosewo, Białogrądy, Ciemnoszyje, Flesze, Łosewo, Kolonia Sojczyn Borowy (g, composed with stone and brick masonry), Turczyn (h) - a collection of photos taken in 2012-2022

larly, old barns with hollow brick walls were in existence in other villages in both communes. Their landscape value refers to their aesthetics, because self-made hollow bricks were often ornamented<sup>2</sup>, thus adding pattern coverage to walls and building façades. When old and covered with lichens, hollow brick walls gain unique ambience.
