An Analysis of Major Construction Disasters in Poland

Aleksandra RYCHLIK*¹, Agnieszka TOMASZEWSKA¹, Adam BARYŁKA*²

¹ Centrum Rzeczoznawstwa Budowlanego, Warsaw, Poland

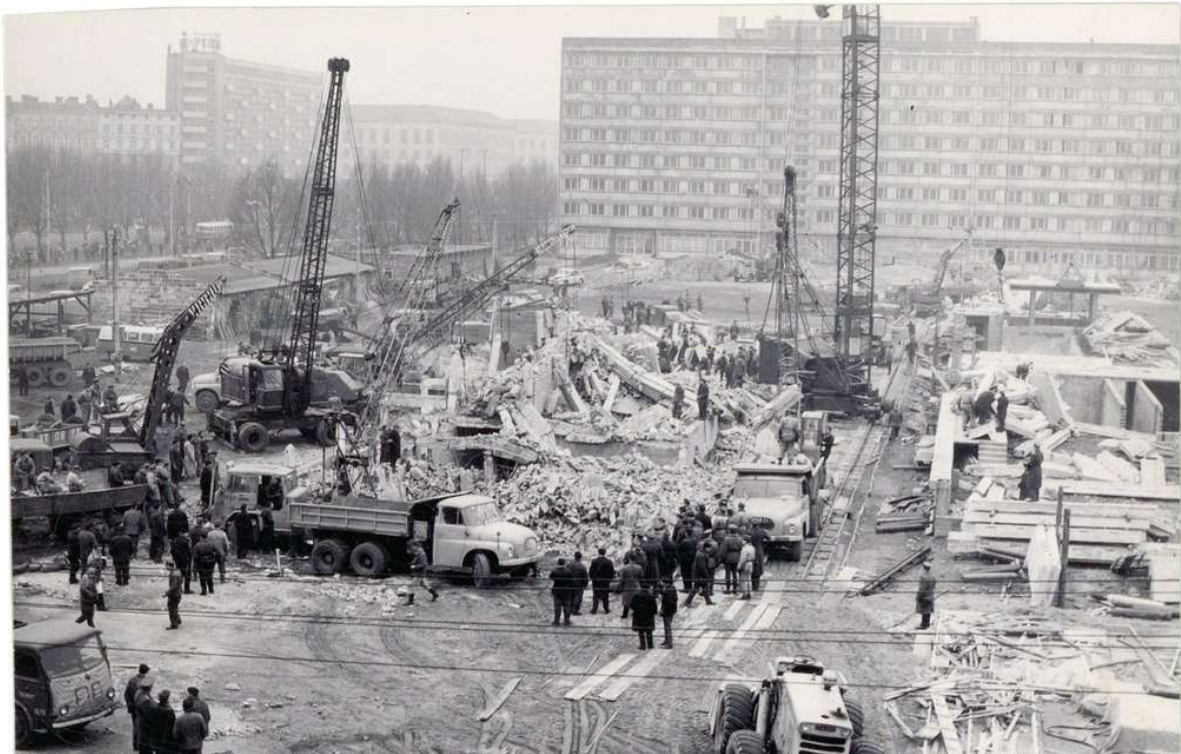
Photo 1. Construction disaster during the construction of the building of the Land Reclamation Department for the Higher School of Agriculture in Wrocław (1966) Source:

The construction disaster, which occurred on 22.03.1966 during the construction of the building of the Faculty of Land Reclamation for the then Higher School of Agriculture (now the University of Environmental and Life Sciences)

in Wrocław at Grunwaldzki Square was the result of haste and failure to maintain the technological schedule of works. As a result of the pressure of the then political authorities, for whom the propaganda effects of the fact that the "growth" of the building is visible were extremely important, the construction management ordered the workers to erect subsequent elements of the floors without parallel masonry works on individual floors, which would ensure the stiffening of the structure. As a result of the wind in March 1966, the structure collapsed. The construction foreman and nine workers were killed in the crash.

After the disaster, with the help of the army and equipment available at that time, the rubble was dismantled, transporting elements to the rubble dump and trying to reach the buried as soon as possible. None of them survived.

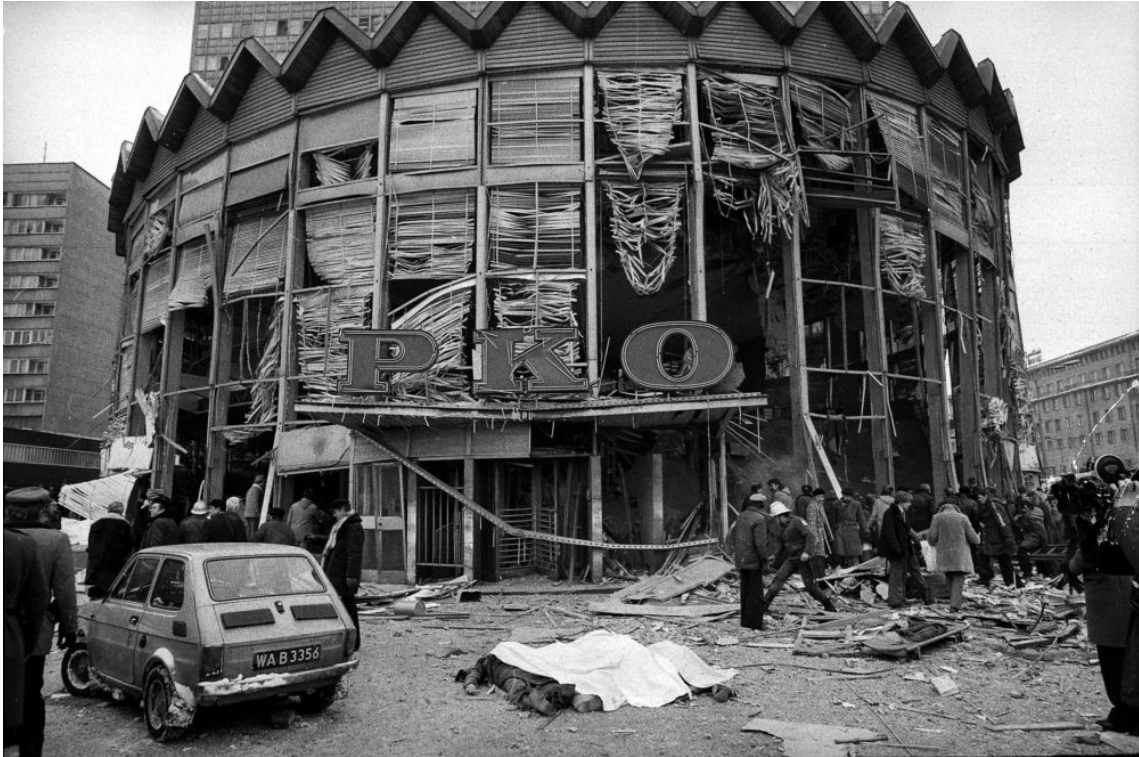
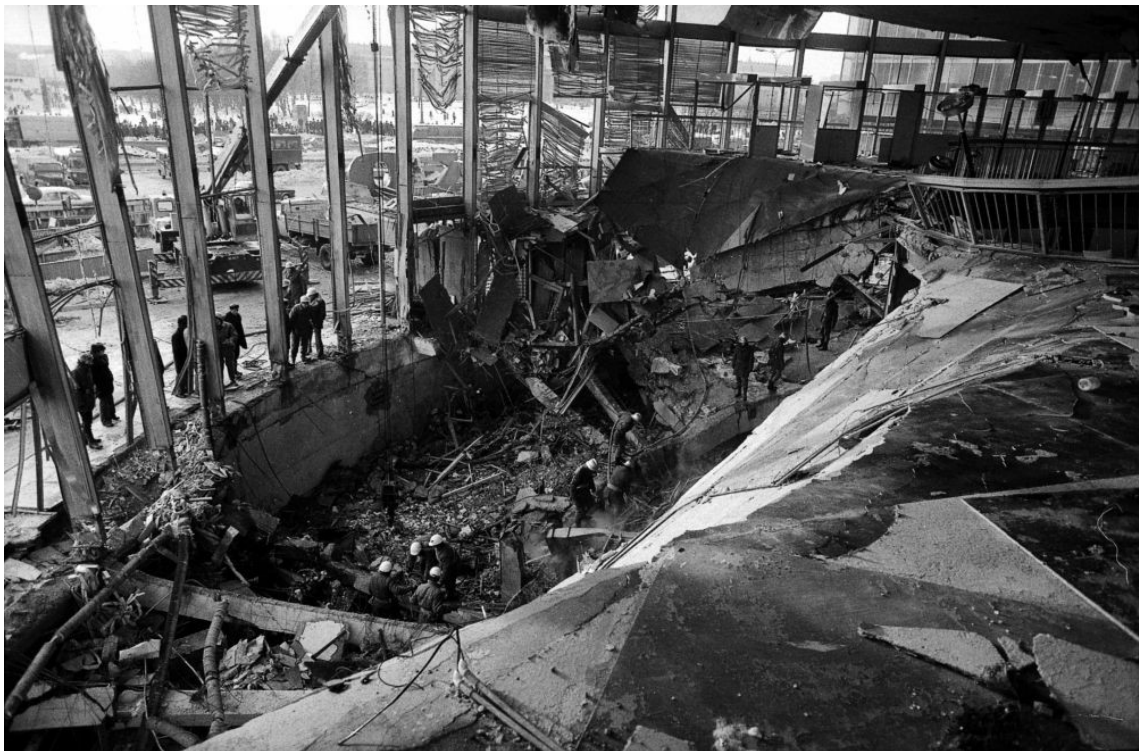
Photo 2. Construction disaster of the PKO Rotunda building in Warsaw (1979)
Source: PAP/CAFFoto: A. Urbanek, https://dzieje.pl/sites/default/files/201902/rotunda_0.jpg

Photo 3. Construction disaster of the PKO Rotunda building in Warsaw (1979)
Source: PAP/CAFFoto: M. Kłoś. <https://dzieje.pl/sites/default/files/201902/rotunda2.jpg>

15.02.1979 r. o godzinie 12.37, miał miejsce wybuch gazu w Rotundzie PKO w Warszawie. Gmach Rotundy został zniszczony w siedemdziesięciu procentach, wszystkie kondygnacje zapadły się do środka, elementy antresoli spadły na zgromadzonych ludzi, poraniły ich też szyby z olbrzymich okien. W tamtym momencie wewnątrz placówki znajdowało się 170 pracowników i prawie trzystu klientów. W katastrofie uszkodzonych zostało 126 osób (zginęło 49 osób i 77 rannych).

Experts determined that the cause of the drama was a leaky gas installation. It was probably not the fault of man. The winter of 1978/1979 was the winter of the century, low temperatures and ground vibrations caused by trains passing underground (the Rotunda stood, and today - rebuilt and rebuilt - also stands, over the railway tunnel leading from the Central Station to the East) caused the installation to crack, and the thick snow cover meant that the gas did not escape outside, but got into the nearby telecommunications installation, from there to the interior of the building.

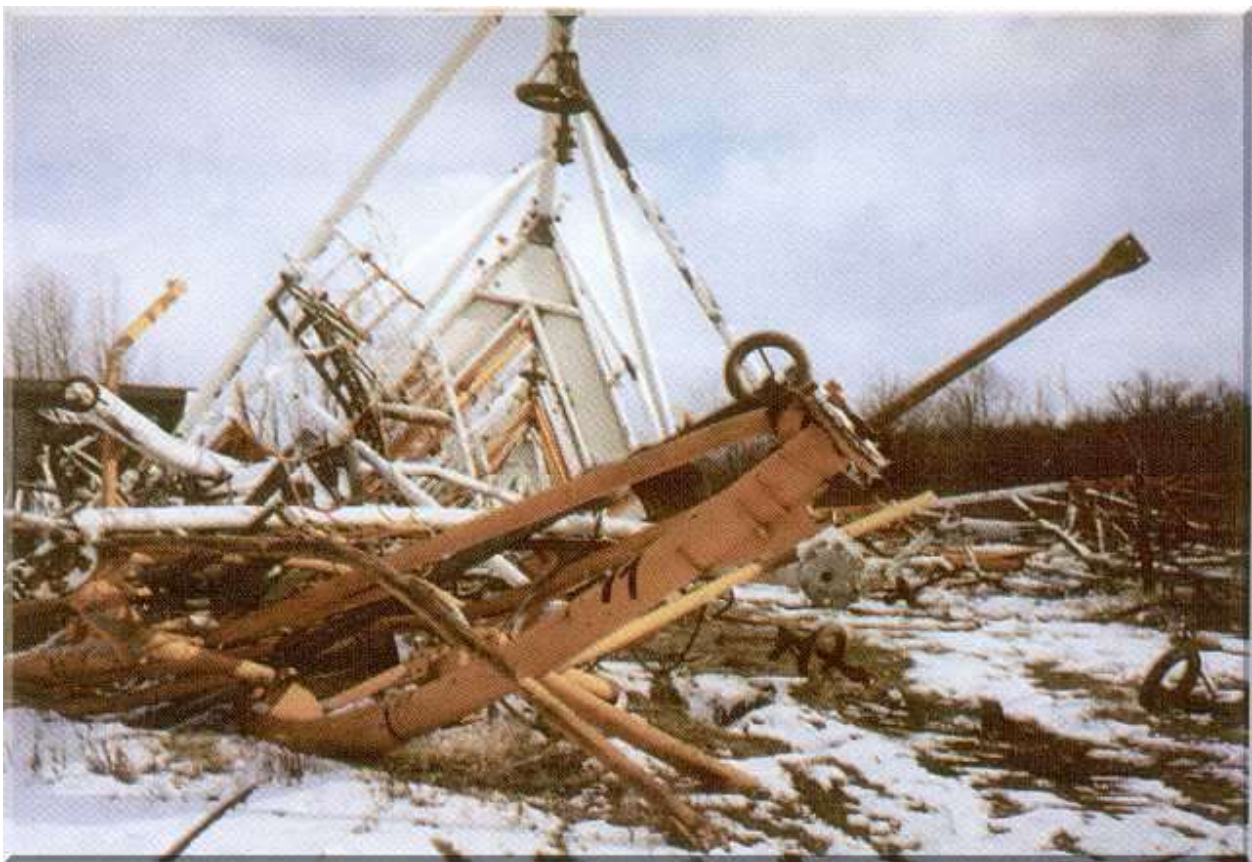
Photo 4. 646 meter mast in Konstaktyńów near Gąbin after the disaster (8.08.1991)

The radio mast in Konstaktyńów near Gąbin with a height of 646m built in the years (1972-1974) by Mostostal Zabrze - for 17 years (1974-1991) due to its record height was a sensation on a global scale, it was officially entered into the Guinness Book of Records - it was the highest building in the world. The entire mast structure weighed 577 tons and was entirely made of steel. The mast structure is divided into 86 sections, each with a height of 7.5 meters. They had a cross-section in the shape of an equilateral triangle with a side length of 4.8 m. The main supporting elements were made of steel pipes with a diameter of 24 cm. Depending on the place, the walls of the pipes were from 8 to 34 mm thick, they were produced by Huta Batory. The mast was held vertically by 5 lashing units, i.e. a total of 15 ropes with a diameter of 5 cm. Workers entered the mast in a diesel lift; The journey to the top took half an hour.

The mast in Gąbin collapsed on 8.08.1991 during conservation works. The reason was incorrect lashing voltage. Fortunately, no one was hurt during the disaster. The mast broke and fell in such a way that its tip dug into the ground right next to its base. It was planned to rebuild the mast, but the local residents did not agree to it. The successor of the mast was the radio station in Solec Kujawski, whose highest mast is only 335 meters, which is less than half the height of the mast from Gąbin

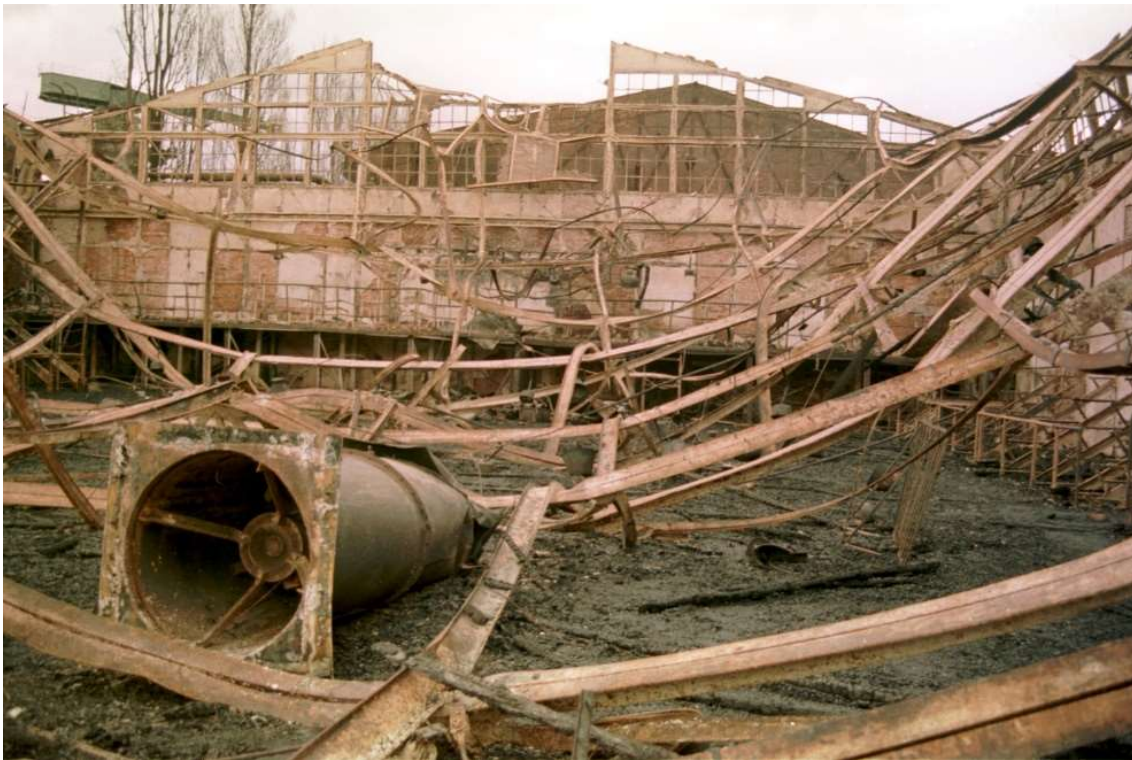
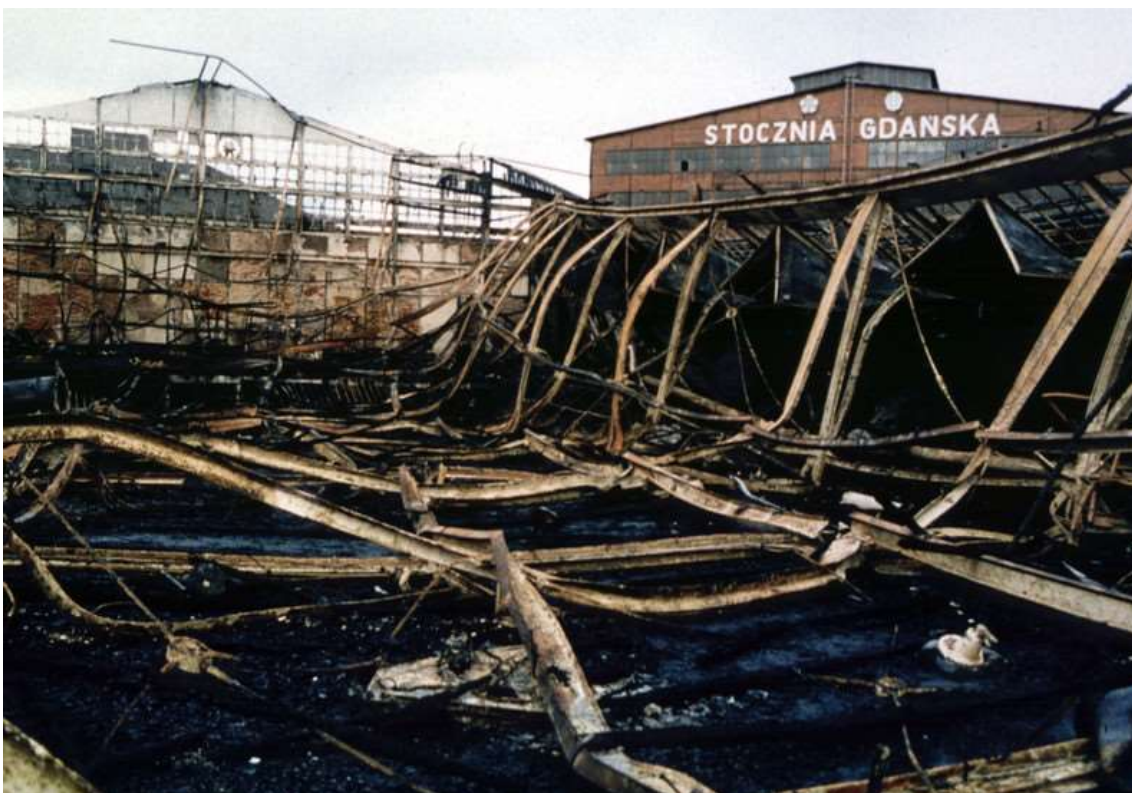
Photo 5. Steel structure of the Gdańsk Shipyard hall after the disaster caused by fire (1994 r.), photo. Maciej Kosycarz/KFP

Photo 6. Steel structure of the Gdańsk Shipyard hall after the disaster caused by fire (1994 r.), photo. Maciej Kosycarz/KFP

On 24.11.1994 in the entertainment hall at Jana z Kolna Street in the hall of the Gdańsk Shipyard a musical event was held with the participation of about 2000 people (mainly young people aged 13-20). An hour after the musicians left the stage (around 8:50 p.m.), a fire was noticed on the wooden stand in the depths of the Hall, which very quickly began to spread, the curtain took care of and the fire reached the ceiling. When the lights went out, panic broke out. Everyone rushed to the only known exit from the hall – the main exit, which was not fully open. People fell over each other and were scalded with hot air. 307 people were injured in the incident (7 fatalities and 300 people injured). As a result of the fire, the steel supporting structure of the hall was completely destroyed. It is assumed that the cause of the fire was arson, the perpetrator has not been determined to this day. The organizers of the event sat in the dock, who were accused of not providing unobstructed emergency exits and bypassing the basic rules of fire protection.

According to the prosecutor, the hall did not meet fire safety requirements. Some of the exits were closed and the fire spread so quickly m.in because the stored fiberboard and carpet were taken care of in the wrong place.

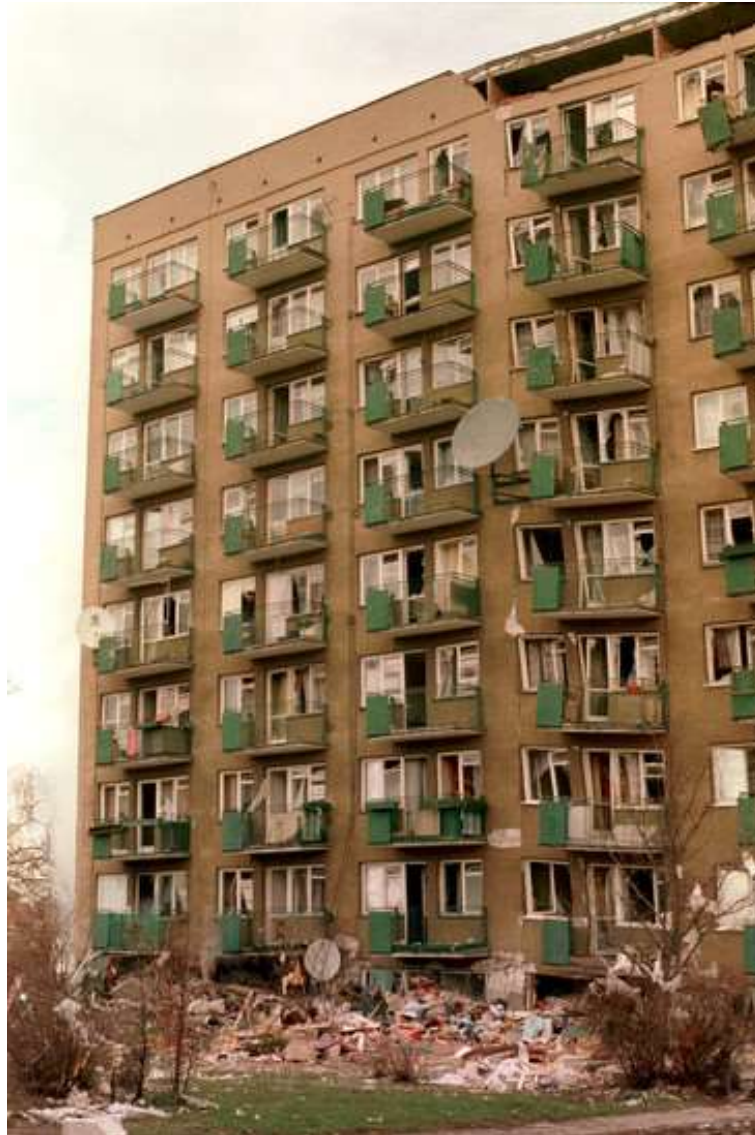
Photo 7. Destroyed multi-family residential building (Gdańsk, 39 Wojska Polskiego Street) as a result of a gas explosion in 1995, Maciej Kosycarz / KFP

The catastrophe of a single-staircase multi-storey residential building occurred on 17.04.1995 at 5.50 a.m., as a result of a gas explosion. The 3 lower floors collapsed completely (2 floors were driven into the ground). Because the damaged building threatened to collapse at any time, the commission chaired by the Chief Inspector of Building Supervision assessed that the technical condition of the building does not allow for any security works and decided to blow up the remaining part of the building, which was made on 18.04.1995. The rescue operation was carried out only on the rubble. As a result of the disaster, 22 people died, 1 person died suddenly as a result of shock on April 18. In addition, 12 people were injured.

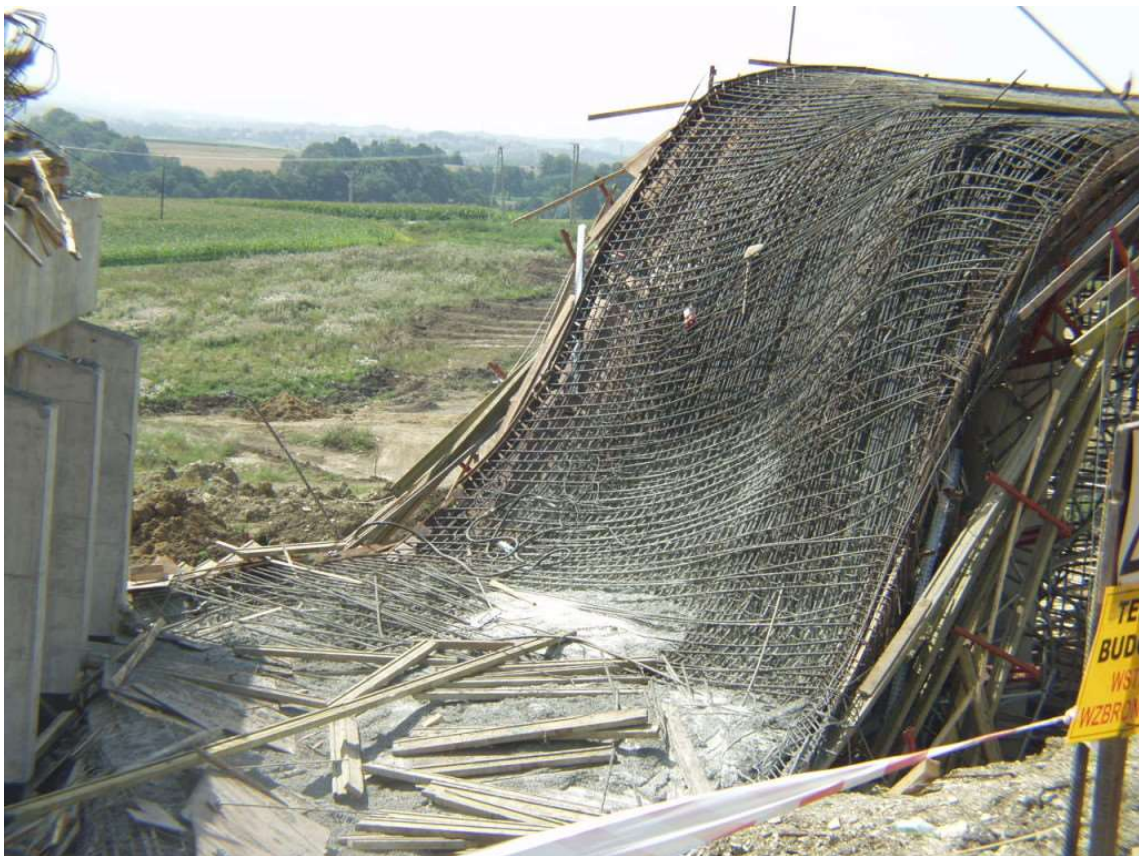
Photo 8. Disaster of the viaduct built on the national road No. 1 in the village of Ogradzona, 4.08. 2003,
Source: <https://nemu.com.pl/case-studies/zawalenie-sie-konstrukcji-wiaduktu/>

The catastrophe of the viaduct built on the national road No. 1 in Ogrodzona (the viaduct on which the disaster occurred is part of the modernized national road No. 1 to the border crossing with the Czech Republic in Cieszyn-Boguszowice), occurred in the evening of 4.08.2003 – when during the concreting of the viaduct the structure supporting the scaffolding could not withstand the weight of the concrete and collapsed together with the scaffolding on which

there were 25 workers; 16 were injured, of which 11 were taken to hospitals in Bielsko-Biała, Cieszyn, Jastrzębie Zdrój and Piekary Śląskie.

The commission appointed by the Silesian Provincial Inspector of Building Supervision to conduct proceedings to determine the causes and circumstances of the construction disaster determined that errors in the scaffolding design and its implementation are the main reasons for the catastrophe of the above-mentioned viaduct: "the scaffolding suffered a catastrophe already at 65 percent of the normal nominal load, orders to consider the errors made by the scaffolding designer and its contractor as gross".

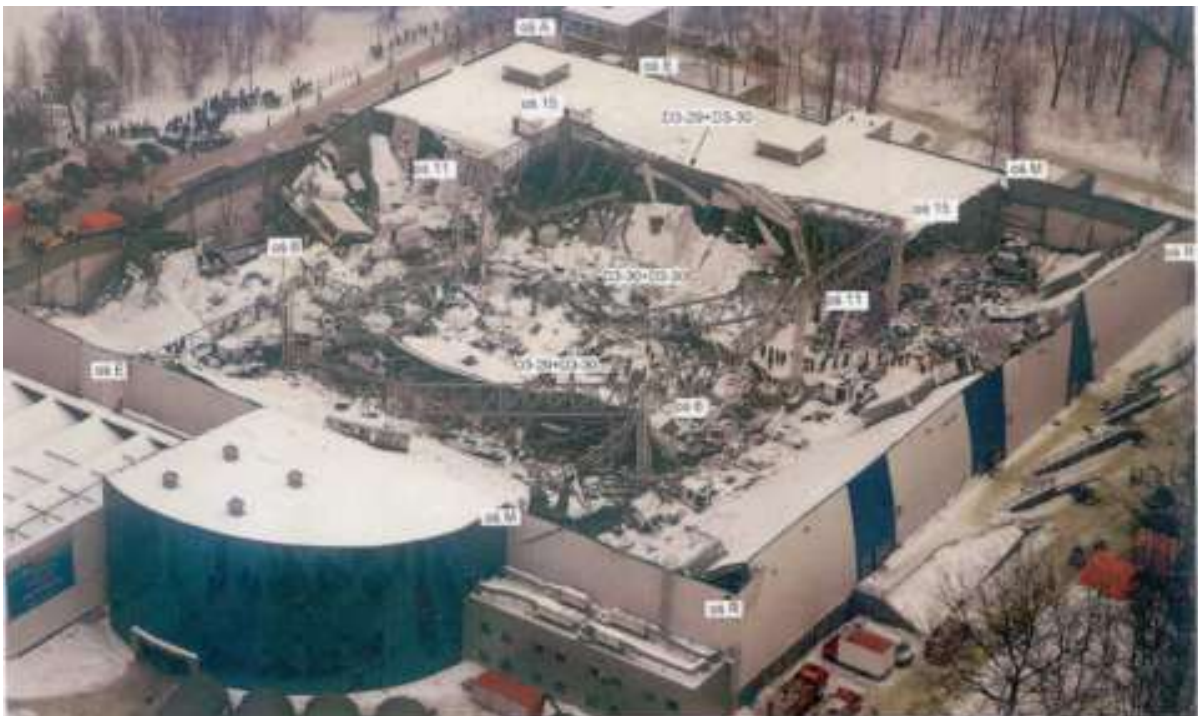
Photo 9. Construction disaster of the exhibition pavilion at the International Fair in Katowice at 1 Bytkowska Street (2006), Source: General Office of Building Control, Warsaw, May 2006.

The exhibition hall at 1 Bytkowska Street on the premises of the International Katowice Fair with a steel structure with dimensions in the projection of 97.36x102.875 m and a maximum height of 13.2 m suffered a construction disaster

on 28.01.2006 at 17.15 - during a large mass event. To explain the causes and circumstances of this disaster, the Chief Inspector of Building Supervision appointed a commission, which stated that:

- The direct cause of the ICC hall disaster was the loss of load capacity of trusses and main lattice beams and columns in the central part of the hall, as well as overloading its structure with snow.

- The hall was designed with numerous construction errors, including the load-bearing capacity of the hall structure elements. The construction of the hall did not meet all the requirements of design standards.

- The rapid course of the catastrophe resulted from: defective structural solution of the hall - girders and pole heads; defects in the joints connecting the bundles of the columns with the branches; high strain of many roof elements, such as: purlins, strings, connections between elements; lack of slope and vertical concentrations of the hall roof structure; pseudo-spatial nature of the structure, in which all roof purlins - lattice and beam were connected with each other by braces.

- At the crash site, among m.in negligence in the assembly of the hall structure and excessive strain of the strings were found.
- Already during the construction of the hall and after its failure in 2002, the designer informed the owner of the hall about the need to remove snow from the roof. However, the roof was not cleared of snow with due care.

- The low load capacity of the hall cover was signaled by a failure in January 2002. After such a failure, the entire steel structure of the MTK hall cover should be re-checked computationally, which was not done. The quality of the welds in the main bearing elements was also not checked at that time, despite negative test results.

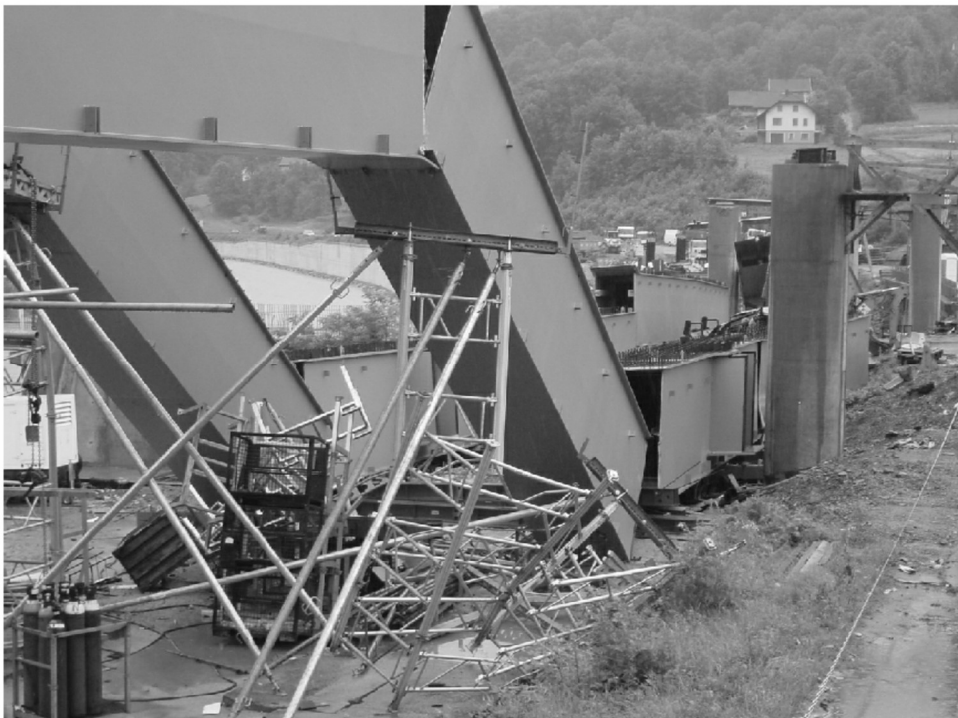
Photo 10. General view of the destroyed viaduct structure in Stróža, (according to Prof.PL, M. ŁAGODA, Lublin University of Technology, Road and Bridge Research Institute, Warsaw 2007)

The construction disaster during the construction of the viaduct in Stróža (01.07.2006) occurred as a result of the collapse of scaffolding supports under the girders of the steel structure, prepared for merging (photo 10). Before the disaster, several segments were laid on scaffolding. Subsequent segments were attached to each other by connecting the internal longitudinal ribs stiffening the web of the segments on the prestressing screws (Fig. 2). As a result of the disaster, one person died and one was injured. The steel structure of the viaduct built at that time was destroyed, as well as the scaffolding supporting it. The disaster was caused by neglect of many duties, as well as unfavorably from the rights resulting from the Construction Law, m.in the investor's supervision inspector, the designer.

The Commission agreed with the assumptions of the technical expertise prepared by Prof. Z. Mendera on the basis of the results of on-site inspections, analysis of the construction project, executive design and organization of the construction. Entries in the construction log and assembly log were also analyzed. The technical report shows that the errors were due, in particular, to:

- careless preparation of the assembly organization project, primarily incorrect estimation of vertical and horizontal mounting loads,
- improperly adopted system of mounting supports, as well as the method of their implementation limiting the displacement of the assembled structure, as well as caused by the difference in daily temperatures,

- careless development of a construction project where:
 - the drawing part was made in the form of sketches, and the calculations were made by hand on loose sheets, without evidence of a strength check by another person,

- construction drawings of mounting supports were developed by people who did not have the appropriate building licenses,
 - design errors led to further shortcomings, because the loads were underestimated, the system of mounting supports of the PERI type was unfortunately chosen, too flabby, inappropriate for this type of heavy construction, as well as improper use of the road plate and it was not protected against washing out the ground.

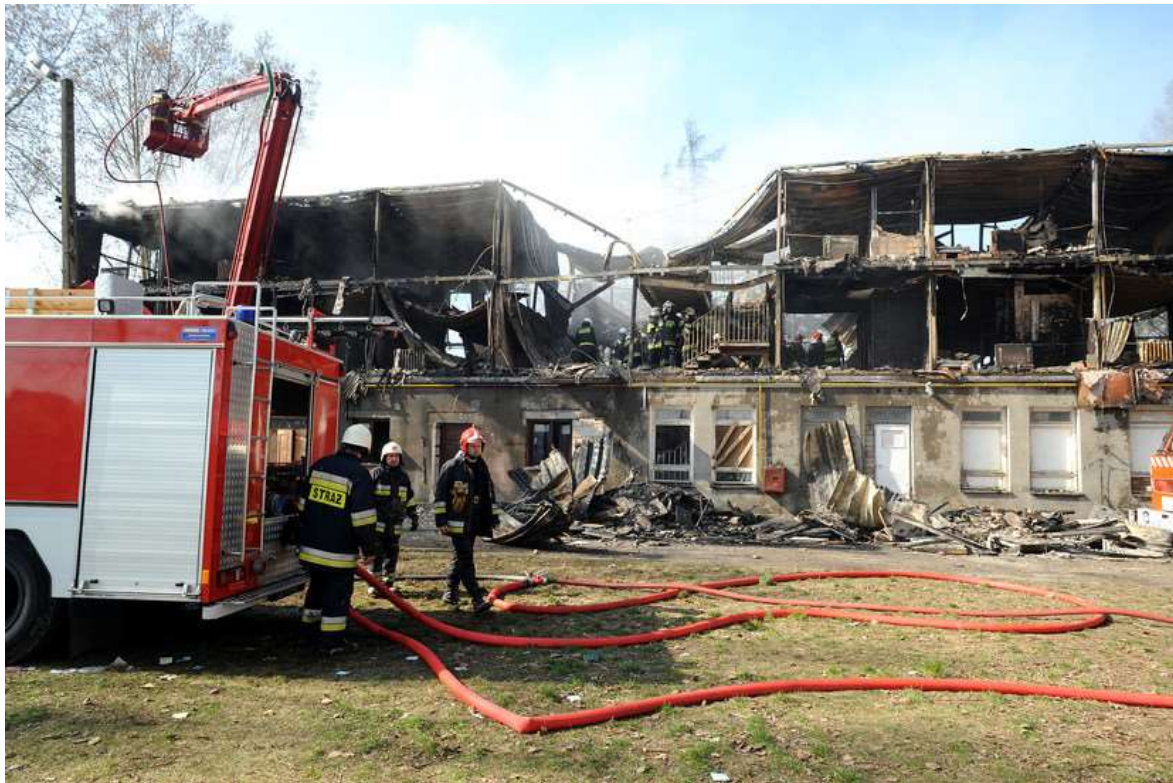
Photo 11. Construction disaster of a three-storey social hotel building in Kamień Pomorski caused by a fire (1995),
Source: <https://www.rmfm24.pl/fakty/polska/news-pozar-w-kamieniu-pomorskim-urzednicy-skazani-na-wiezienie,nld,1678845>

The catastrophe of the three-storey building of the social hotel in Kamień Pomorski at Wolińska Street - occurred on the night of 12 to 13.04.2009 as a result of a fire outbreak. In the hotel, where 77 people were checked-in, 23 people died in the fire. The fire spread very quickly to all floors of the building, which cut off the evacuation route for residents. According to expert opinions, the fire was started as a result of a short circuit of the electrical installation. It was not possible to determine what was the direct cause of the short circuit. The rapid spread of the fire was influenced by the use of flammable materials in the construction of the hotel.

According to the prosecutor's office, the main irregularities that led to the construction disaster were, m.in, the lack of required inspections and periodic inspections as well as the required expert opinions on the structure of the facility, failure to ensure the limitation of the spread of fire and smoke contrary to the construction law, or failure to ensure the possibility of evacuating people. These obligations resulted from the provisions of m.in on fire protection. By their negligence, a fire was inadvertently caused.

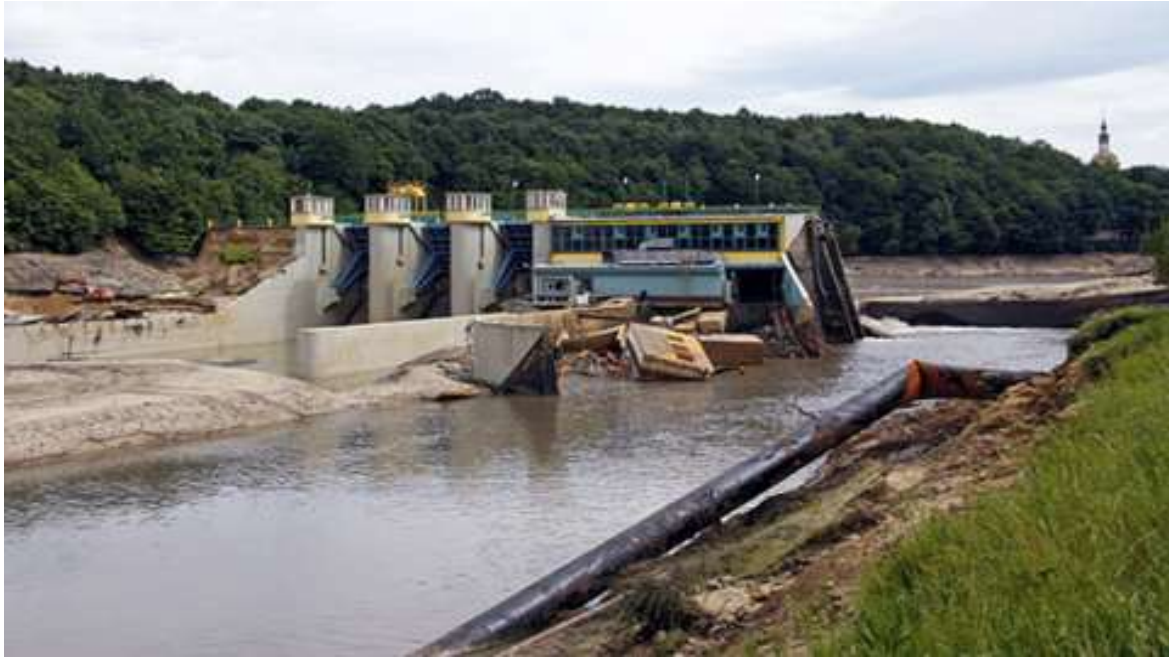
Photo 12 The disaster of the dam on the Niedów reservoir on the Witka River on 7.08.2010

On 7.08.2010 there was a construction disaster of the dam on the Niedów reservoir on the Witka River (built in 1962). The catastrophe consisted in the rupture of the dam under the action of a flood wave. Water from the reservoir in the form of a high wave flooded the surrounding towns on the route Bogatynia - Zgorzelec and Zgorzelec itself) - causing disasters of numerous buildings (Fig. 12).

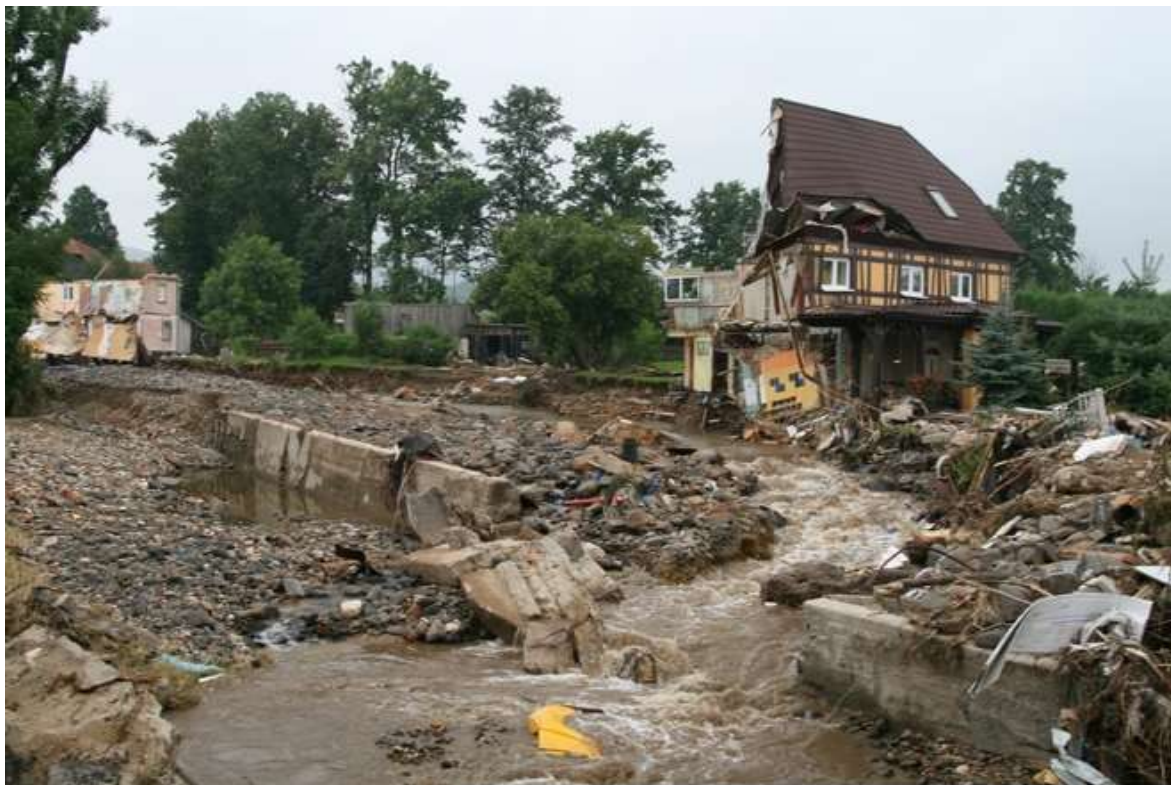
Photo 13. Example of a construction disaster caused by the action of a flood wave resulting from the dam disaster on the Niedów reservoir on the Witka Zgorzelec River,

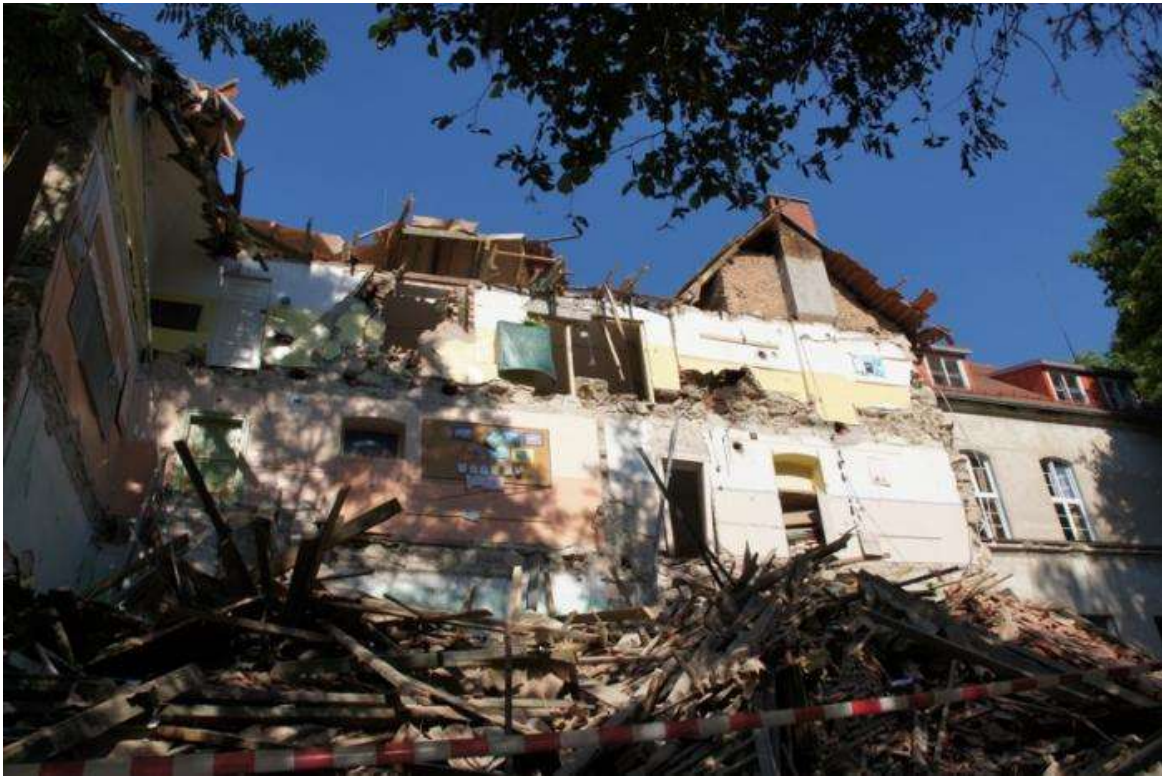
Photo 14. As a result of a gas explosion on the ground floor of the school building (in the food block, in the east wing), the eastern wing was completely destroyed – 31.05.2011 (photo by M. Stachyra)

As a result of a gas explosion on 31.05.2011 at 6 am (before the start of school classes) on the ground floor of the school building (in the feeding block, in the east wing) three floors with the attic collapsed. In view of the destruction

of the building, damage to part of the roof structure, ceilings, external and internal walls and weakening of the technical condition of the entire structure of the building, the Puławy starost issued a decision on permission for its demolition.
