Research paper / Praca badawcza

Issues related to the cessation of special production in chemical plants

Michał Kaczorowski*, Piotr Prasula, Piotr Kasprzak

Military Institute of Armament Technology, 7 prym. S. Wyszyńskiego Street, 05-220 Zielonka, Poland

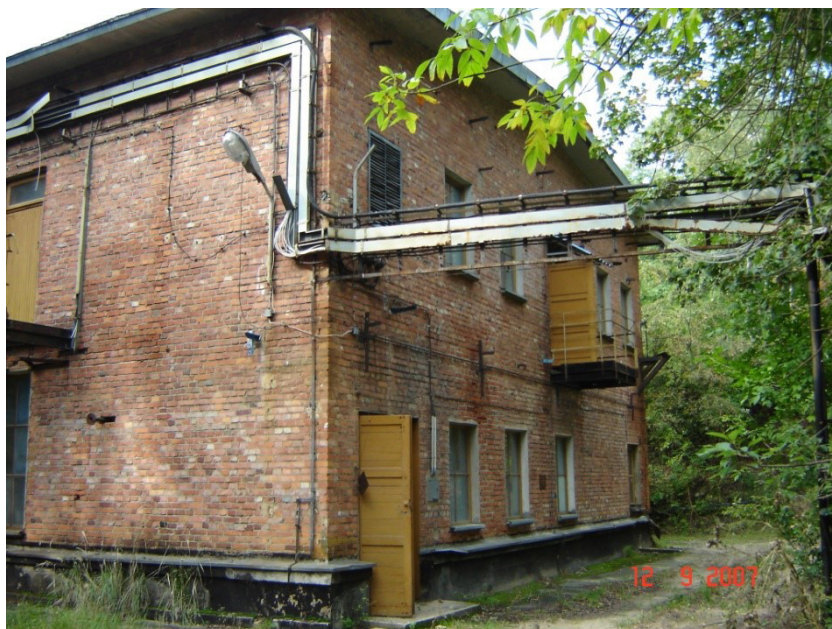
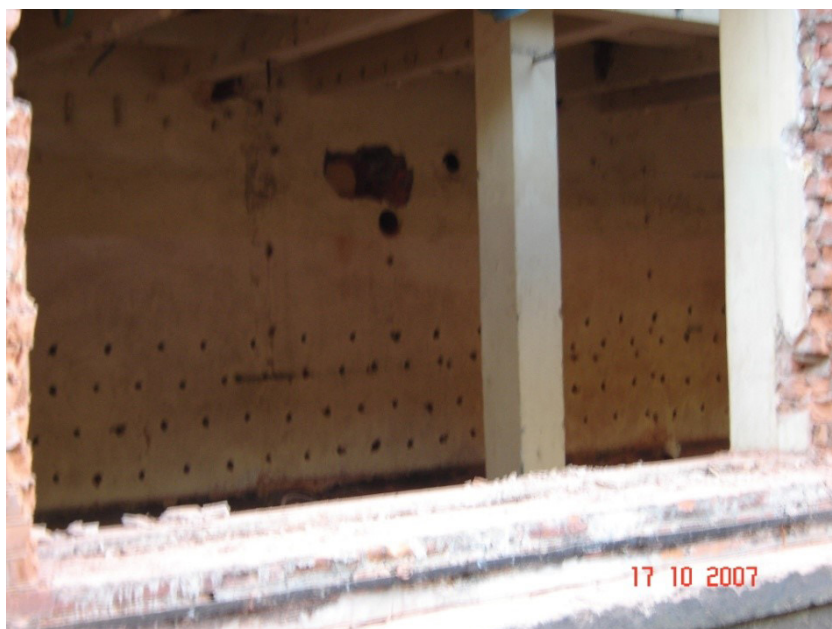
Figure 1. Nitration building: (a) general view; (b) nitration building wall with demolition charge holes

In 2007, the demolition of Department 100 buildings, by a specialized company, was ordered. Due to dense reforestation, the buildings were not cleaned by firing before demolition. The company decided to demolish the buildings using explosive microcharges. Before demolition, the building was washed with water daily and the blasting holes were drilled under a water stream. First, the floors and equipment foundations inside the building and then the internal and external walls were demolished. During detonation of the microcharges, effects of microremnants of hexogen were observed (increased noise and intensified explosive effect). The debris was loaded onto tipper trucks under a stream of water and transported to the local wastewater treatment plant. The debris was used as a base course for the slab road to facilitate the restoration of the settling tank.

Figure 1 shows the view of the nitration building prepared for demolition and Figure 2 shows the effects of demolition of parts of the building. Most buildings of Department 100 were demolished using this method, except for some auxiliary buildings (where no hexogen production was carried out) and reinforced concrete storage bunkers located deeper in the woods. This example of cessation of explosive production can be considered correct, prioritising the safety of personnel and property.

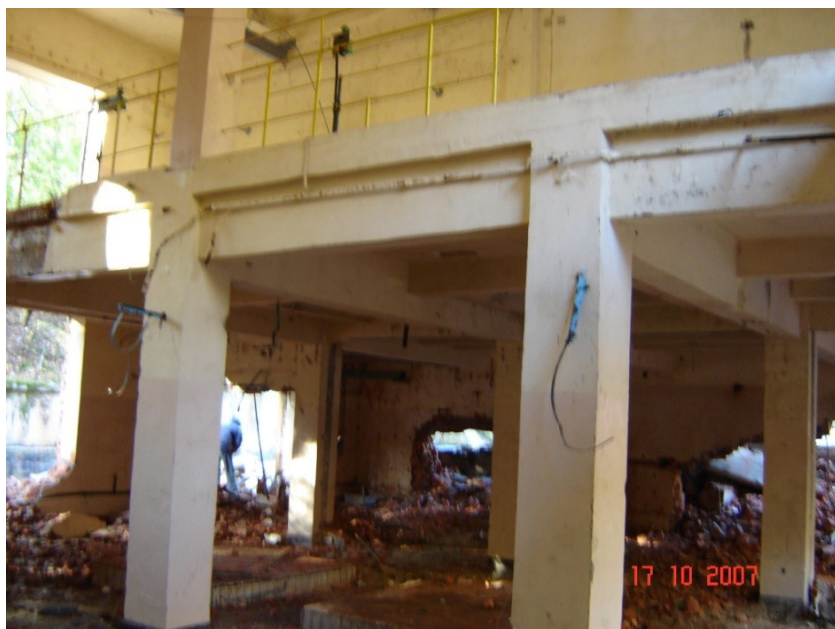
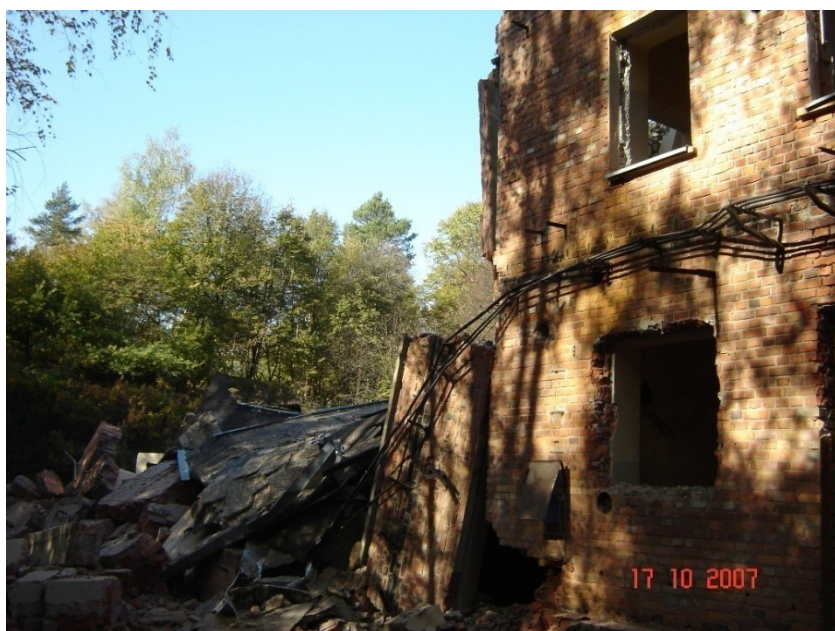
Figure 2. Nitration building during demolition: (a) demolished side walls, prepared for further demolition, (b) view after partial demolition

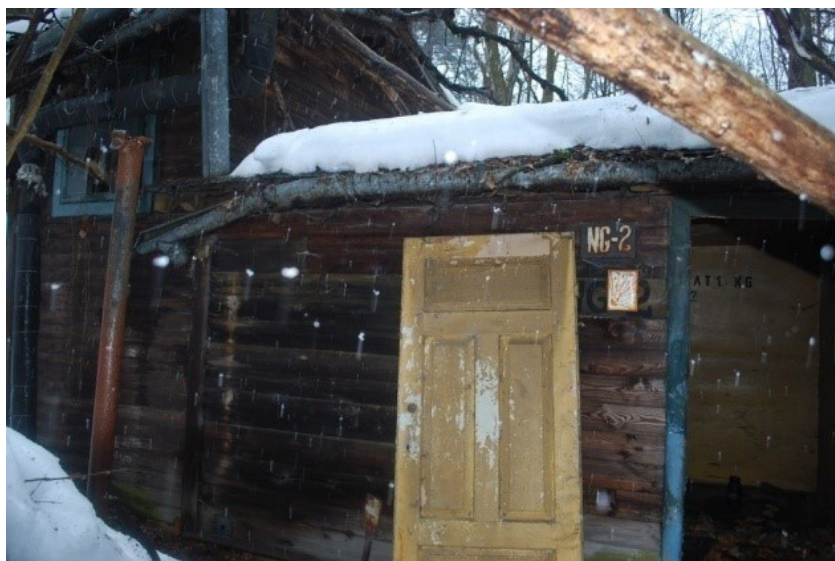
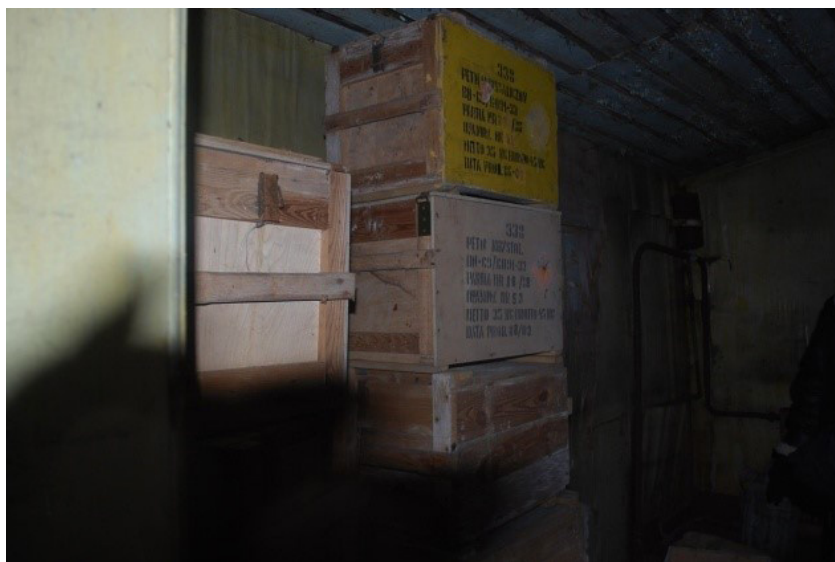
Figure 3. The production building in Pronit plant: (a) outside view, (b) interior with explosives transport packaging

Figures 3(a) and 3(b) show the view of the production building at the Pionki plant and the interior with the wooden crates used for transporting explosives. Figure 4 shows the interior of the building, including production equipment and the remainder of reagents in glass and plastic containers. Figure 5 shows the interior of the production building and the press, where the fatal accident took place.

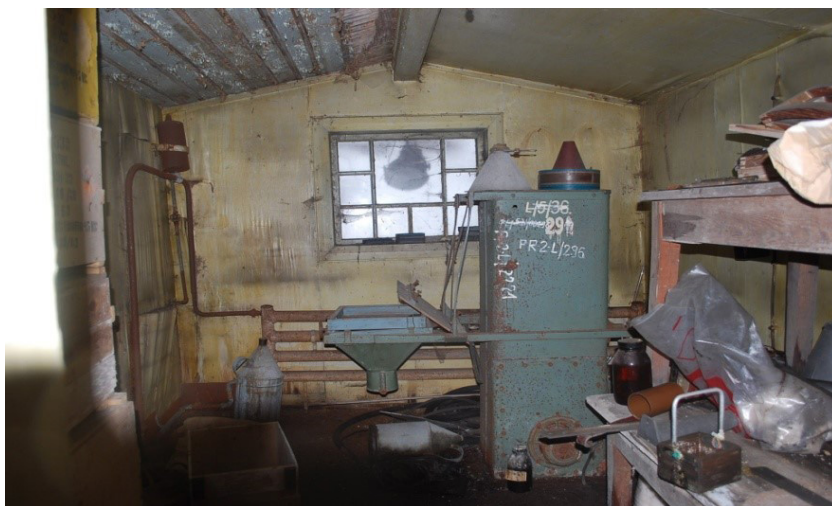
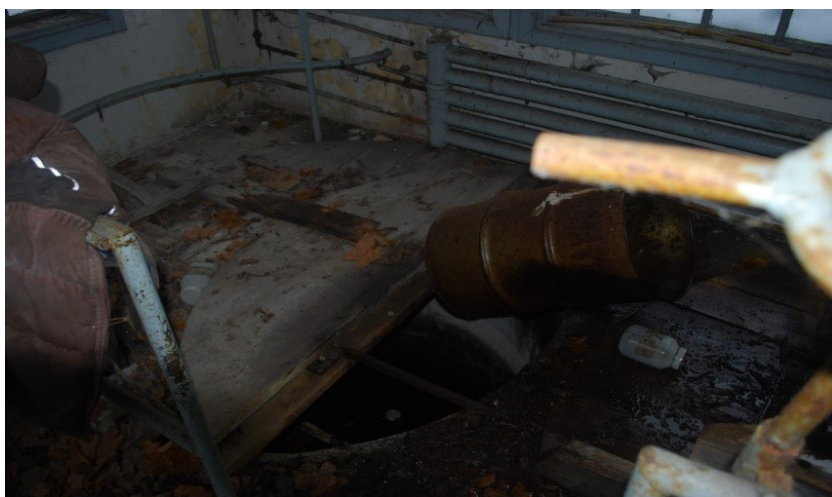
Figure 4. Interior of the building including the production equipment and the remainders of reagents in glass (a) and plastic containers and metal drums (b)

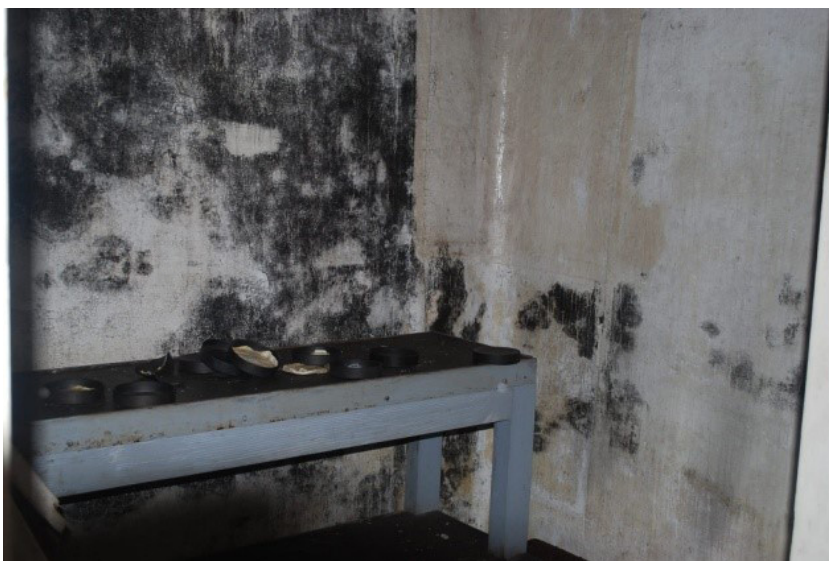
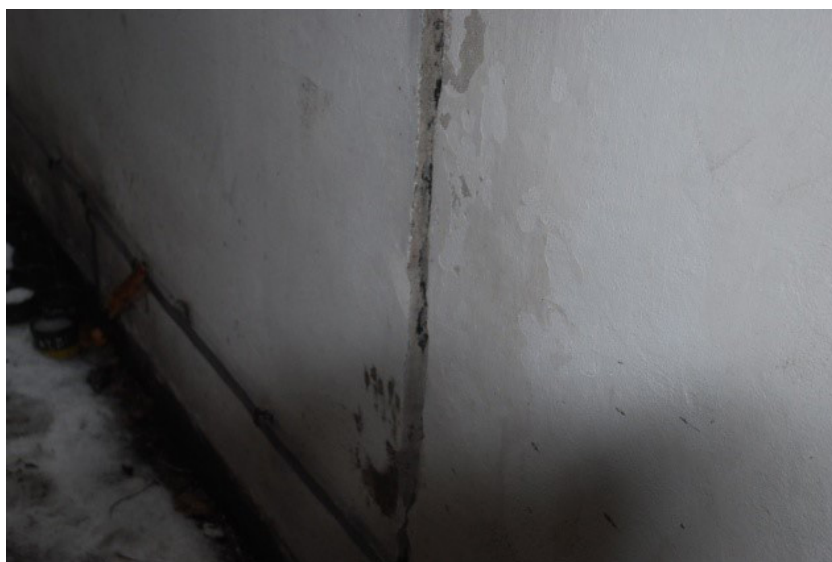
Figure 5. Production building: (a) table with scale pans for explosives; (b) drift in which the fatal accident took place

The production process at the department described below is key to the case. The walls and floors of the production facility were rinsed with water before and after every shift. The water was drained to a sedimentation tank *via* concrete troughs. Because of this, the presence of explosives in the floors and under the floors, in the production facilities, as well as near and under the troughs needed to be considered. In 2011, the plant advertised for tenders to demolish part of the department's buildings. The cheapest offer was selected and the tender was awarded to a contractor without a license to work with explosives. As a result, the tender was invalidated, and after several

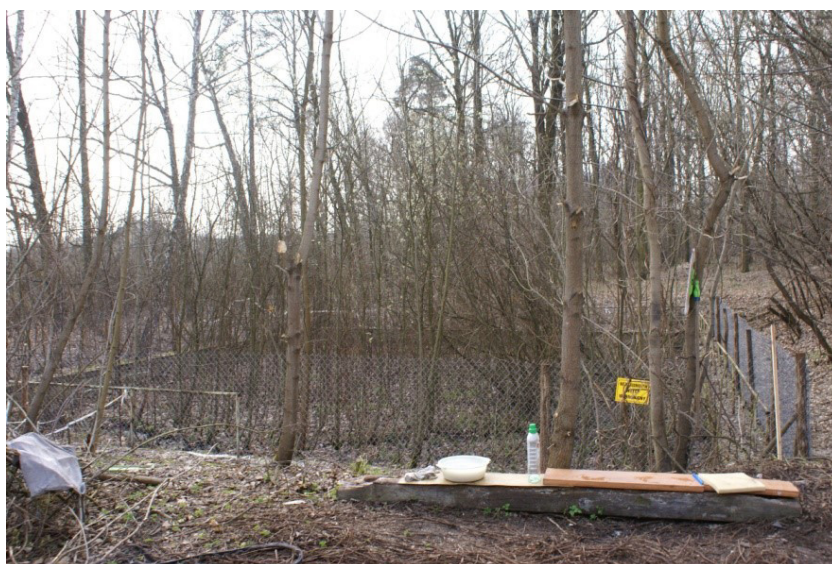
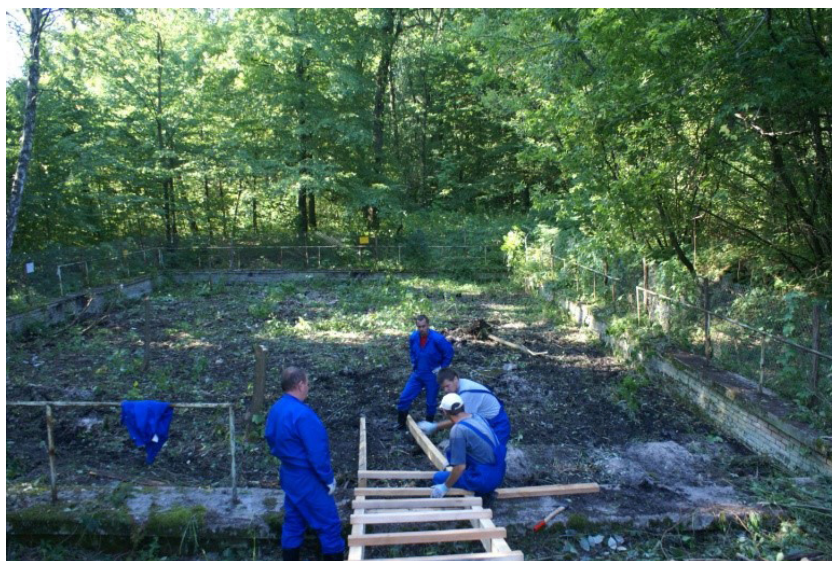
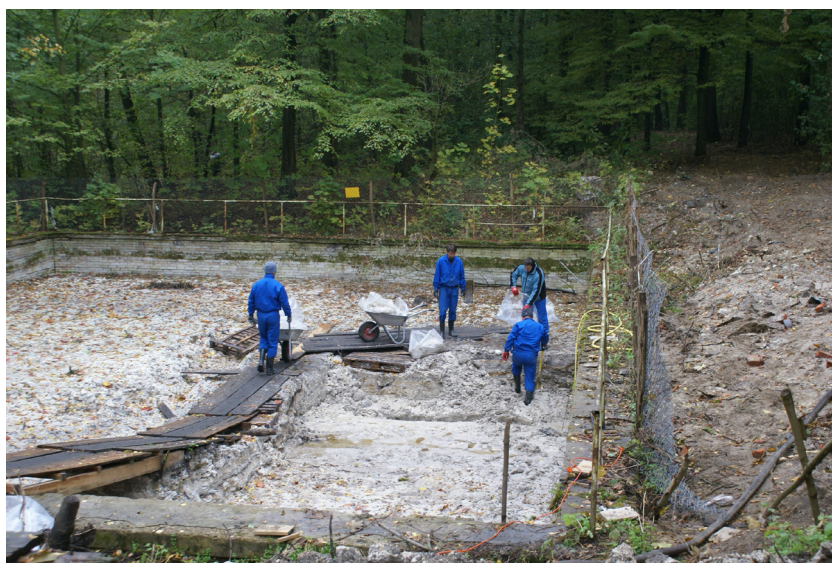
Figure 6. View of the production area: (a) open tank containing nitrocellulose before commencing works; (b) tank after tree felling; (c) tank cleaning, nitrocellulose rinsed with water, staff wearing anti-static clothing and using non-sparking tools

In 2012, an explosion occurred in the nitrocellulose production department, killing two people. The Municipal Council attempted to locate the contaminated areas, and secure the means for decontamination and disposal of nitrocellulose. Approximately 240 tonnes of nitrocellulose were identified. In 2015, following a successful tender, decontamination was attempted by the Military Institute of Armament Technology. Within 4 months, the nitrocellulose was extracted and removed from the plant. The biggest hazard was a settling tank filled with nitrocellulose. The explosives were found in the inspection chambers, drain pipes and wooden troughs removing rinsing water from the sector. Deposited nitrocellulose was found down to a depth of approximately 80 cm under the wooden troughs. During normal production, the troughs were periodically cleaned, and their contents thrown aside, forming nitrocellulose mounds. Figures 6 and 7 show the location at the production area where nitrocellulose was left in the tank, inspection chambers and drain pipes. Figure 8 shows nitrocellulose loading into certified transport containers.

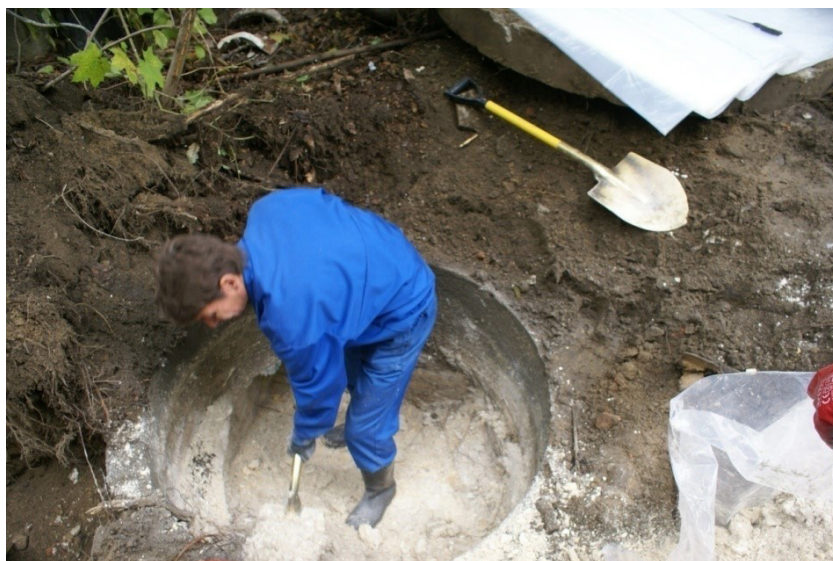
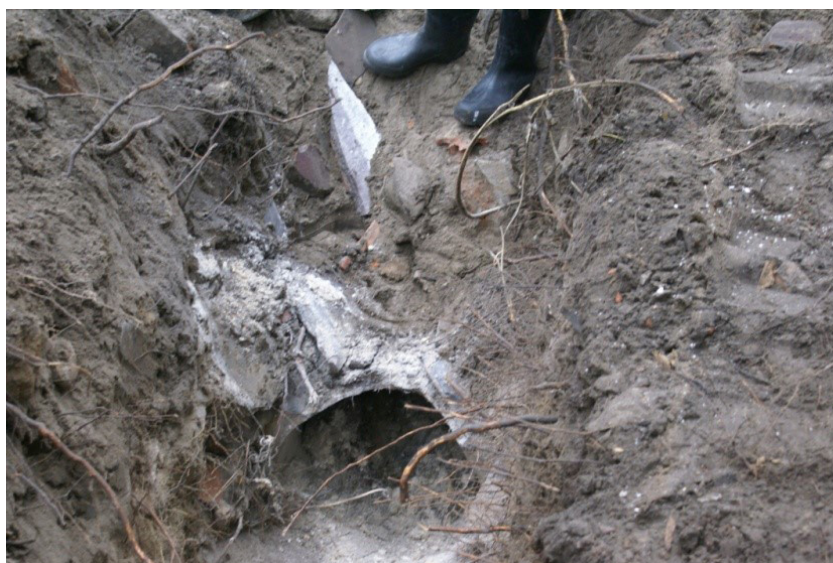
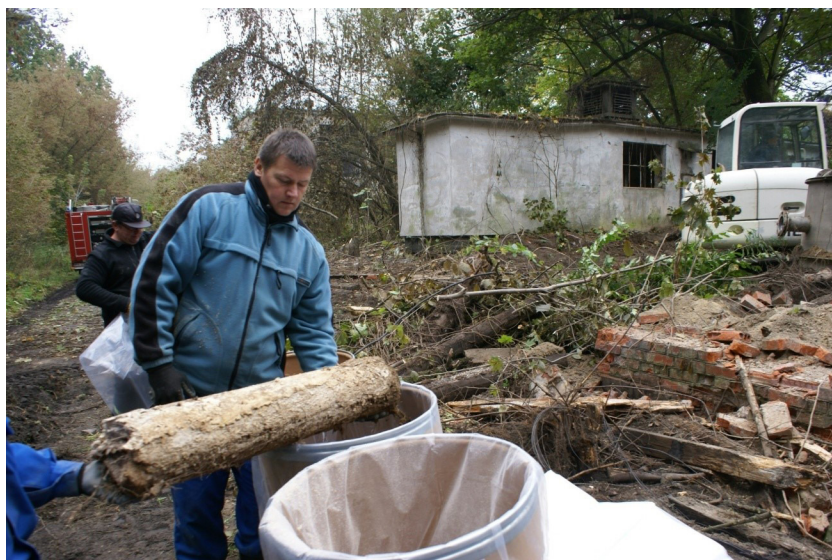
Figure 7. View of the production area: (a) inspection chamber containing nitrocellulose – material removal process; (b) drain pipe containing explosive sediments; (c) charge removed from the drain pipe formed by nitrocellulose deposits inside the pipe

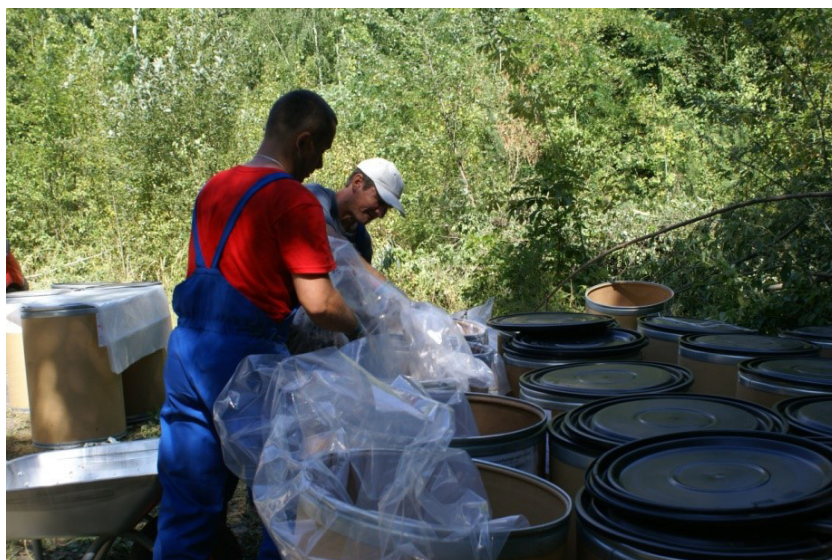
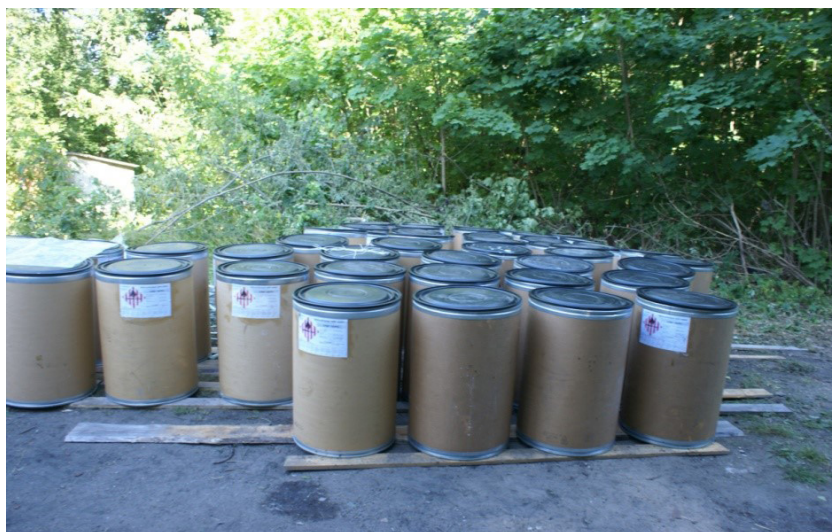
Figure 8. Placing the extracted nitrocellulose after immersing it in water into an internal bag (a) water-proof, anti-static protecting the content placed into cardboard drums, (b) transport containers as required by the agreement concerning the International Carriage of Dangerous Goods by Road (ADR)

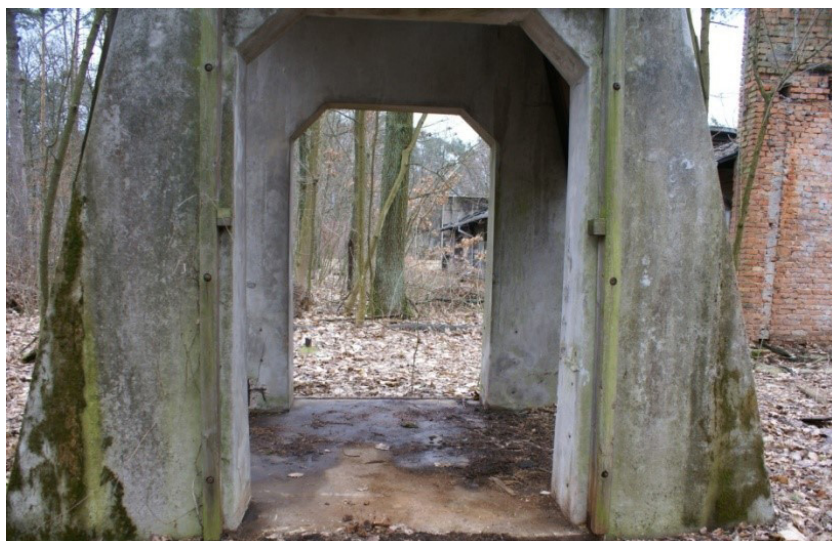
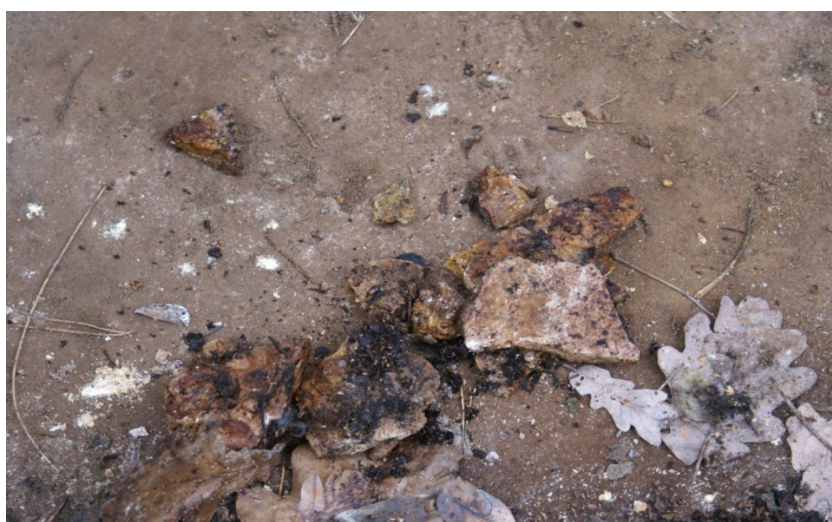
Figure 9. Trinitrotoluene melting plant (a) and the remaining explosives found near the melting plant (b); the physical and chemical analysis showed trinitrotoluene removed from the shells

As it turned out in 2016, in the area handed over by the Municipal Council to the MESKO branch in Pionki, there is an undisclosed, overgrown former trinitrotoluene melting plant. A vat with 335 kg of trinitrotoluene was found at the location. An on-site visit carried out this year showed pieces of trinitrotoluene and tetralite under the leaf litter. Figure 9 shows the location of the melting plant and the remaining explosives.
