E.N. Serov\*, S.I. Mironova\*\*, Roman Orłowicz\*\*\*

## Lower Quadrangular Frame Beams of the Church of the Transfiguration on Kizhi Island, Russia

**Cytowanie / Citation:** Serov E.N., Mironova S.I., Orłowicz R. Lower Quadrangular Frame Beams of the Church of the Transfiguration on Kizhi Island, Russia. *Wiadomości Konserwatorskie – Journal of Heritage Conservation* 2016;46:125-130

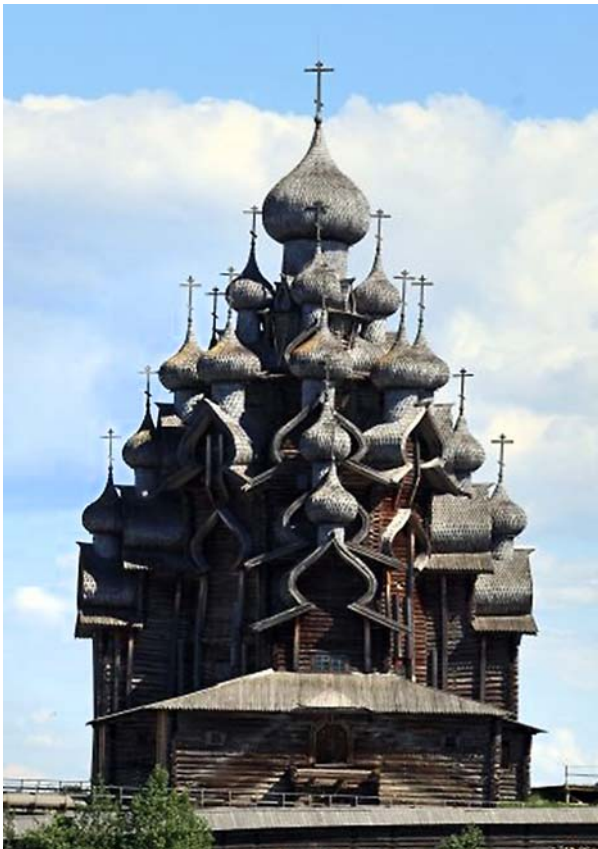
Fig. 2. The Church of the Transfiguration

The cruciform floor-plan of the church is formed by a central octagonal log structure with four two-tier side annexes facing the four cardinal points. The nave is connected on both sides to a monastery refectory which, in turn, is connected to a porch with two staircases on its western side. The central dome of the Church of the Transfiguration is 37 metres high. This makes the church a unique example of a complete multi-tiered, multi-dome building structure (a masterpiece of a complete multi-tiered, multi-dome structure, Fig. 2).
