RAMMED EARTHEN FARM BUILDINGS IN TWORKOWICE, CIECHANOWIEC MUNICIPALITY, N-E POLAND

Paulina Bartoszewicz* , Magdalena Berezniak* , Kinga Wiśniewska * , Jarosław Szewczyk**

Abstract

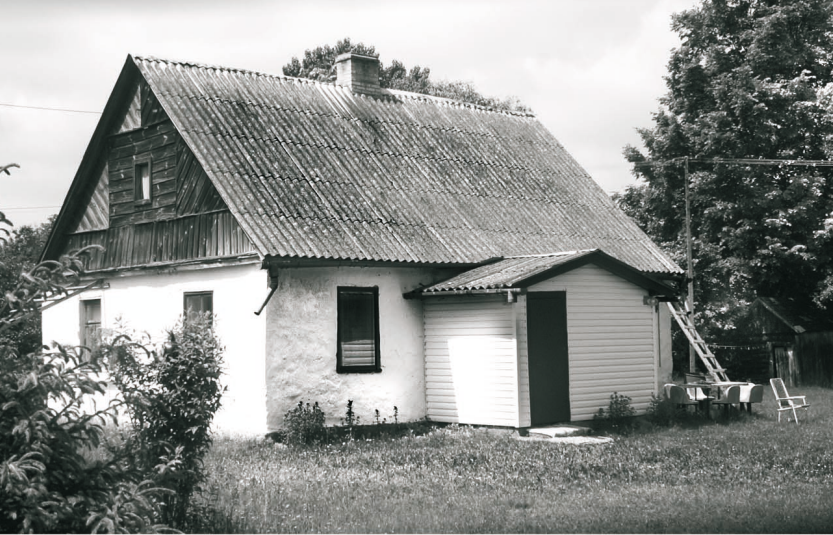
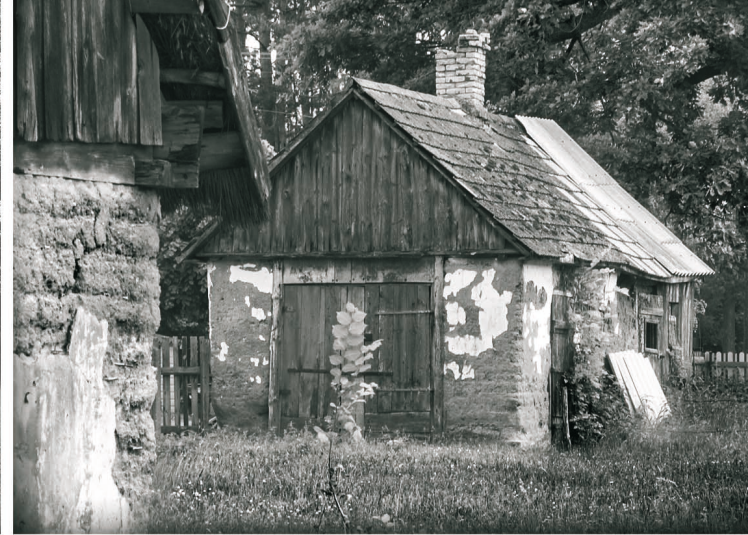
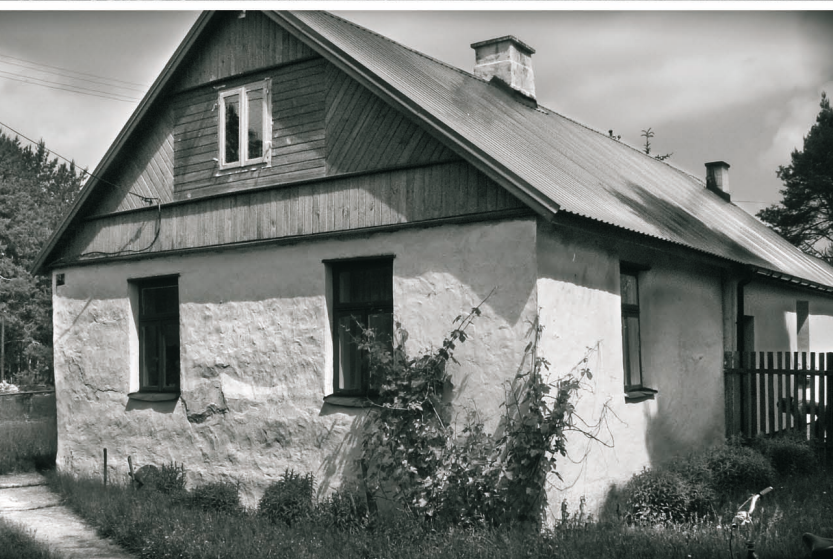
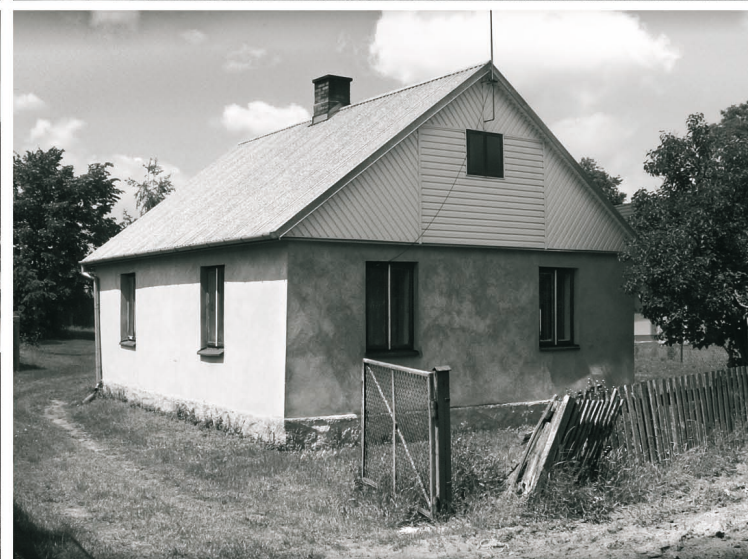
Fig. 2/a-d. Rammed earthen farmhouses in Tworkowice; source: the authors, 2009

loosely built-up area in the newer eastern part of the village (Fig. 2). No clay houses were found in the densely built-up old (western) part of the village.

A visual inspection of the Tworkowice clay buildings reveals a surprising paradox: the foundations of the pigsties and other livestock buildings are more solid than those of the houses. The dwelling houses were built on brick foundations up to about 35 cm above ground level (Fig. 2; Fig. 4/a,b,d), while the foundations of the seemingly more inferior livestock buildings are not only higher, elevated more than half a metre above ground level, but also more solid, made of large split stones (Fig. 4/c; Fig. 6/c,d; Figs. 7-10). That this is not the case is evidenced by the buildings comprising a re-

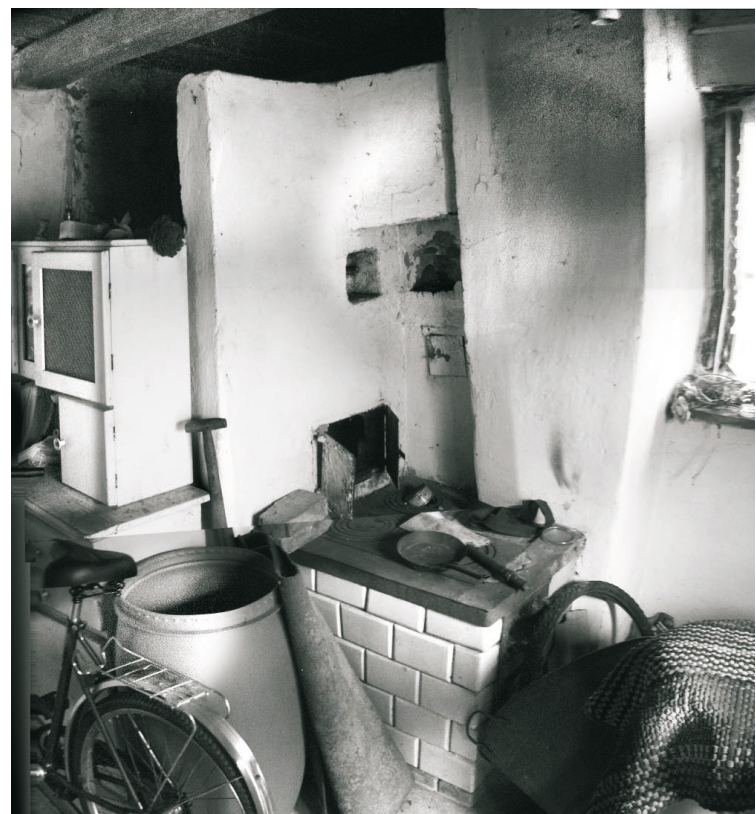
Fig. 3. Inside an earthen house in Tworkowice (No. 9); source: the authors, 2009

The other two former houses are interesting insofar as they were built as combined with a livestock section. They are no longer in use and, from the outside, only the chimneys, without which they would look like ordinary, small animal buildings, bear witness to their former residential purpose (Figs. 4-5). Inside, they usually have a vestibule and a living room with a brick and kettle cooker (Fig. 3), while the remaining rooms were used as non-residential. These buildings were whitewashed and unplastered. The falling off white-wash exposed the clay structure of the walls.

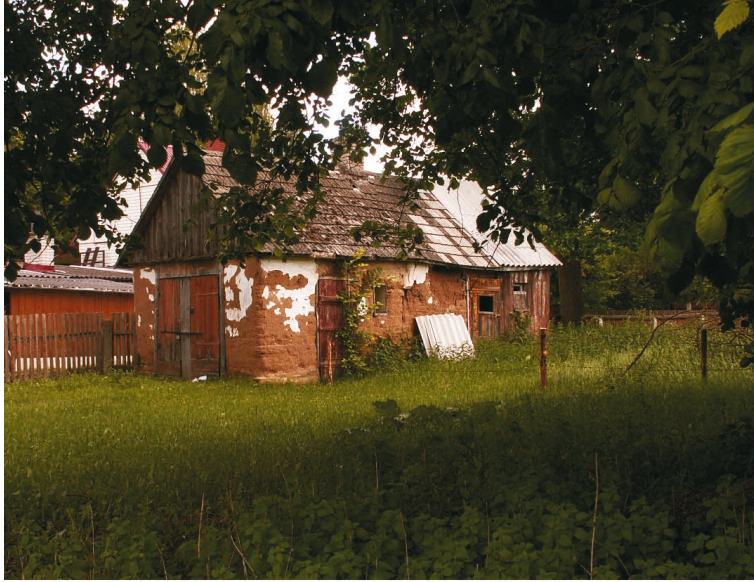
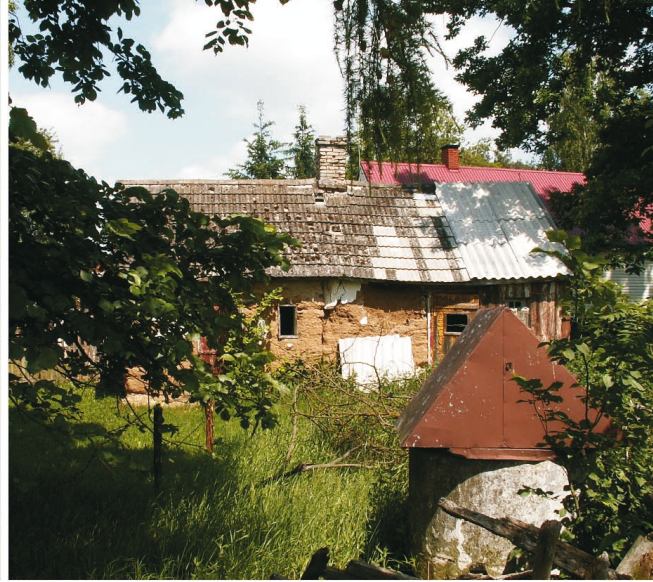
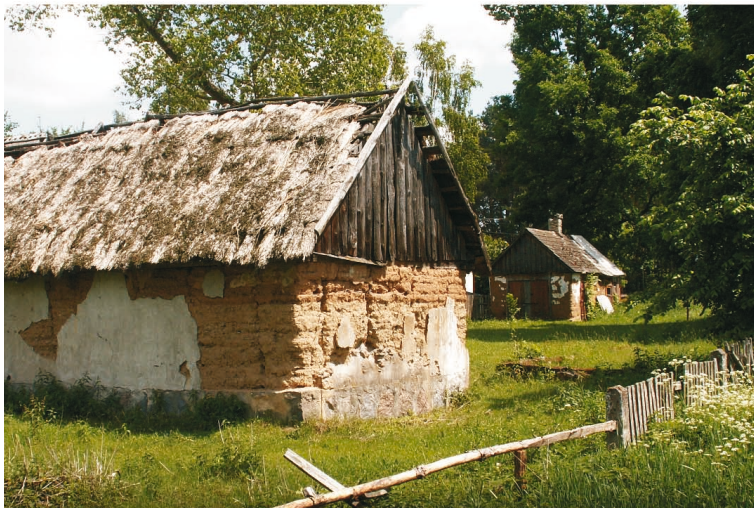
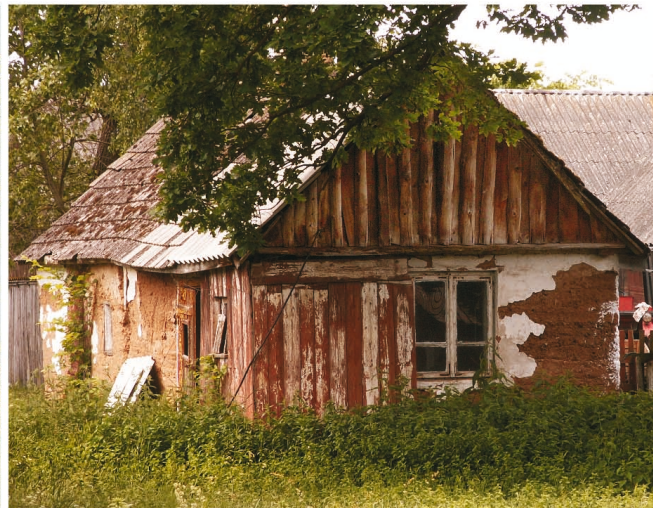
Fig. 4/a-d. An old earthen farmhouse in Tworkowice (No. 15); source: the authors, 2009

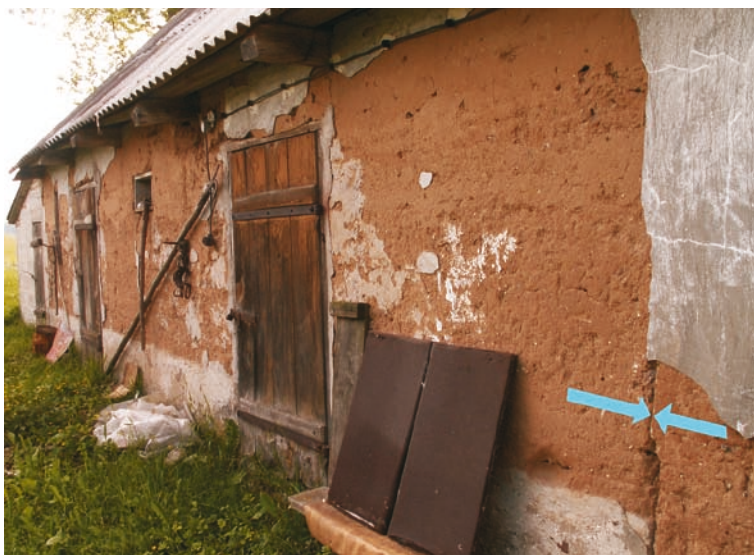
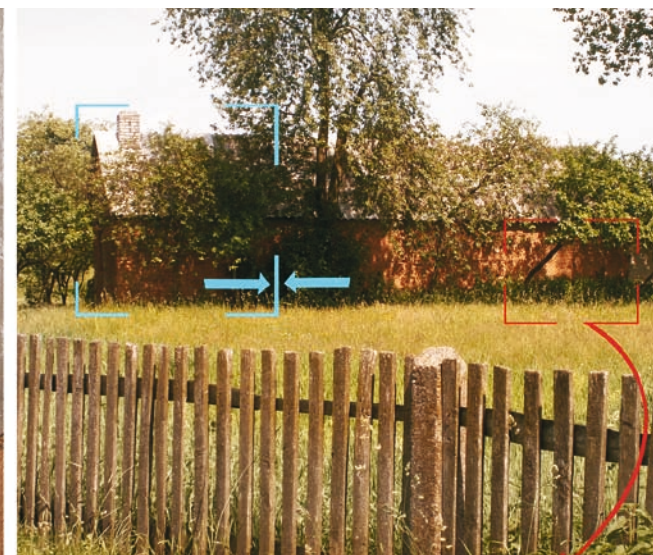
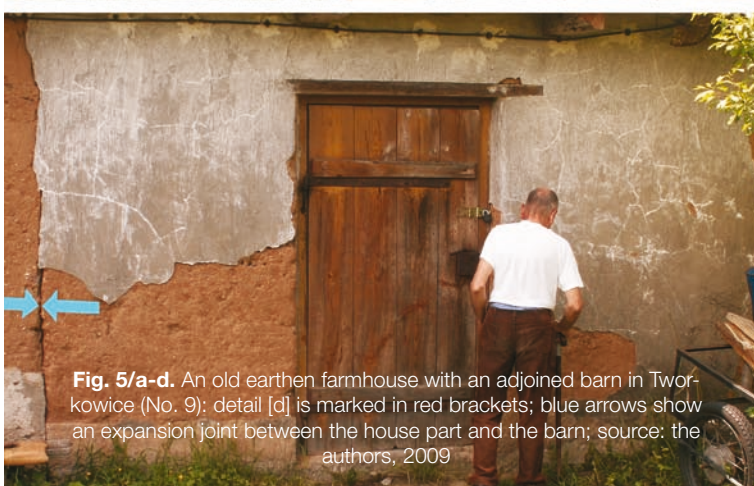
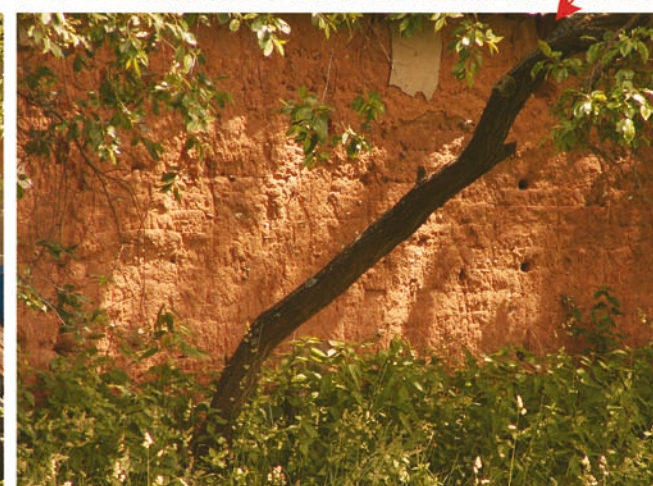
Fig. 5/a-d. An old earthen farmhouse with an adjoining barn in Tworkowice (No. 9); detail [d] is marked in red brackets; blue arrows show an expansion joint between the house part and the barn; source: the authors, 2009

sidential and a livestock section. For example, in the building shown in Fig. 5, the residential part is separated from the livestock part and has a lower foundation than the livestock part.

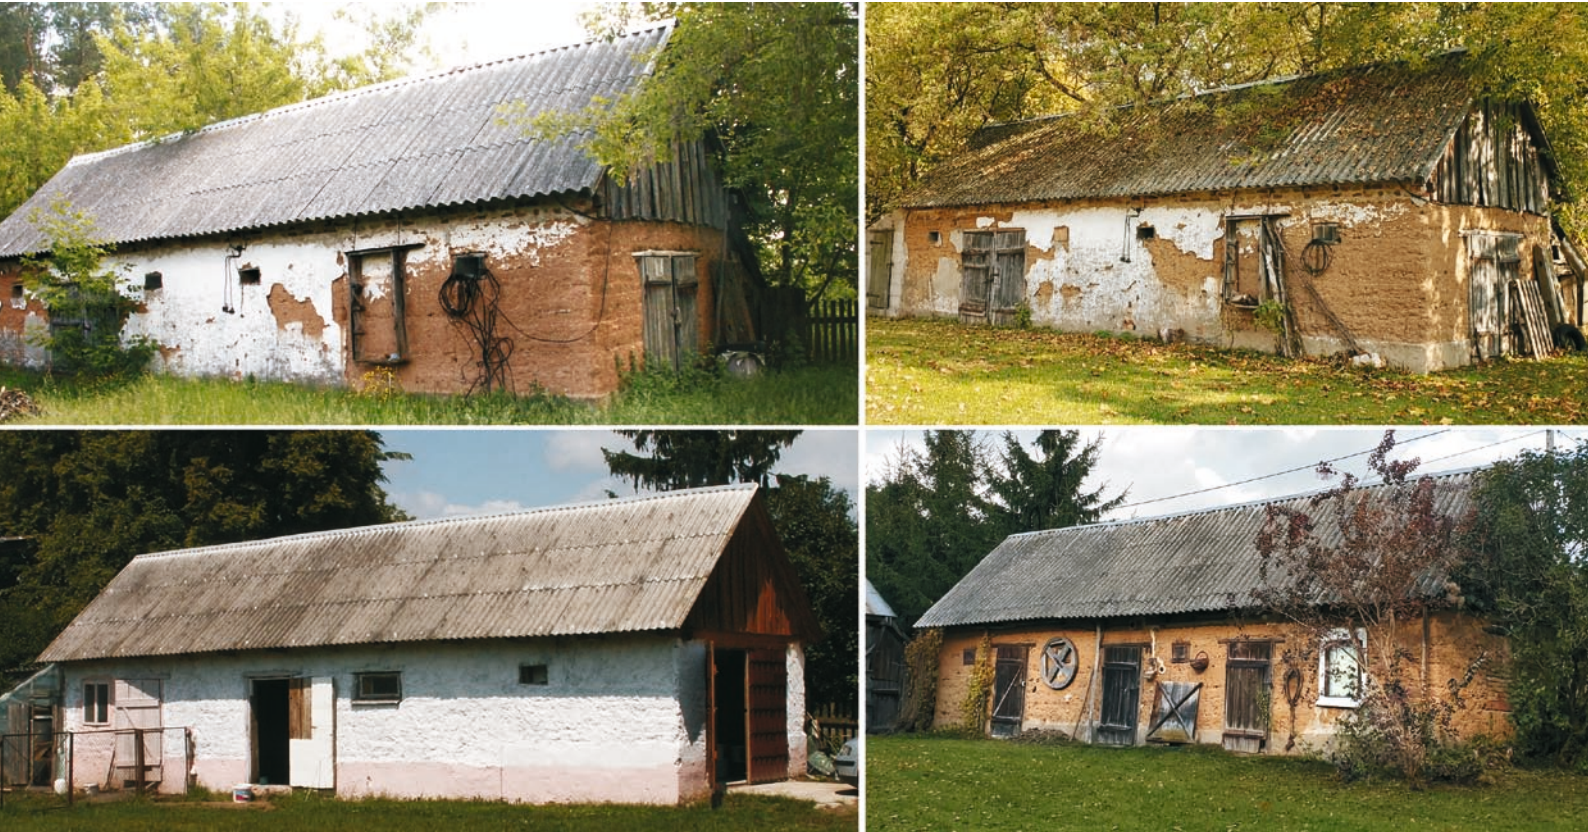
Fig. 6/a-d. The most popular type of earthen barn in Tworowice (above: the same barn in 2009 and 2021); source: the authors, 2009 and 2021

On the other hand, most of the clay-built buildings in Tworkowice are former small livestock buildings, designed to house a horse, several cows, pigs and chickens, but nowadays are no longer in use or at most serving a storage function. They may have been built on the basis of typical (model) designs, taking into account the clay-block construction. This could be evidenced by the repetition of several similar layouts of livestock buildings in different homesteads (with turrets on the axis of the gable wall; Fig. 6). Some of them have later extensions – wooden (Fig. 8/c,d) or of hollow blocks (Fig. 6/a,b, Fig. 7, Fig. 8/b, Fig. 10/c; Fig. 11/a).

The unplastered or stripped original thin plaster walls of the livestock buildings made it possible to compare their degree of erosion under weathering between June 2009 and October 2021 (Fig. 6/a,b, Fig. 7/a,b). During these more than 12 years, the cavities increased in the corners not exposed to the wind (irrespective of the sides) and at the window frames, while the wall planes did not suffer much damage (Fig. 7b). It is interesting to note that, some 70 years after they were erected, Tworkowice clay buildings generally remain in a good state of repair and some are well cared for and kept in excellent condition despite the lack of plaster to protect the masonry (Fig. 8/c,d; Figs. 9 and 11).

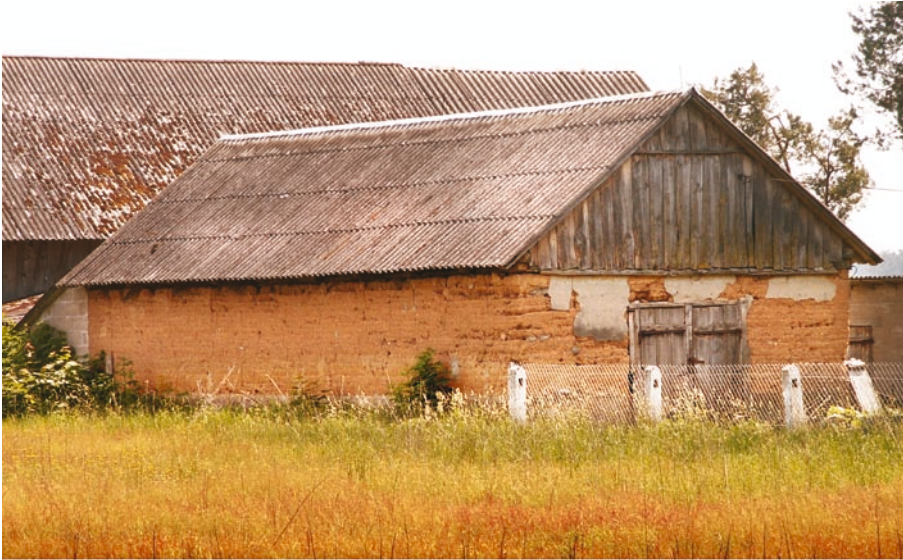
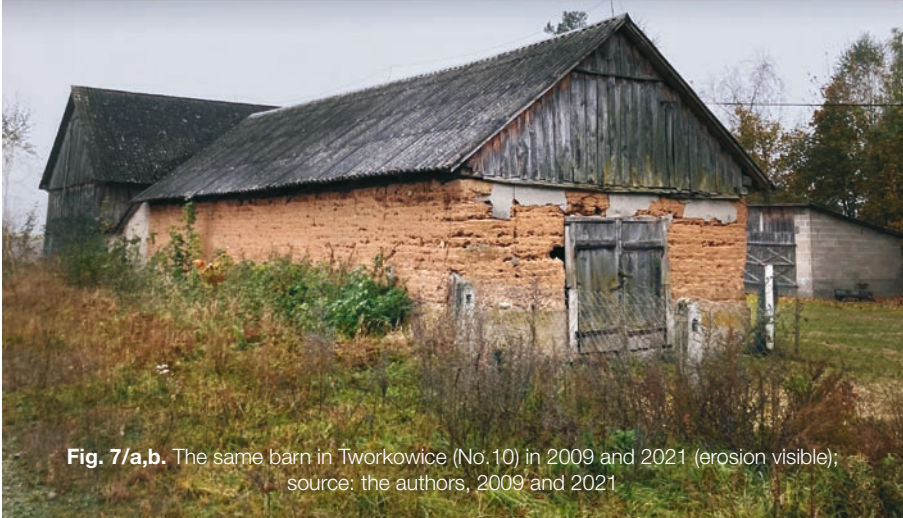
Fig. 7/a,b. The same barn in Tworowice (No.10) in 2009 and 2021 (erosion visible); source: the authors, 2009 and 2021

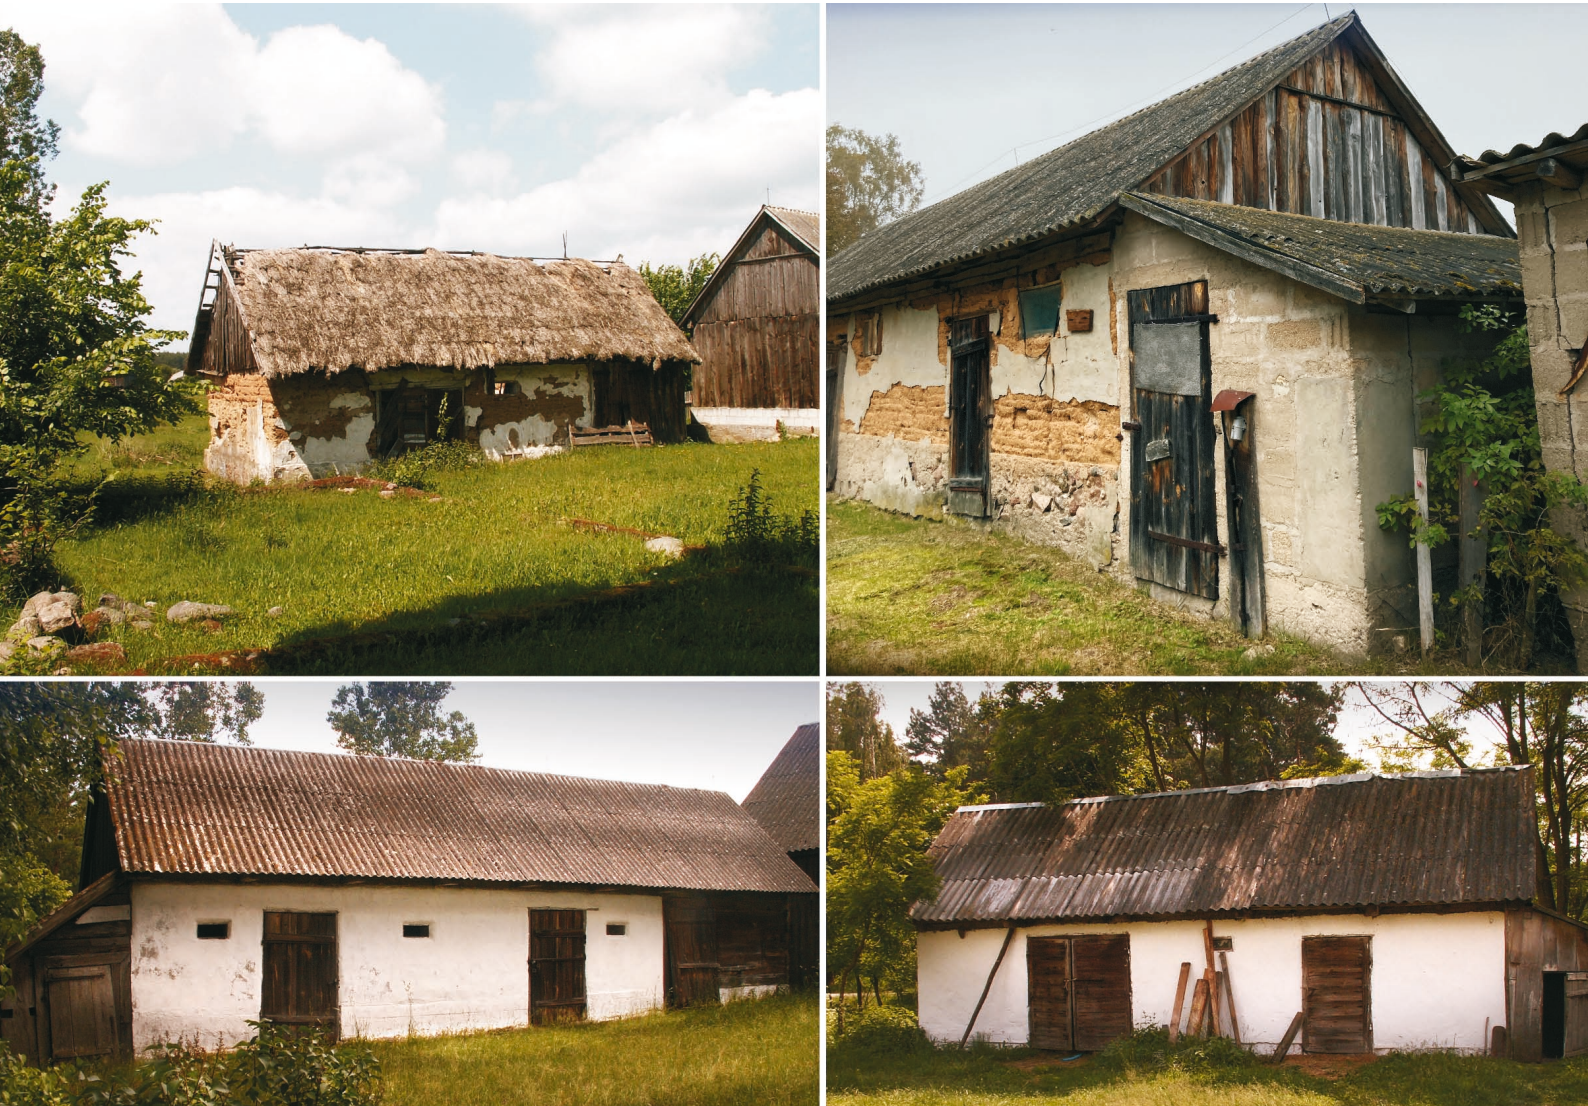
Fig. 8/a-d. Rammed earthen barns in Tworkowice; source: the authors, 2009 (a, c, d) and 2021 (b)

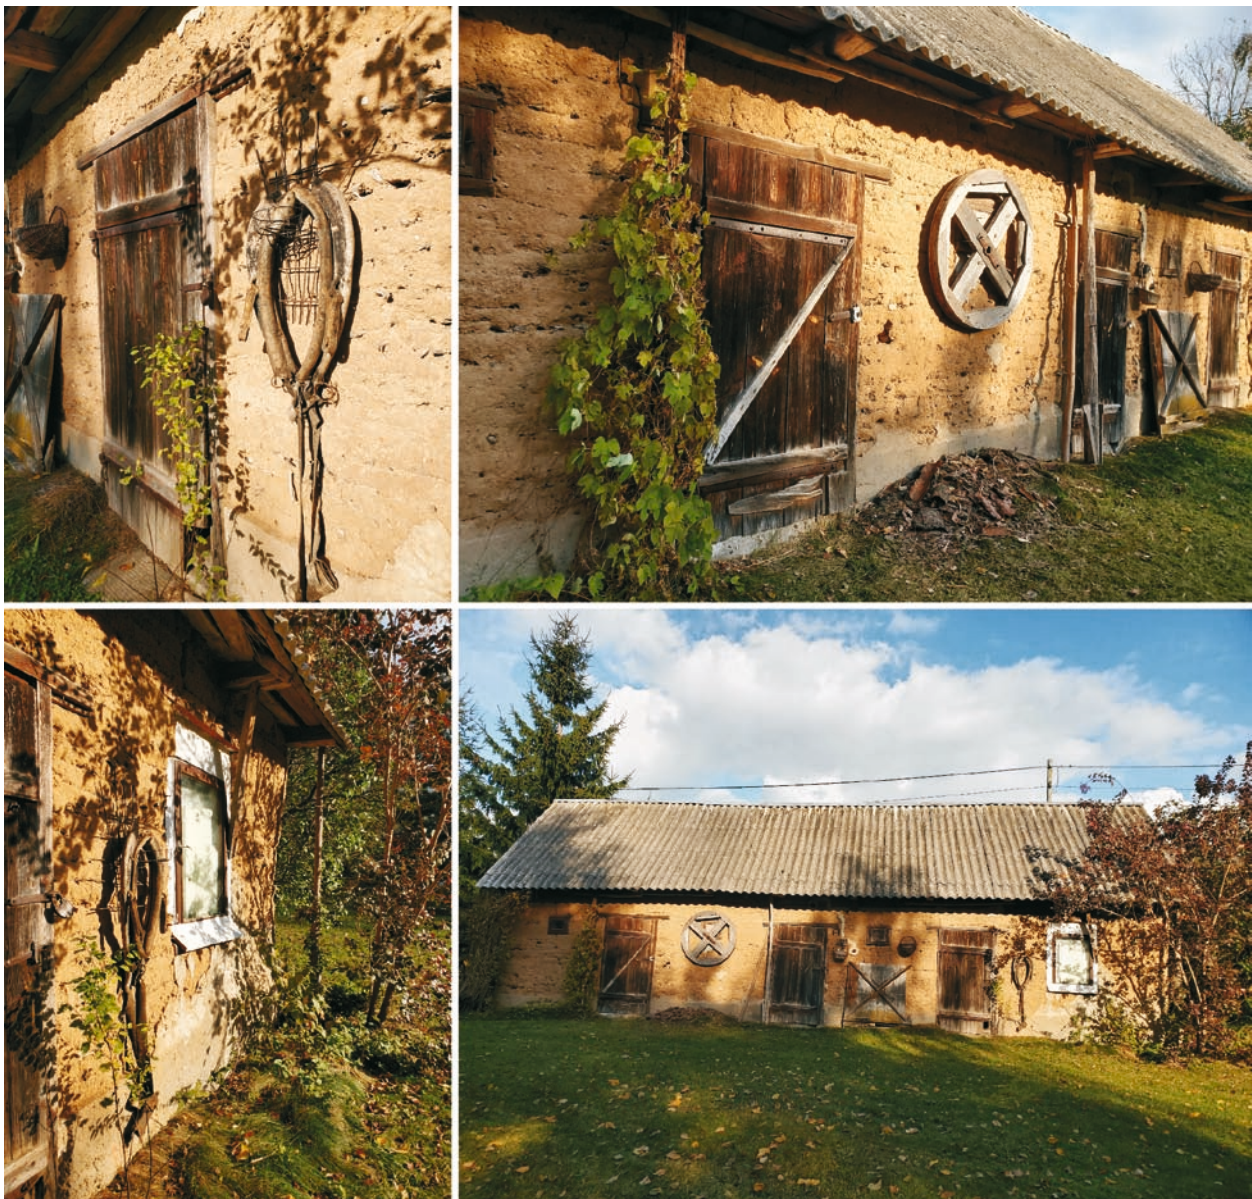
Fig. 9/a-d. A rammed earthen barn in Tworkowice; source: the authors, 2021

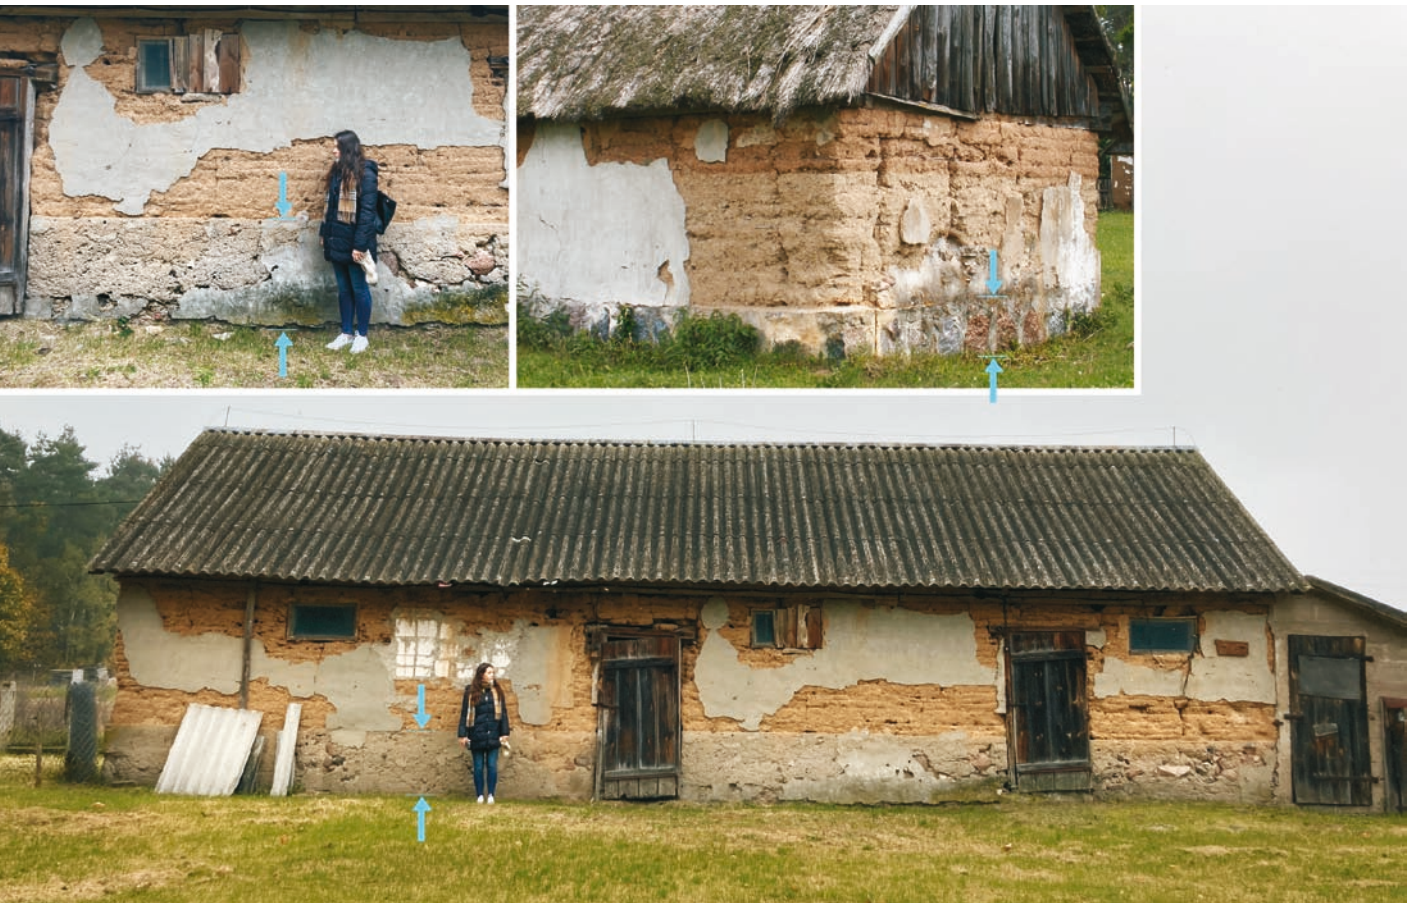
Fig. 10/a-c. Elevated foundations of rammed earthen barns; source: the authors, 2021

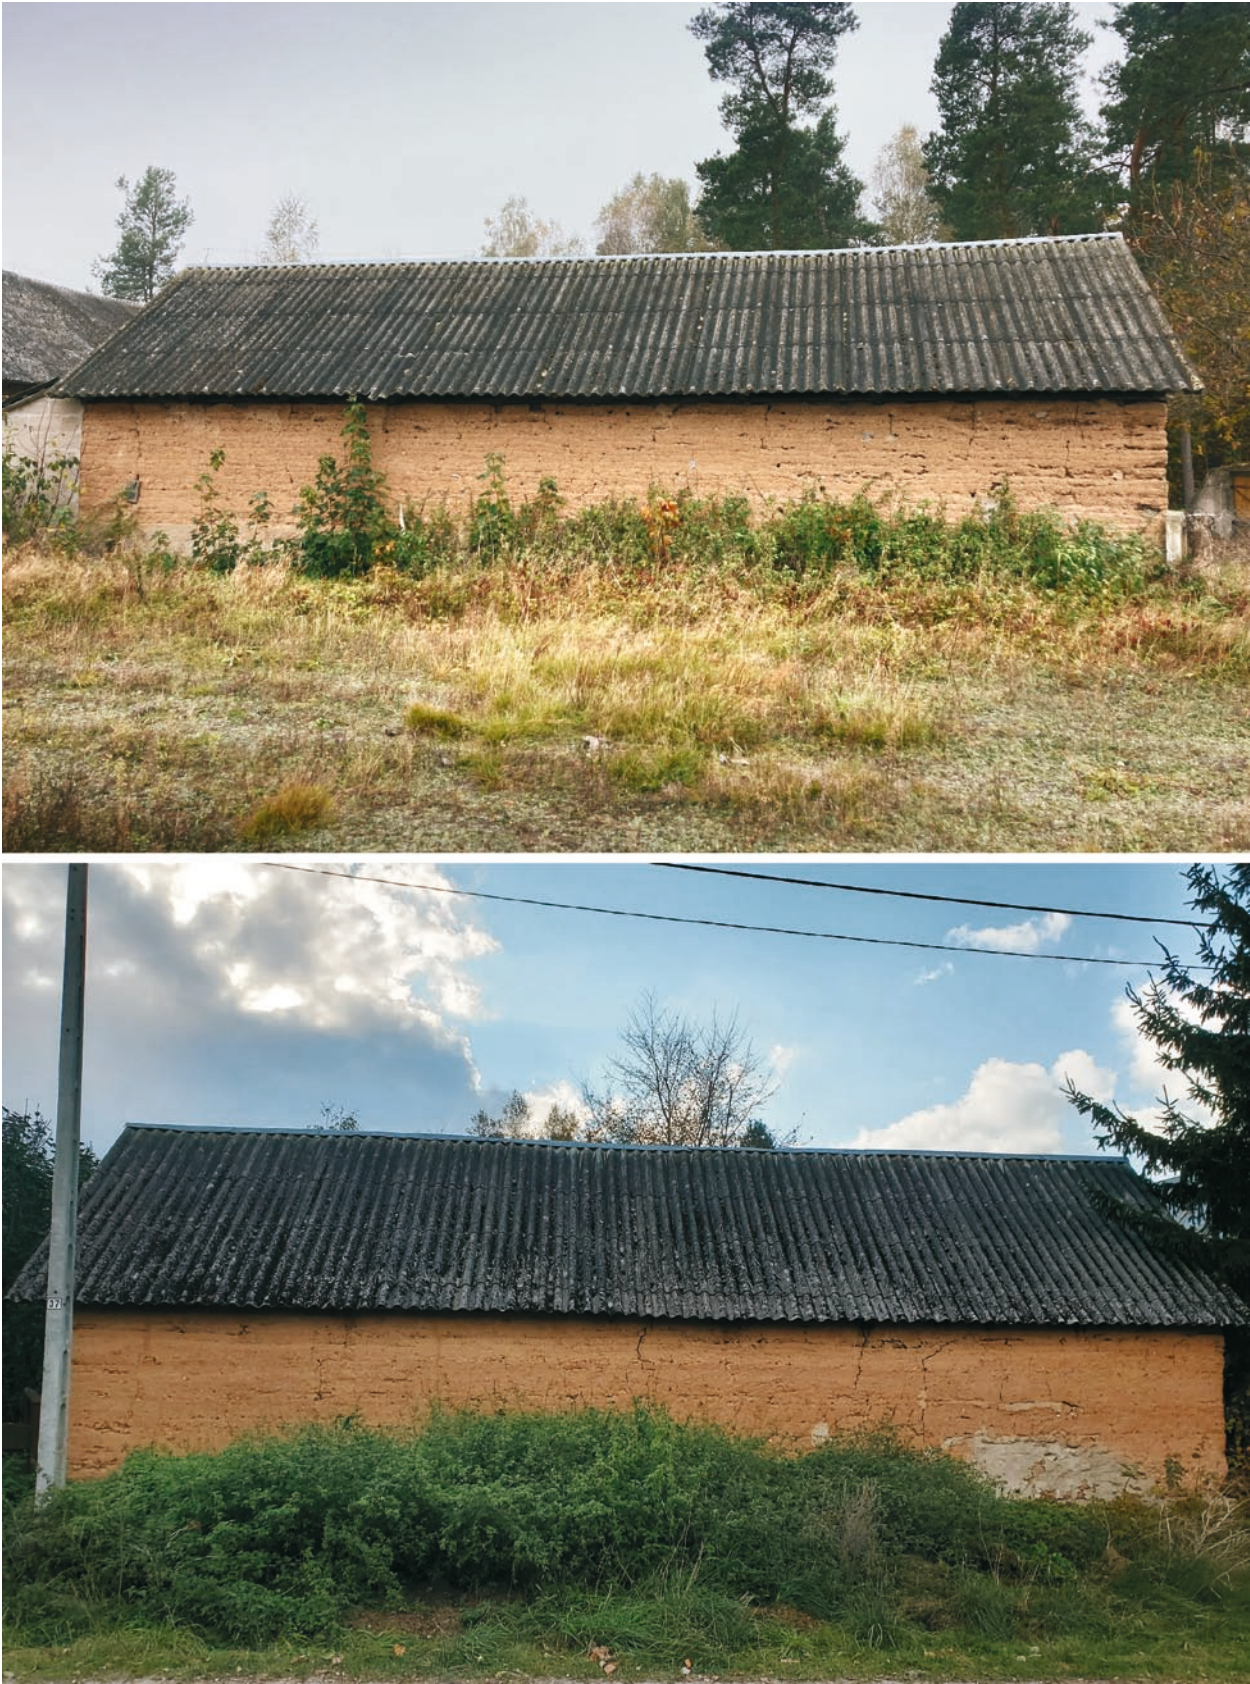
Fig. 11/a-b. Earthen barns; source: the authors, 2021
