Teresa Dziedzic*

Hatshepsut Temple in Deir el-Bahari, Egypt – research and conservation work

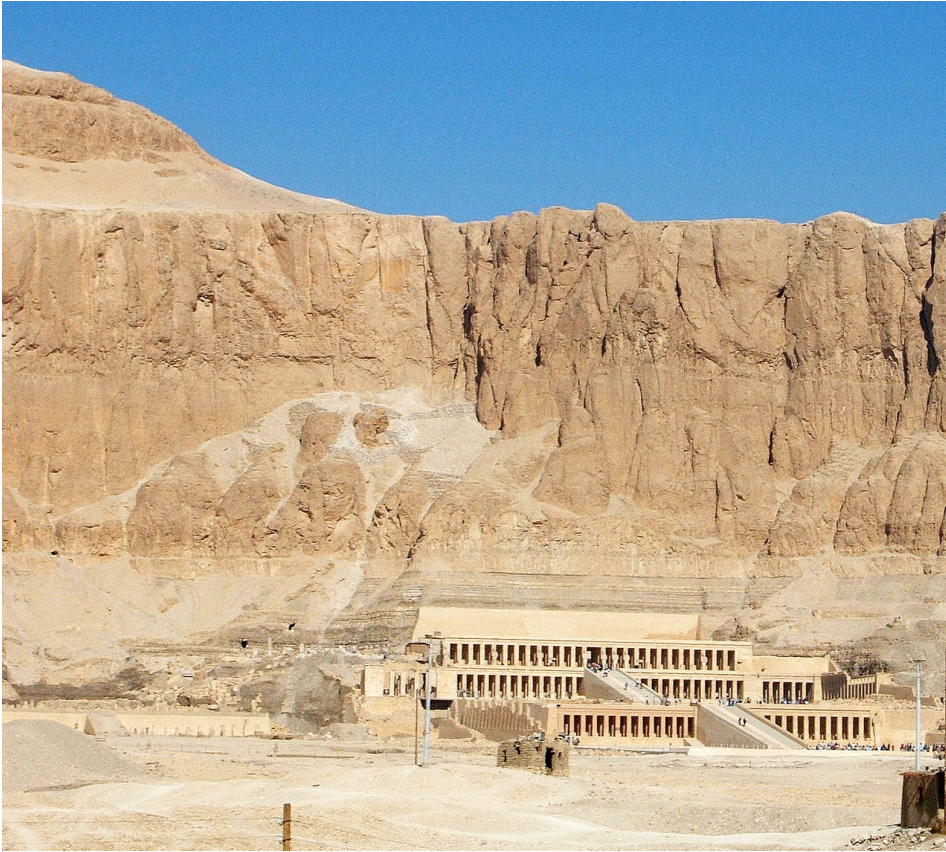
Fig. 1. An overview of the Hatshepsut Temple (photo by author)

The Temple of Hatshepsut features three terraces, and the highest platform serves as a protective element (Fig. 1). The Lower Terrace is at an elevation of 102.13 meters, the Middle Terrace at 111.75 meters, and the Upper Terrace at 119.9 meters. The temple's highest element, the reconstructed platform, stands at 133.87 meters [2]. On the lowest terrace, there is a courtyard that is bounded by porticoes on its western side. A ramp connects this terrace to the Middle Terrace, flanked by two porticoes on the west side, just like the Lower Terrace. The chapels are positioned on either side of the entrances dedicated to the temple's worshipped deities: the chapel of Hathor is found to the south, and the Chapel of Anubis is situated to the north. On the third level are the main rooms of the temple. One can also access this level through a ramp. On either side of it are pillar porticoes with Osirian statues. The main entrance is located on the axis and leads through a portal into the temple's central courtyard. Beyond the courtyard is the partly rock-cut Sanctuary of Amon, situated in the Festival Courtyard. Additional chapels can be found on either side of the inner courtyard: to the north, an open courtyard with an

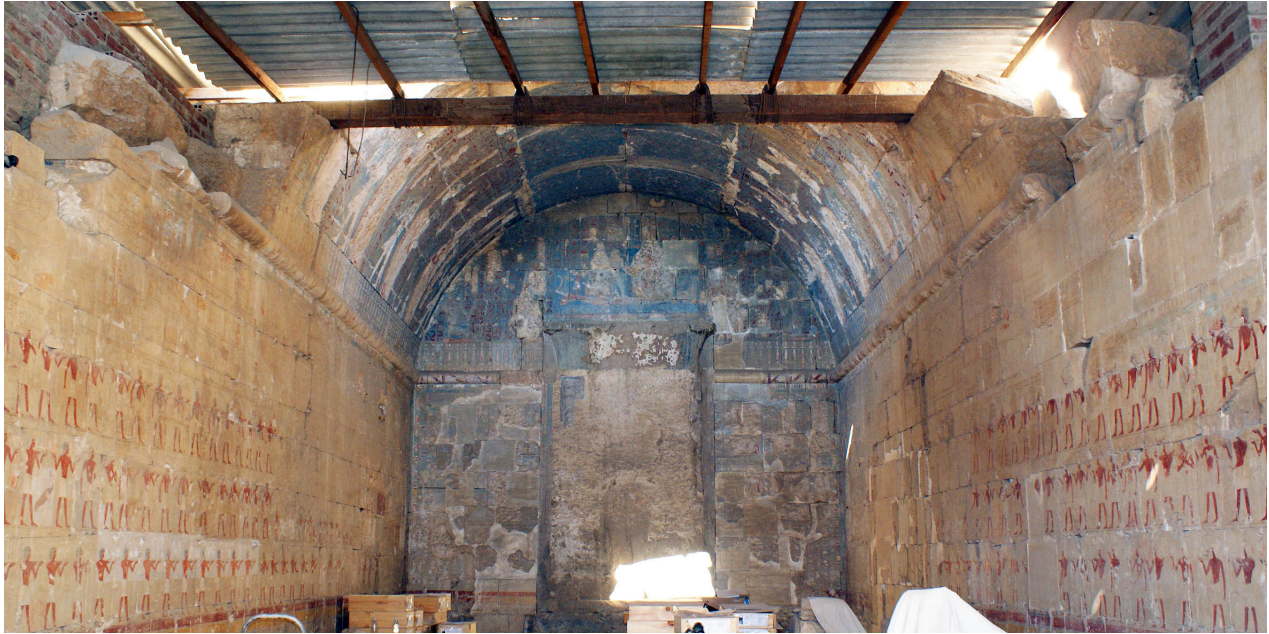
Fig. 2. Hatshepsut chapel, view of the west wall. State as of 2009 (photo by T. Dziedzic)

The chapel is a hall covered by a partially preserved and illusive vault, making it the largest in ancient Egyptian architectural history (Fig. 2). The chapel's fully preserved in situ section is located on the west side. The chapel was designed on an east-west axis, adhering to a rectangular plan. At floor level, the chapel's dimensions are characterised by irregularity. They range from 13.33 m to 13.36 m in length, from 5.23 m to 5.33 m in width, and their height from floor to vault arrow is 6.28 m¹. A 3D scan by LabScan, a division of the Faculty of Architecture at Wrocław University of Science and Technology, was used to determine the parameters. The chapel's entrance is situated on the eastern wall, with the chapel's only surviving equipment, the blind gate stele, positioned on the western wall.

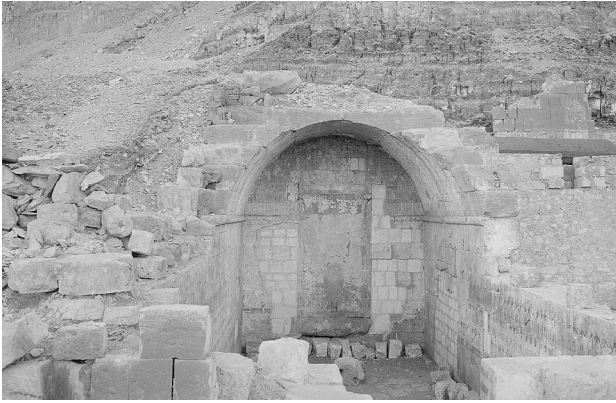
Fig. 3. The Hatshepsut chapel as of 1912
(source: Archive of the Maison de l'Orient et de la Méditerranée Jean Pouilloux Université Lumière Lyon)

in the project was Somers Clarke, who documented the temple's architecture and published it in the sixth volume of a publication edited by Naville from 1895 to 1908. The period was marked by a substantial amount of restoration and conservation work. The archaeological team made an exciting discovery during their work – the wall that once separated the chapel of Tuthmosis I from the Hatshepsut chapel had been toppled. Consequently, the wall underwent reconstruction from 1897 to 1898, utilising new stone material and the original blocks. The placement of these blocks was determined through detailed epigraphic research [14]. In 1911, Herbert E. Winlock began work on the temple of Hatshepsut, heading the American mission of the Metropolitan Museum of Art in New York. Over the next two decades, the Americans involved in the temple project unearthed multiple tombs, sarcophagi, mummies, and sculptures. Winlock has published comprehensive reports detailing the progress made throughout each work season. Winlock's archival photographic records confirm that, during his mission at the temple, the walls of Hatshepsut's shrine were only partially reconstructed (Fig. 3).

During the Egypt Exploration Fund mission, restoration was carried out at the Hatshepsut chapel, filling the cavities in the north and west walls with original and newly excavated limestone blocks. The restored section on the north wall starts 1.48 m from the northwest corner and is 2.61 m long. In the 1912 photograph (Fig. 3), we see the restoration work already completed after the mission led by Naville.

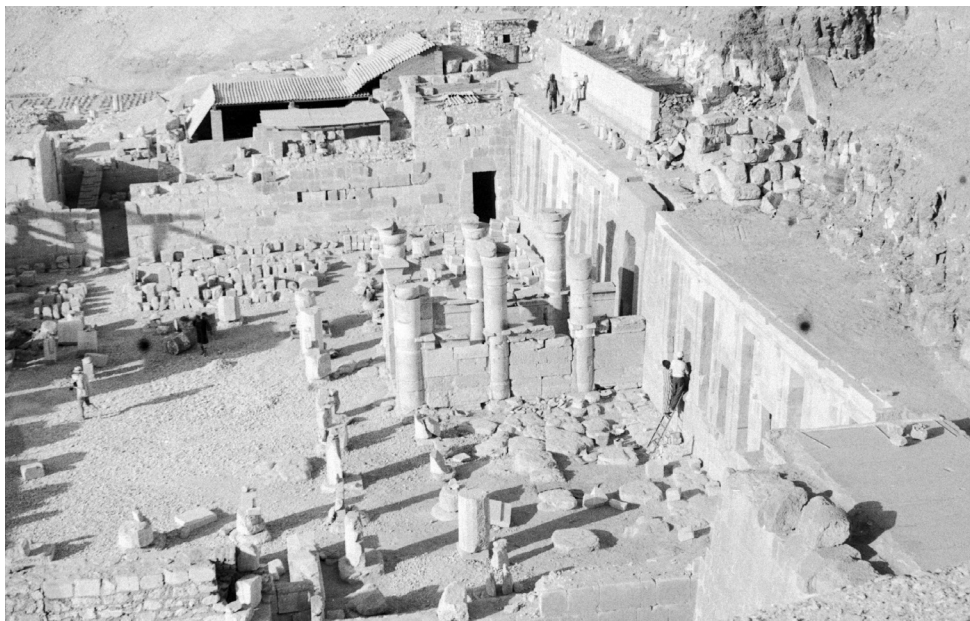
Fig. 5. View of the temple's upper terrace with the royal cult complex in the background and the chapels covered by a provisional roof. State as of 1969–1970 (source: Archive of the Centre for Mediterranean Archaeology, University of Warsaw, negative no. 0149)

In the 1960s, the chapels of Hatshepsut and Tuthmosis I in the Royal Cult Complex were protected by a timber-framed roof with an eternity cladding (Fig. 5).

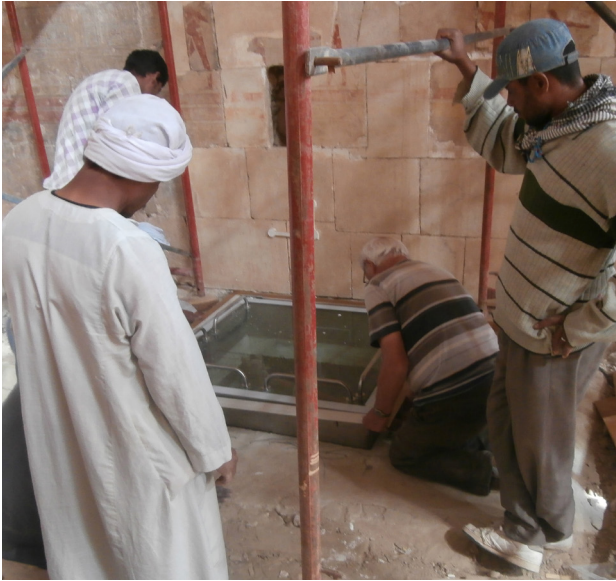
Fig. 7. Installation of a manhole to the tomb of members of the royal family from the 23rd–25th dynasties (S.7A/82), 2013 (photo by T. Dziedzic)

In 2013, a significant conservation project was undertaken at the Hatshepsut Chapel to expose and open up the tomb of members of the royal family from the 23–25th dynasty (S.7A/82) (Fig. 7). A manhole was designed, and a steel ladder permanently installed. The manhole was made of insulated glass (three layers of bonded reinforced glass) with a stainless-steel frame. The design accounted for the glass's load-bearing capacity of 4 kN (four people) and the convenience of opening the hatch using gas struts. The ladder's fixing anchor spacing was determined based on the type of steel, step spacing, and strength calculations. The grave shaft and its chamber were equipped with electrical installation. The entire project was designed by engineer Mieczysław Michiewicz, who supervised the project.
