HYDRAULIC ANALYSIS OF CAUSES OF WASHOUT OF GDYNIA-ORŁOWO SEA-SHORE DURING THE FLOOD IN THE KACZA RIVER ESTUARY

Michał Szydłowski

Gdańsk University of Technology, Faculty of Civil and Environmental Engineering, Poland

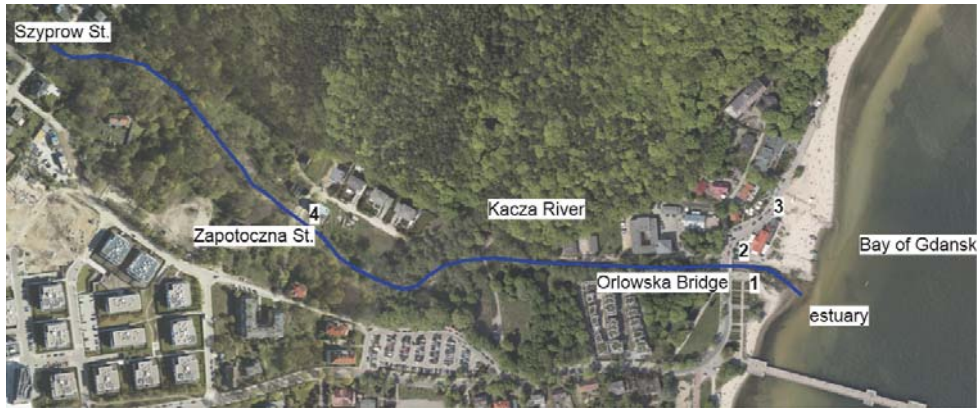
Fig. 1. The Kacza river estuary section with enumeration of flood- damaged places shown in Fig. 2. (image prepared by these authors on the basis of an orthophotomap from geodesic resources of Gdynia city, Gdynia Municipal Council licence No. PND.6642.1.1697.2018_2262_N, without scale)

Gdynia area and how big values of water flow rate in the river were as there is no control over the Kacza river catchment basin. However, it is probable that summary rainfall height could be similar to that measured in the same time at the station Gdańsk Oliwa (170,2 mm) and Gdańsk Osowa (161,9 mm) [5]. The so high daily rainfall amount was a direct cause that the Kacza river overflowed its banks in many sections of its full length. The freshet wave propagation resulted in the damaging of many infrastructure objects located along the river's valley. The estuary section of the river suffered most, especially the sea- shore belt together with the beach close to the Orłowo pedestrian pier at the river's estuary (Fig. 1), which appeared to be washed out along a significant length.

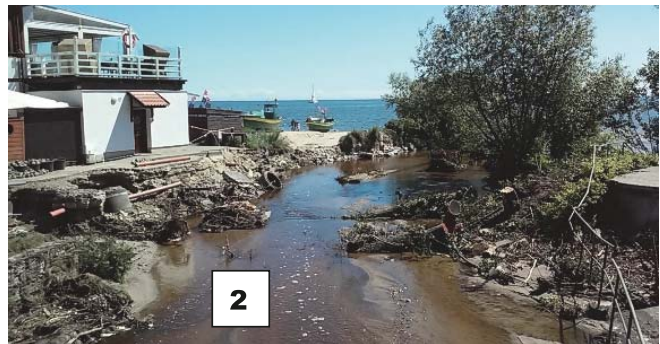
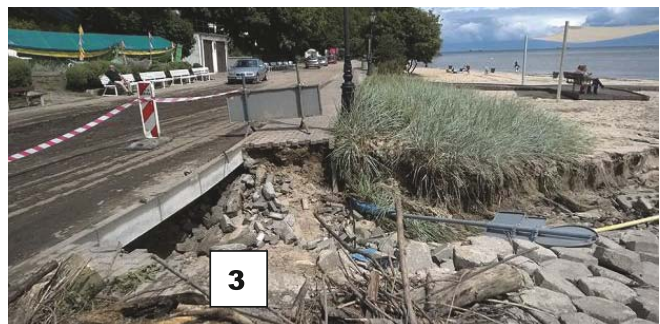
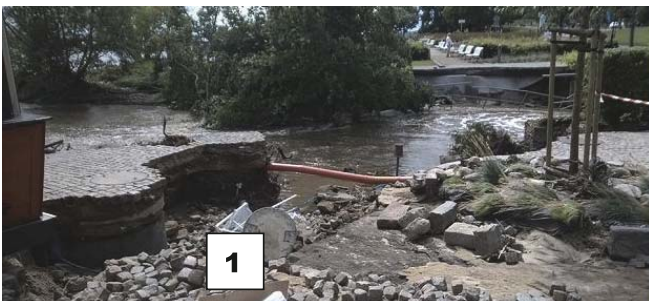
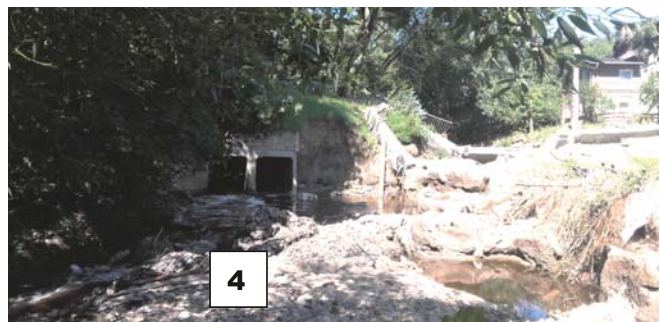
Fig. 2. Damages in the Kacza river estuary area in Gdynia Orłowo as a result of the freshet in July 2016 (photos No. 1, 2, 3 – washout of sea-shore belt below Orłowska street bridge, photo No. 4 - breach in road embankment of Zapotoczna street. Location of subsequent shots – see Fig. 1. (acc. this author's archive)

On the analyzed estuary section of the river (covering 800 m length from the Gdansk Bay coast) the greatest damages and losses were associated with heavy washout of banks and bed of the river and its valley beneath Szyprów street, water damming up and breaking the road embankment along Zapotoczna street, flooding the areas adjacent to the river –bed before the Orłowska street bridge as well as washout of the sea-shore belt together with the beach and touristic infrastructure below the bridge in Orłowska street. The photographs showing example damages resulting from the freshet run-off along the Kacza river estuary section are presented in Fig. 2.

During the flood of July 2016, as a result of blocking the culvert outlet by floating trees, branches and bed load, the river valley above the embankment of the Zapotoczna street filled in with water and after exceeding the top of the embankment (abt. 4 m above the river bed) suffered a washout resulting in an uncontrolled water run-off to the river bed.

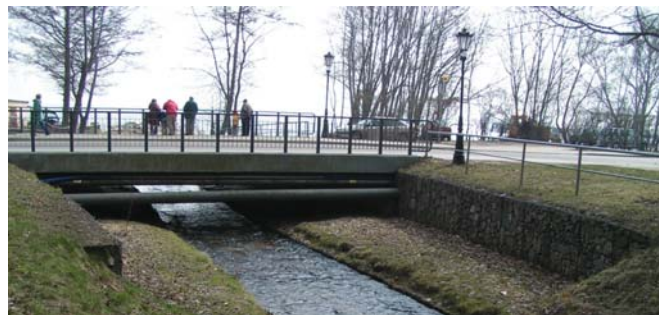
Fig. 4. The bridge over Kacza river in line of Orłowska street in Gdynia (a photo from this author's archive),

The second object (the bridge in line of Orłowska street) is built in the form of a reinforced concrete plate supported only on its heads (lack of abutments). Its breadth amounts to $11,0 \text{ m}$ and the height to $1,5 \text{ m}$. The upper ordinate of the plate is close to that of the surrounding terrain. Below the bridge there are located pipelines which obstruct a significant part of the free cross-section area under the bridge from the side of inlet. (Fig. 4).

As results from the calculations, a factor of a decisive impact on the excessive damming-up of the water and its breaking through Orłowska street was the reduction in the free cross-section area under the bridge resulting from the installation of the pipelines across the river bed (Fig.4). The fact of taking into account the reduction of the free cross-section under the bridge during

4. The reduction in the cross-section of flow passage area under the bridge due to the engineering infrastructure (pipelines) installed across the river valley above the bridge, proved by the calculations in variant 3, should be taken as the direct cause of the excessive water damming-up before the Orłowska street bridge and consequently the water overflowing above it towards the beach. Only the cumulated effect of the natural rainfall freshet, the breach in the Zapotoczna street embankment and the reduced cross-section of flow passage area under the bridge caused that the ordinate of Orłowska street was exceeded which in consequence triggered the water flowing down the reinforcements of sea shore and beach toward the sea, which resulted in their damage.

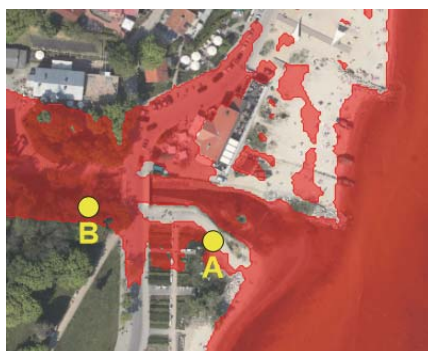
Fig. 6. Maximum depths [m] and range of flooded area in the region of Kacza river estuary and Gdynia- Orłowo beach together with depicted measurement points of maximum water level ordinates after the flood in July 2016 (A, B) (images prepared by this author on the basis of orthophotomap from municipal geodesic resources of Gdynia, Gdynia Municipal Council licence No. PND.6642.1.1697.2018_2262_N, without scale)

The differences in the calculated range of flooded area near the Orłowska street bridge and the beach are shown for particular simulation variants in Fig. 6. As can be seen, in successive variants the flooded area range increases and the zones of potential washing -out the sea shore belt and beach spread. Worth mentioning, that the flooded areas indicated in the last graph of Fig. 6 correspond to the location of the washout areas observed after the flood, shown in Fig. 1 (No. 1, 2 and 3). Simultaneously, neither in variant 1 nor 2 the flow streams north from the visible building and those on the southern side over the right bank of the river close to its estuary, were reproduced. This way the hypothesis has been proved on the decisive role of the reduced flow passage capacity of the cross-section under the Orłowska street bridge in forming the freshet run-off in the area of Kacza river estuary and its impact on the flood damages resulting in the washout of the sea-shore belt in Gdynia –Orłowo .

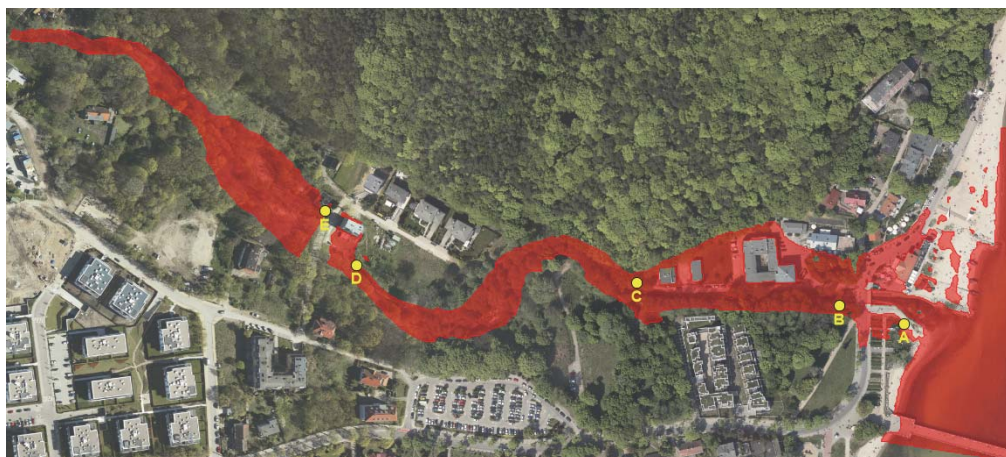
Fig. 7. Maximum range of flooded area along the whole analyzed section of Kacza river in variant 3 together with depicted measurement points (A, B, C, D, E) of maximum water level ordinates after the flood in July 2016 (image prepared by this author on the basis of orthophotomap from municipal geodesic resources of Gdynia, Gdynia Municipal Council licence No. PND.6642.1.1697.2018_2262_N, without scale)

In order to quantitatively verify the numerical simulation results as well as simultaneously evaluate the model, a comparison was made between the calculated maximum water level ordinates and the geodesic-measured ordinates of maximum water level in the valley after the flood in July 2016. The measurements were conducted by a team of Gdansk University of Technology during its on-site visit [9]. The points where the measurements were taken are denoted by letters A through E in Fig. 6 and 7. Point A is placed beneath Orłowska street on the right side of the river away its main bed ; point B is placed above the Orłowska street bridge on the right flooding area of the river ; point C is situated on the left side of the river directly at its main bed; point D lays directly below the road embankment of Zapotoczna street; point E is placed above the road embankment. The common list of measurement and calculation results is given in Tab. 2.
