ANALYSIS OF THE WEAR OF PISTON RINGS PROTOTYPE IN TERMS OF TEAM ENDURANCE TEST

Keywords: combustion engine, piston ring, wear

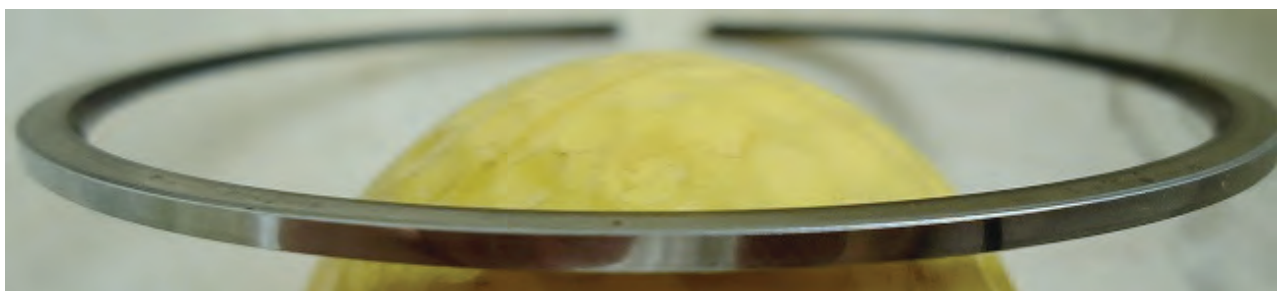
All of the rings shows the correct cooperation with the surface of the cylinders. The surface of the rings is evenly worn around the perimeter of the height of the rings (Fig. 2-5).

Fig. 2. View of side surface of the first ring of the cylinder No. 1

Average value of wear of the radial width of the ring 1/1 is equal to 0.003 mm. In all 10 measuring points on the circumference of wear ranging from 0.00 to 0.008 mm were measured. Also the rending of the axial high is equal to 0.007 mm were measured . Was measured the weight gain equal to 0.0322 g, confirms the results of the wear of the width and height of the ring.

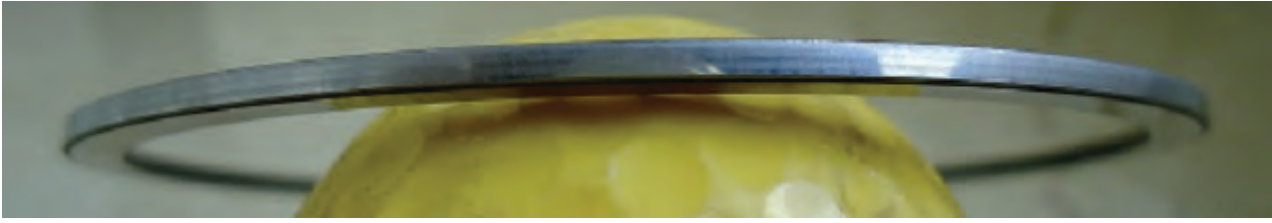
Fig. 3. View of side surface of the first ring of the cylinder No. 2

Average value of wear of the radial width of the ring 2/1 is equal to 0.004 mm. In all 10 measuring points on the circumference of wear ranging from 0.002 to 0.006 mm was measured. Average value of wear of the axial height is equal of 0.006 mm. Loss of weight of the ring 2/1 is equal to 0.0181 g and it confirms the results of the wear of the width and height of the ring.

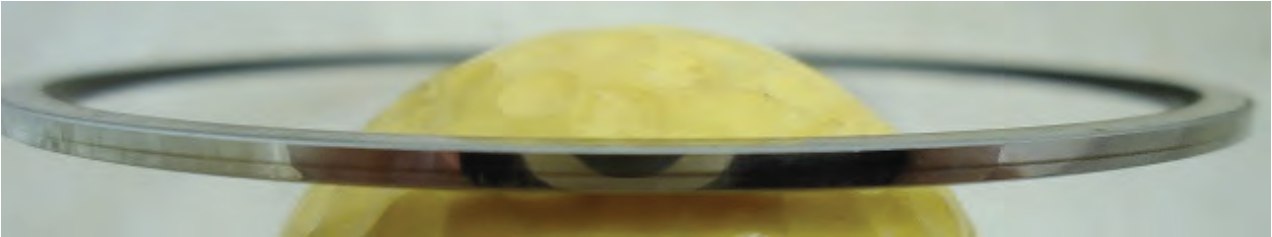
Fig. 4. View of side surface of the first ring of the cylinder No. 3

Average value of wear of the radial width of the ring 3/1 is equal to 0.006 mm. In all 10 measuring points on the circumference of wear ranging from 0.001 to 0.008 mm were measured. Average value of wear of the axial height is equal of 0.009 mm. Was measured the weight gain equal to 0.0268 g, confirms the results of the wear of the width and height of the ring.

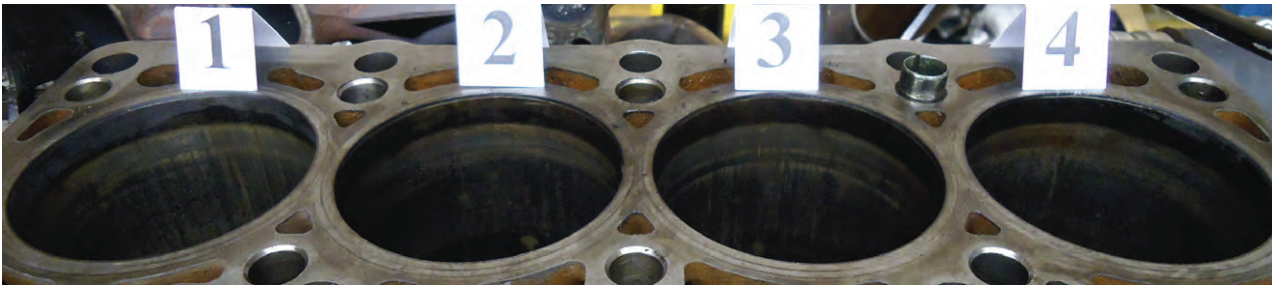
Cylinder liners have a little wear except the sleeve 2 and 4. Honing features are not visible. On all surface of the cylinder above the TDC I of the sealing ring and on the surface of the combustion chamber of the cylinder head were found deposits. Deposits have a thickness of about 0.1 mm.

In all cylinders between the TDC of the third ring, and the BDC of the first ring was found the occurrence of longitudinal features on both sides of the sleeve (Fig. 6) [4, 5].

Fig.6. View of the engine block after test, removing the pistons and removing deposits

- The cause of a number of longitudinal cracks in cylinders 1 and 3 is to use an internal undercut the top of the first ring described in the section above.

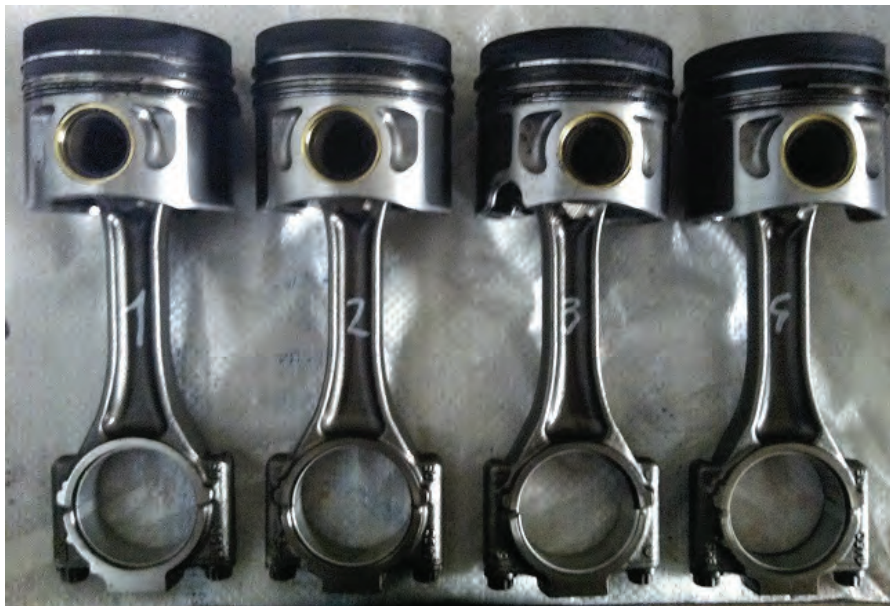
Pistons organoleptic tests showed no significant wear. Cooperation with the piston rings, cylinder liners as well was fine. It was found only a tiny imperceptible features on the piston surface in the section parallel to the axis of piston pin (Fig. 7).

Fig.7. The view of the piston groups after the tests
