Ewa PIĄTKOWSKA\*

## A COMPARISON OF WEAR PROPERTIES OF WATER LUBRICATED NBR AND PTFE SLIDING BEARINGS

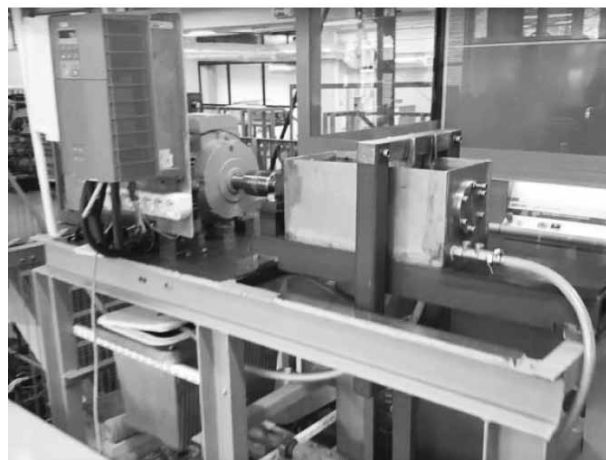
Fig. 2. Test stand

alignment of the shaft with the seal (7), which prevents water from escaping from the tank. Below are photos of the test stand (Fig. 2 and Fig. 3).
