Adaptation of Reinforced-Concrete, Postindustrial Buildings in Terms of Thermal Retrofitting on the Example of a Historical Water Tower

Keywords: historical construction, reinforced concrete, diagnostics, thermal retrofitting, adaptive reuse

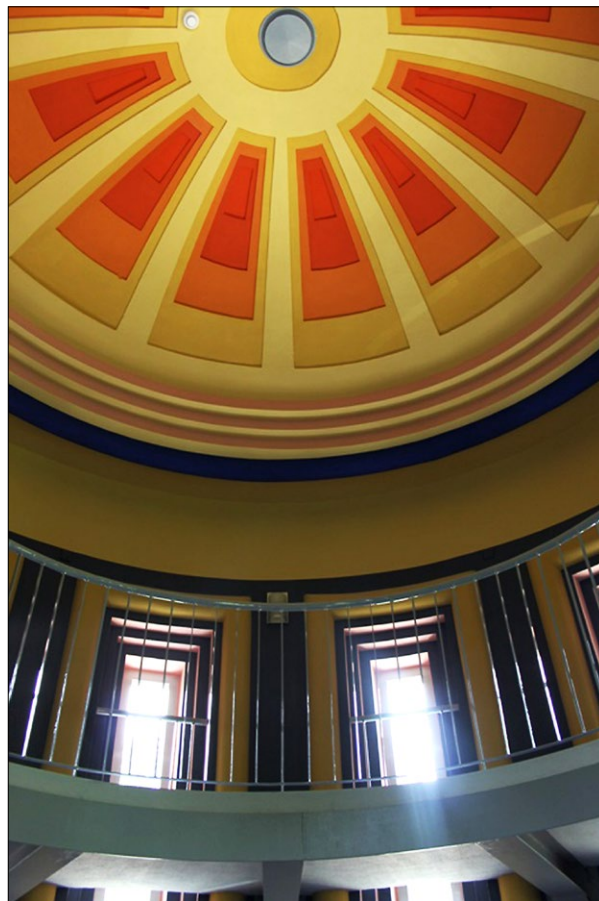
Fig. 6. The former "Hall of the Fallen" with its original architectural detail and color scheme restored, 2012; photo by I. Solisz

Essentially, interference with the structure of the building during the refurbishment works was limited to the demolition of the secondary built-in water tank and the connection of the lower floors inside the main body of the tower cylinder by making two openings in the ceilings for stairs and the introduction of two mezzanine floors. The demolition of the reinforced concrete water tank (with a diameter of approximately 7.3 m and a height of approximately 8.3 m) allowed the introduction of an additional story. The first floor's level was lowered by 0.5 m. In the former "Hall of the Fallen," equipped with the richest visual decoration, the original color scheme and architectural details were restored on the basis of stratigraphic surveys (Fig. 6).
