The impact of the modified ships' routes in the Kattegat on the safety of navigation at the entrance to the Baltic Sea

Agnieszka Kerbrat¹✉, Sambor Guze²

Gdynia Maritime University, Faculty of Navigation
3 Jana Pawła II Ave., 81-345 Gdynia, Poland
e-mail: ¹a.kerbrat@wn.umg.edu.pl; ²s.guze@wn.umg.edu.pl
✉ corresponding author

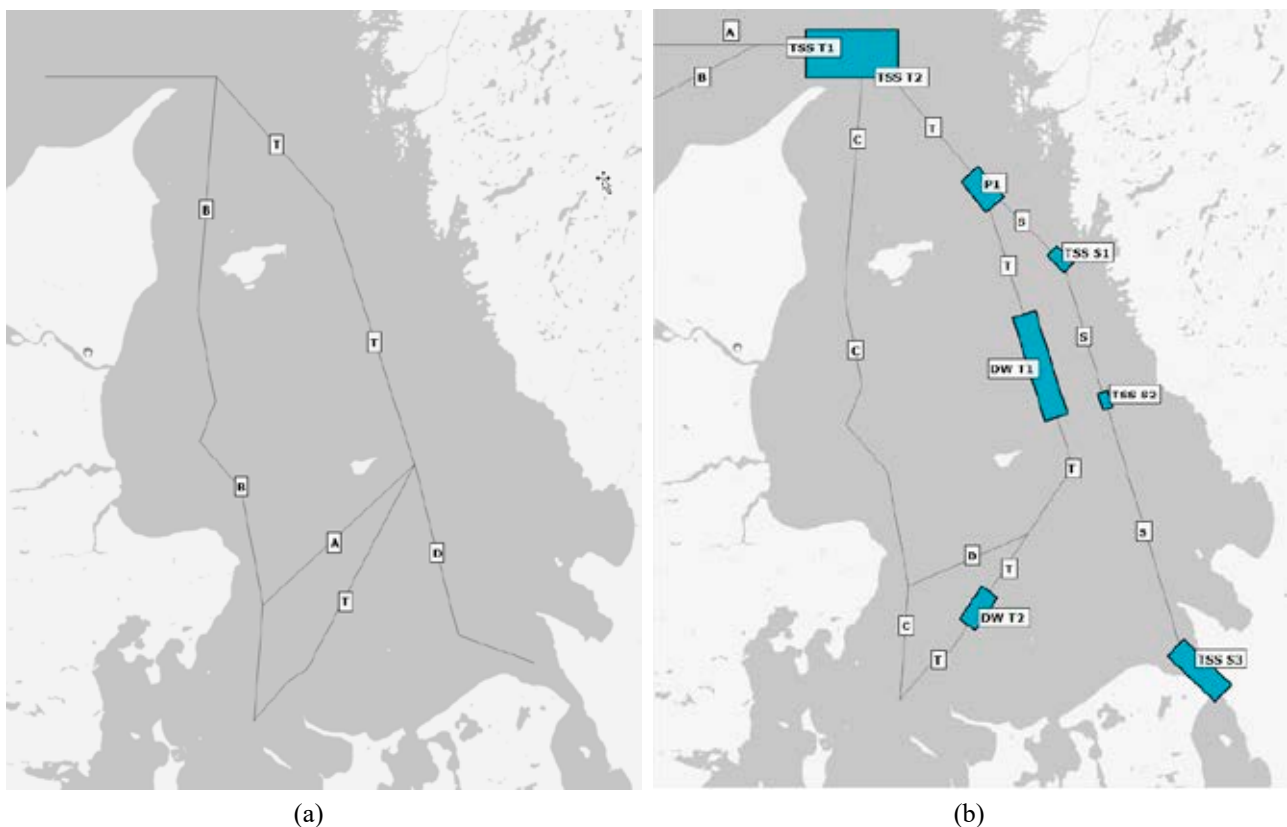
Figure 1. General overview of (a) old and (b) new traffic arrangements in the area of Kattegat (NCSR, 2017)

On the 1st of July 2020, planned routing changes in the area of Kattegat came into force. Planned changes started in Skagerrak, where two approach routes to Skagen were implemented: Route A, with a minimum depth of 23 meters outside of Danish territorial waters, and Route B, located 6 nm from the coast and with depths of at least 14 meters. They join before the Skagen peninsula and direct all traffic easterly towards the traffic separation system (TSS). Two TSSs and the precautionary area between them off Skagen were established (TSS T1 & TSS T2 in Figure 1b). Then Route T leads traffic south-easterly towards the precautionary area at Kummel Bank (P 1 in Figure 1b) near Læsø Island. After the Kummel Bank, the waterways then part. Route T continues closer to islands Læsø and Anholt, and Route S is starting to lead traffic closer to Swedish shores. Route T is advised for vessels of draught 10 meters or more, and Route S for all those with less than 10 meters of draught. Along Route T, two deepwater routes were established (DW T1 and DW T2 in Figure 1b). One is located between islands Læsø and Anholt (DW T1), and the second one is at the entrance to the Great Belt (DW T2), both with

a charted depth of 19 meters. Northbound traffic not restricted by ships' draught is recommended to use the area east of the deepwater routes, and southbound is recommended to use the area west of deepwater routes. Route S is leading traffic in and out of The Sound. Three TSSs were established along it: TSS Fladen (TSS S1), TSS Lilla Middelgrund (TSS S2), and TSS The Sound (TSS S3). Previously existing Route A, between Grenaa and Anholt, is adjusted to the south, and its name has been changed to Route D. Previous Route D from Anholt to The Sound is canceled and replaced by a recommended direction for traffic, which is intended for the few ships to and from The Sound with a draught more than 10 meters. Route B from Figure 1 has been renamed Route C.

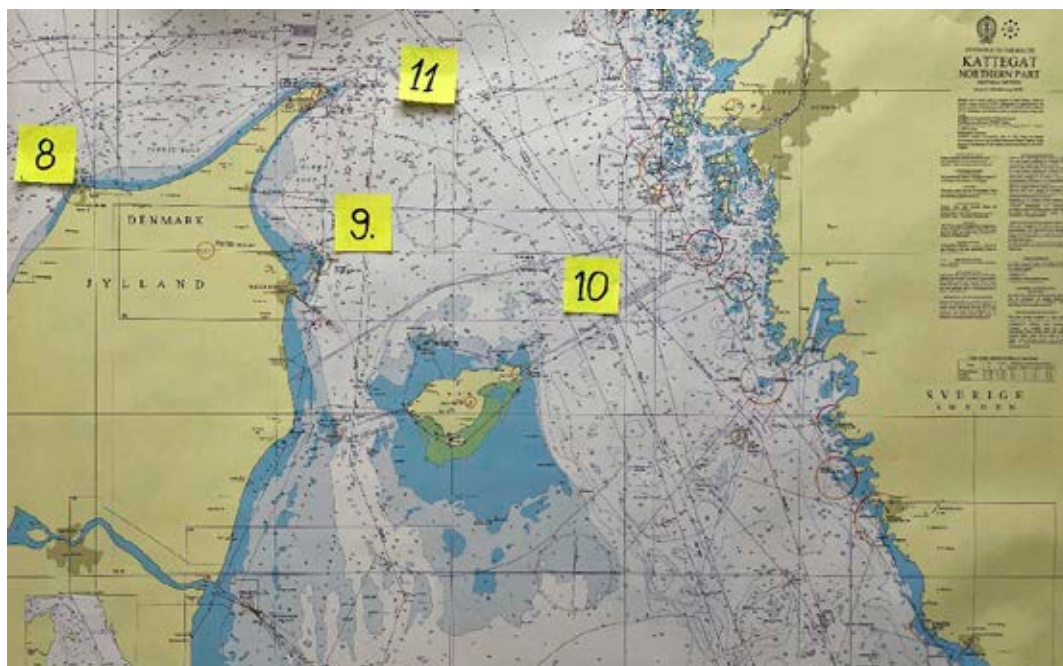
Figure 2 presents accidents reported in the northern part of Kattegat and its approach. The numbers on the navigational chart refer to reports listed in the bibliography. Number 8 is a collision between the fishing boat ORION and the vehicle carrier NECKAR HIGHWAY that occurred on July 1, 2015. As a result, the fishing boat foundered. The crew of the vehicle carrier was not aware of the collision until the next day and, therefore, did not render assistance to the fishing boat crew. The fishing boat sunk within 20 minutes after the collision, and the skipper was lifted from the water by a helicopter.

Figure 2. Collisions reported in the north part of Kattegat and Skagerrak for the years 2011–2022 (DMAIB, 2011a, 2014a, 2015, 2021))

Number 9 was a collision between the fishing vessel BUSTER and the general cargo ship STAVFJORD on May 16, 2021. In this collision, the vessels were damaged, but none of them sunk, and no persons were injured. Number 10 is a collision between the fishing boat INGER MARIE and the general cargo vessel RIG that occurred on July 10, 2014. As a result, the INGER MARIE sank, and her skipper perished. His body was recovered from the water by a coast guard helicopter; he had no safety equipment on him. It is essential to mention that RIG was in a similar collision situation with a fishing

Number 11 is an accident that occurred on June 26, 2011. Two vessels collided with each other, namely, the fishing boat LILLY, which was returning to the port of Skagen from fishing grounds, and the general cargo vessel FRANK W, on its way to Halmstad, Sweden. The vessels noticed each other's presence at a very short distance, and the actions taken to avoid collision were insufficient. As a result, the fishing boat sank within 30 minutes after the collision. Two fishermen from LILLY were lifted to safety by a pilot boat that came to their assistance.

As stated above, all of the collisions that are mentioned involve fishing vessels. According to the information given in "Sailing Directions, vol 18" (NP 18, 2020), the northern part of Kattegat and Skagerrak is a commonly used fishing ground, with many fishing boats passing between these grounds and ports on the west coast of Kattegat. This traffic must cross Routes T and C, and most of the accidents occur at the crossing places.

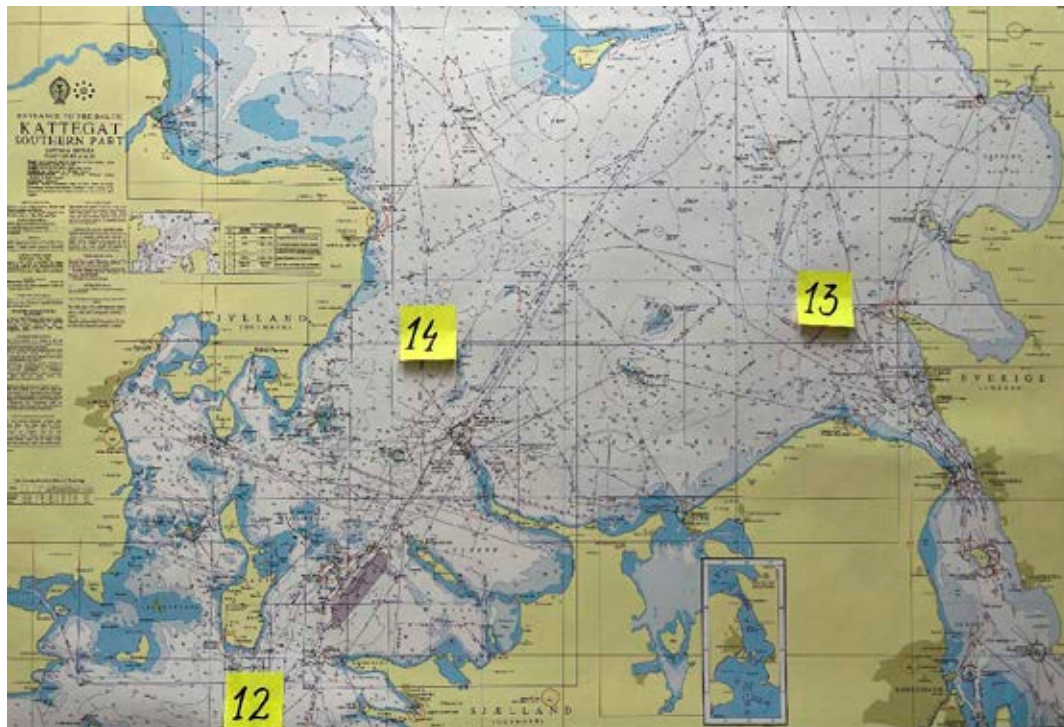
Figure 3. Navigational accidents reported in the south part of Kattegat for the years 2011–2022 (DMAIB, 2011b, 2017, 2022)

There are three accident locations presented in Figure 3, all of which occurred between 2011 and 2022 on established routes or in their direct vicinity.

The accident marked by number 12 is the grounding of the container vessel VICTORIA on February 10, 2017. The vessel was about to turn into the Lillegrund deepwater channel when the grounding

Number 13 in Figure 3 indicates the approximate position of the foundering of the Norwegian coaster BJUGNFJORD on January 20, 2022. The ship developed a heavy list and foundered. The accident is still under investigation, and its exact cause remains unknown. Five crew members were rescued. Number 14 is the collision between the general cargo ship VINGA and the trawler N.A. HANSEN on January 18, 2011. The ships were on almost head-on courses and did not observe each other before the collision, so no action to avoid the collision was taken. As a result, the trawler foundered within minutes after the collision, and two fishermen on board perished.

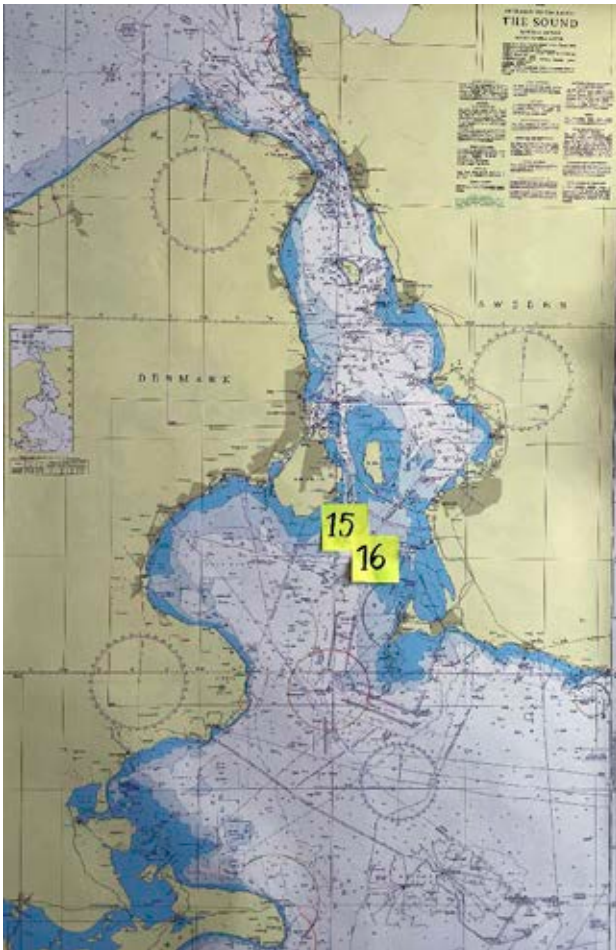
Figure 4. Navigational accidents reported in the Sound for the years 2011–2022 (DMAIB 2014b, 2020)

Figure 4 shows two accident locations that occurred in channels marked by buoys, with restricted visibility due to dense fog. The accident marked by number 15 was a collision between the refrigerated cargo vessel *ATLANTIC LADY*, which was going under ballast towards fishing grounds in Norway, and the chemical/product tanker *KRASLAVA*, which was going under ballast to St. Petersburg in Russia on November 1, 2014. A pilot from the Copenhagen port was still onboard *KRASLAVA* when the accident occurred. The vessel was exiting the Drogden channel where the pilot was to disembark. Both vessels suffered substantial damage, but none of the crew members were injured, and no environmental harm was reported. Details of the accident can be found in the report prepared by DMAIB (DMAIB, 2014).

The second accident marked by number 16 is a collision between the refrigerated cargo vessel *ICE ROSE* and the Russian Navy ship *KAZANETS 311* on September 23, 2020. The navy vessel was exiting the buoyed channel Flintrannan heading towards the Baltic Sea, while *ICE ROSE* was approaching the
