## MORPHOMETRIC PARAMETERS OF THE WATER BODIES OF BAGRY WIELKIE AND BAGRY MAŁE IN THE BIODIVERSITY CONTEXT

The article presents the results of nature-based and geodetic query of two neighbouring endorheic borrow pits, i.e., Bagry Wielkie and Staw Płaszowski (Bagry Małe), situated almost in the centre of the Krakow city. The movements of water tables in 2016–2023 were observed (from the moment of ecological disaster in the Staw Płaszowski, in February 2016) and bathymetric maps were presented.

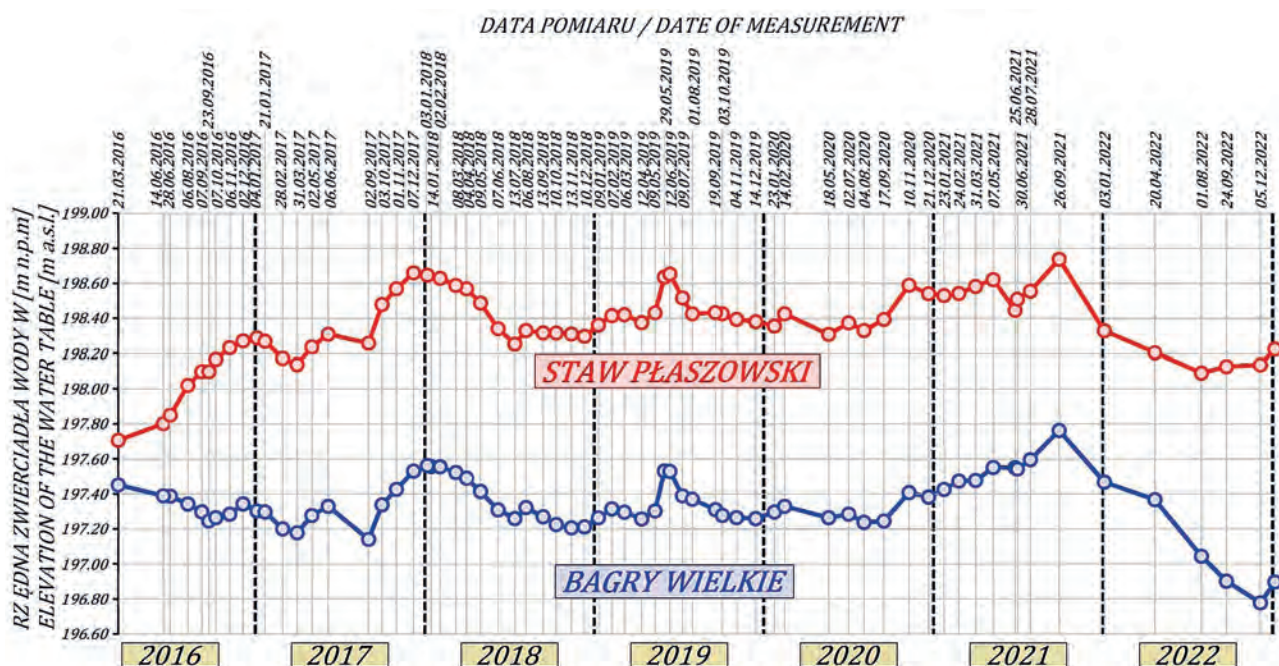
Fig. 2. Water table – chart of changes in the Bagry and Staw Płaszowski – March 2016 – January 2023

Ryc. 2. Wykresy zmian zwierciadeł wód Zalewu Bagry i Stawu Płaszowskiego w okresie 03.2016 – 01.2023

1. levelling measurements – water tables (Fig. 2);
2. GNSS measurements (RTK and RTN mode with the application of receiver R8s + controller TSC3 Trimble'a) shoreline, adjacent areas and positioning of a supersonic sonar during bathymetric measurements;
3. bathymetric measurements (acoustic sonars: Lawrence Elit-4 [15, 16] and Eagle Ultra II) made from a boat equipped with GNSS for precise positioning of the sonar.

back to good state (relatively constant). In October 2021 distinct reduction of the water level in both water bodies was observed (Fig. 2), which continued to be low until December 2022 (in case of Bagry Wielkie) and August 2022 (in case of Staw Płaszowski). It is suspected that the diminishing of the water table level was caused by intensive development in the neighbourhood of Bagry and the cable-stayed viaduct (streets: Żołnierska and Gromadzka) and their negative impact on the water resources of both water bodies (digging and drainage of deep excavations for the basements of the constructions). Sudden and/or distinct change of water tables, especially in case of drainless water bodies of stabi-

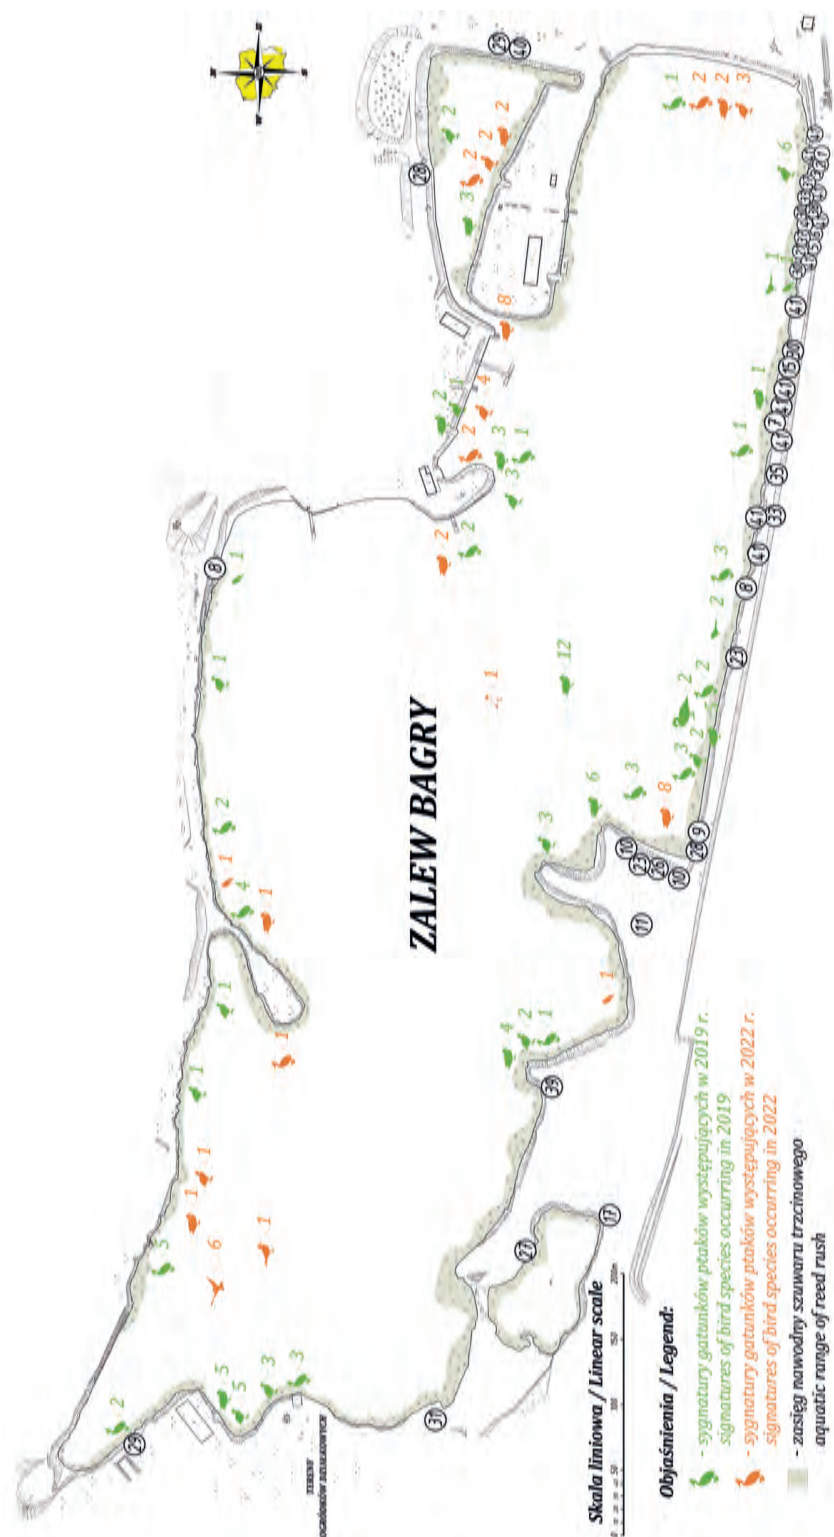
**Fig. 9.** Location of the inventoried elements of flora and fauna around Bagry Wielkie

①, ②, ③, ... – marking the location of flora elements according to table 2
