Anthropogenic factors as determinants of deformation and damage of a bridge structure founded on clayed ground – a case study

Keywords: bridge structure, safety, geotechnical investigation, execution, errors

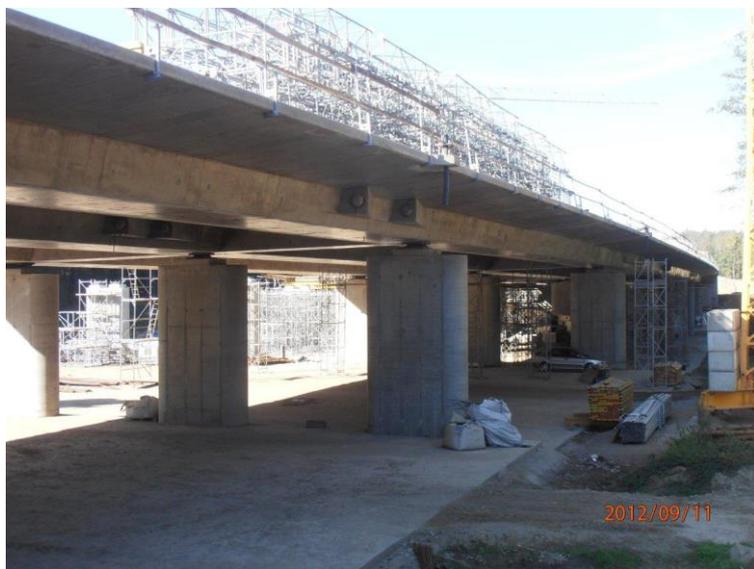
The object of analysis is a monolithic, six-span bridge structure with a beam-and-slab cross-section (Fig. 1). The cross-section for the left-hand carriageway (direction of traffic X-Y) is designed as a three-beam one, while the right-hand carriageway (direction of traffic Y-X) is designed as a two-beam cross-section, all made of prestressed concrete

Figure 1. *General view from below of the superstructure of the left-hand carriageway and of the pillars*

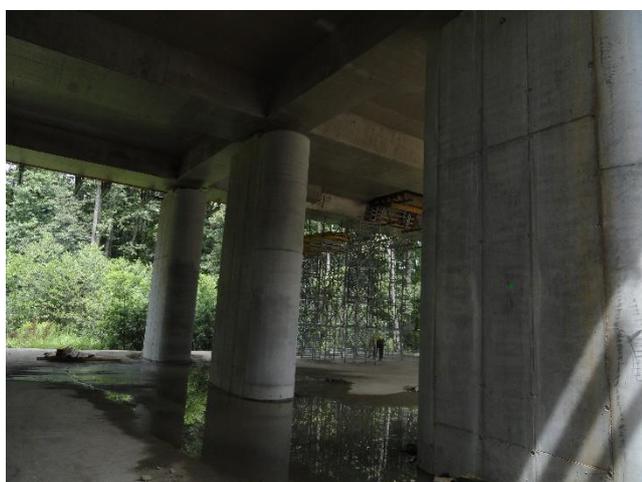
The abutments are designed and realized as solid walls with wings in the form of standing sidewalls on the embankment side, founded directly on footings. The sidewalls on one side are dilatated from the body of the abutment, while on the other side they are designed as side walls monolithically connected to the abutment. The intermediate supports are designed as pillars with 3 (left-hand carriageway) and 2 columns (right-hand carriageway) respectively, each of the oval cross-section, founded shallow in a layer of silty clay (Fig. 2).

Figure 2. *General view of the oval support columns of the left-hand carriageway of the bridge structure*

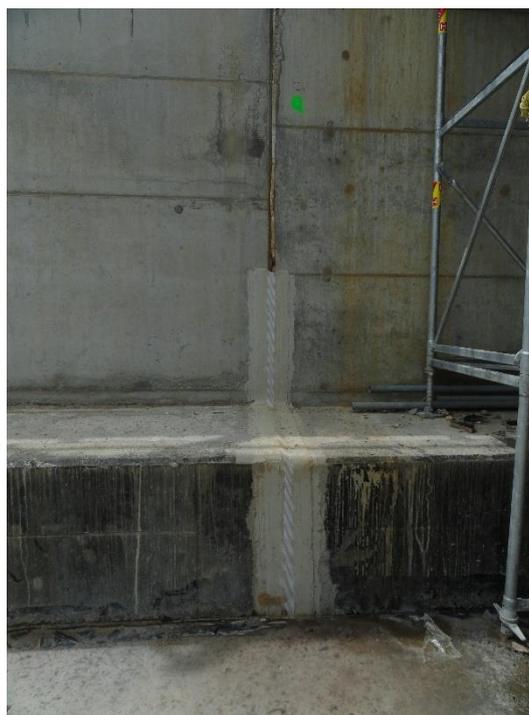
On the basis of the inventory carried out, it was found that there was a displacement at the junction of the wall of the left and right carriageway support bodies as shown in Figure 3.

Figure 3. *Oblique deformation of the tape crossing the expansion joint (dilatation) of abutment P1*

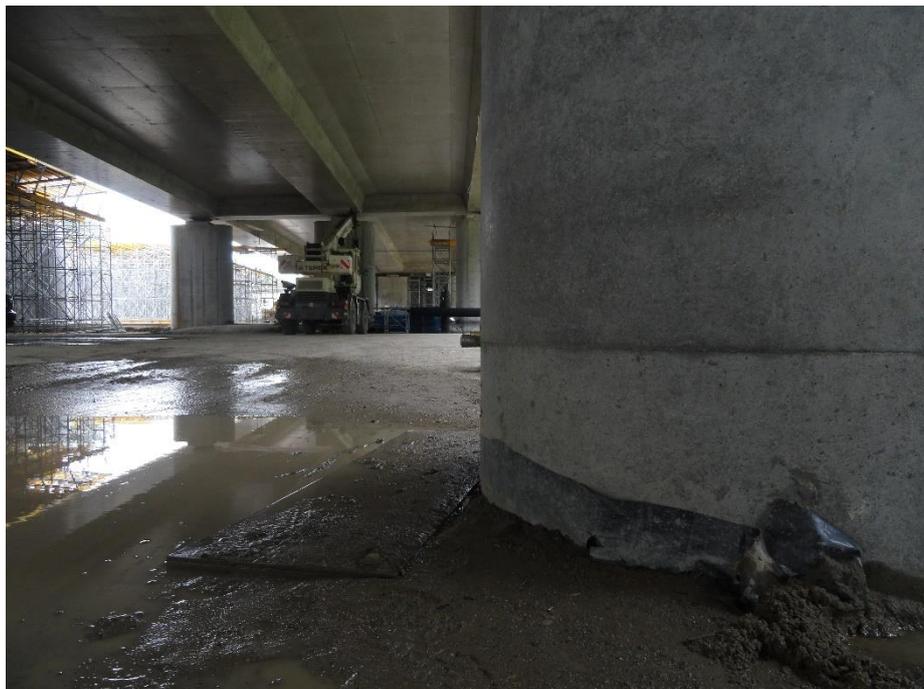
Moreover, a displacement (outwards - approx. 40 to 50 mm at the top of the wing wall) of the wall of the standing wing, founded on a separate foundation, from the side wall of the body of the P7 abutment was observed, which proves that the settlement is uneven with respect to the part of the outermost supports for both roadways and wings. The concrete working platform on both sides of the P4 abutment was also observed to crack, at a distance of approx. 4.0 m each, and there was also visible collapse of the platform in the line of the abutment columns, which resulted in the formation of a small local sinkhole, filled with rainwater coming, among other things, from the platform's drainage facilities not connected properly to the collector (Fig. 4). On the side of the platform, significant cavities (caverns) in the ground underneath were also detected, which may be indicative of soil washing out during heavy rainfall and may also be indicative of high groundwater run-off underneath the platform (Fig. 5).

Figure 4. *Deformation and local depression of the working platform at support P4*

Thus, there must have been a deterioration of the geotechnical parameters of the subsoil at a later time, i.e. during the execution of the works. Another reason for the construction of pillars P3 and P4 was the installation of a steel sheet piling, which was necessary due to the high groundwater table and the depth of the foundation excavations for these pillars. During the pulling in or pushing out of the sheet piling ground destruction may have occurred, not only around the foundations, but also underneath them.

As these soils are very sensitive to water (due to the overlapping of silty sands and dust), even slight wetting (soaking) could have caused significant changes in the condition of the soil and thus, a drastic deterioration in its geotechnical parameters (including compressibility and deformation moduli). In addition, after the foundation trenches were backfilled with sandy soil (to a level allowing to build the platforms), there was a permanent state of watering of these soils with a groundwater column of D_{MIN} height which could also have caused a state of soaking of the near-surface clay layer. There could have been other reasons for the deterioration of the soil at the foundation level - and the consequent increased settlement of the supports, but the abovementioned ones should be considered highly probable and the most important.

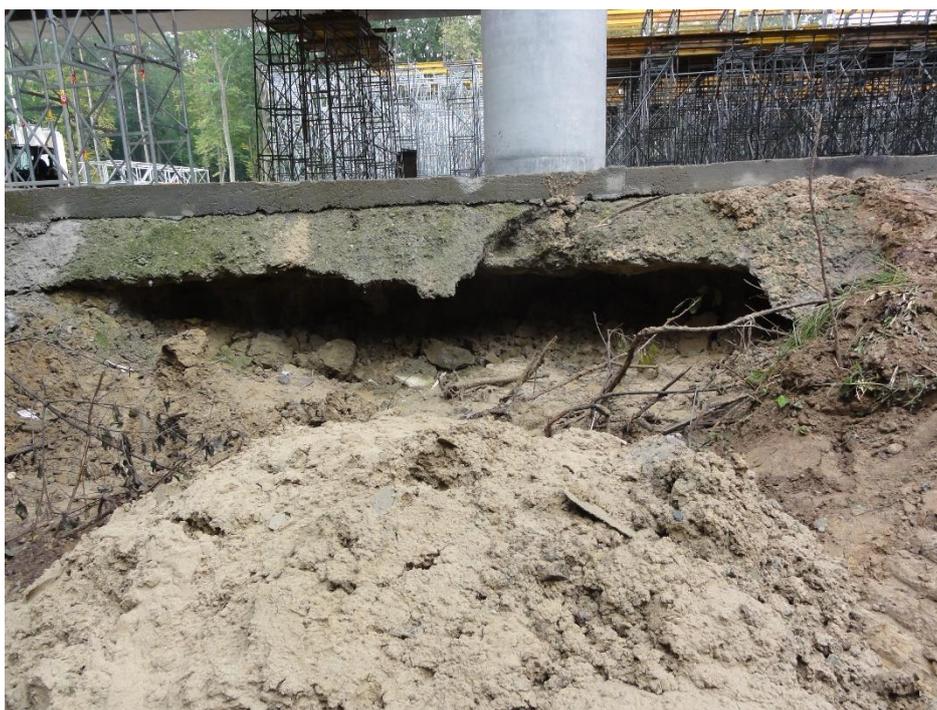
Figure 5. *Caverns under the working platform at support P4*
