CASE STUDY OF AN OLD FARMHOUSE IN OLSZEWO: *PRO MEMORIA*

Magdalena Bogdziewicz*, Natalia Buczyńska*, Jarosław Szewczyk**

Keywords: vernacular architecture; farmhouses; local building materials; the Podlasie region; N-E Poland

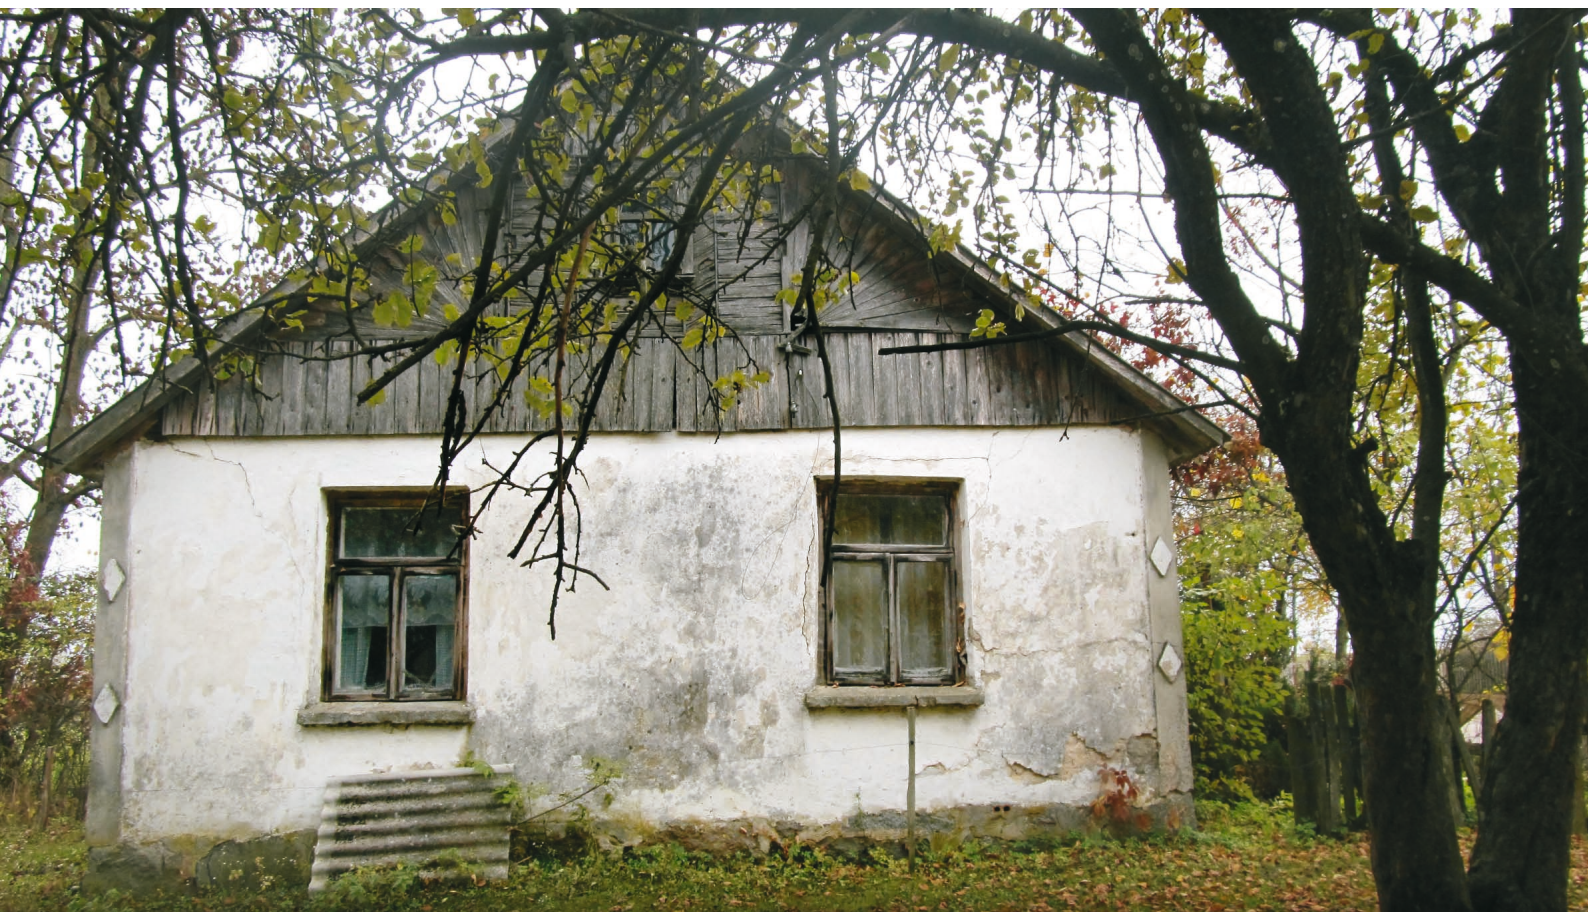
Fig. 2. An old cordwood masonry house in Olszewo; source: the authors, 2021

The exterior ornamentation of the house is modest. The corners are decorated with simple rhombic rustication (Fig. 2). The layer of plaster covering the clay wall is thick, a few centimetres in thickness, but even

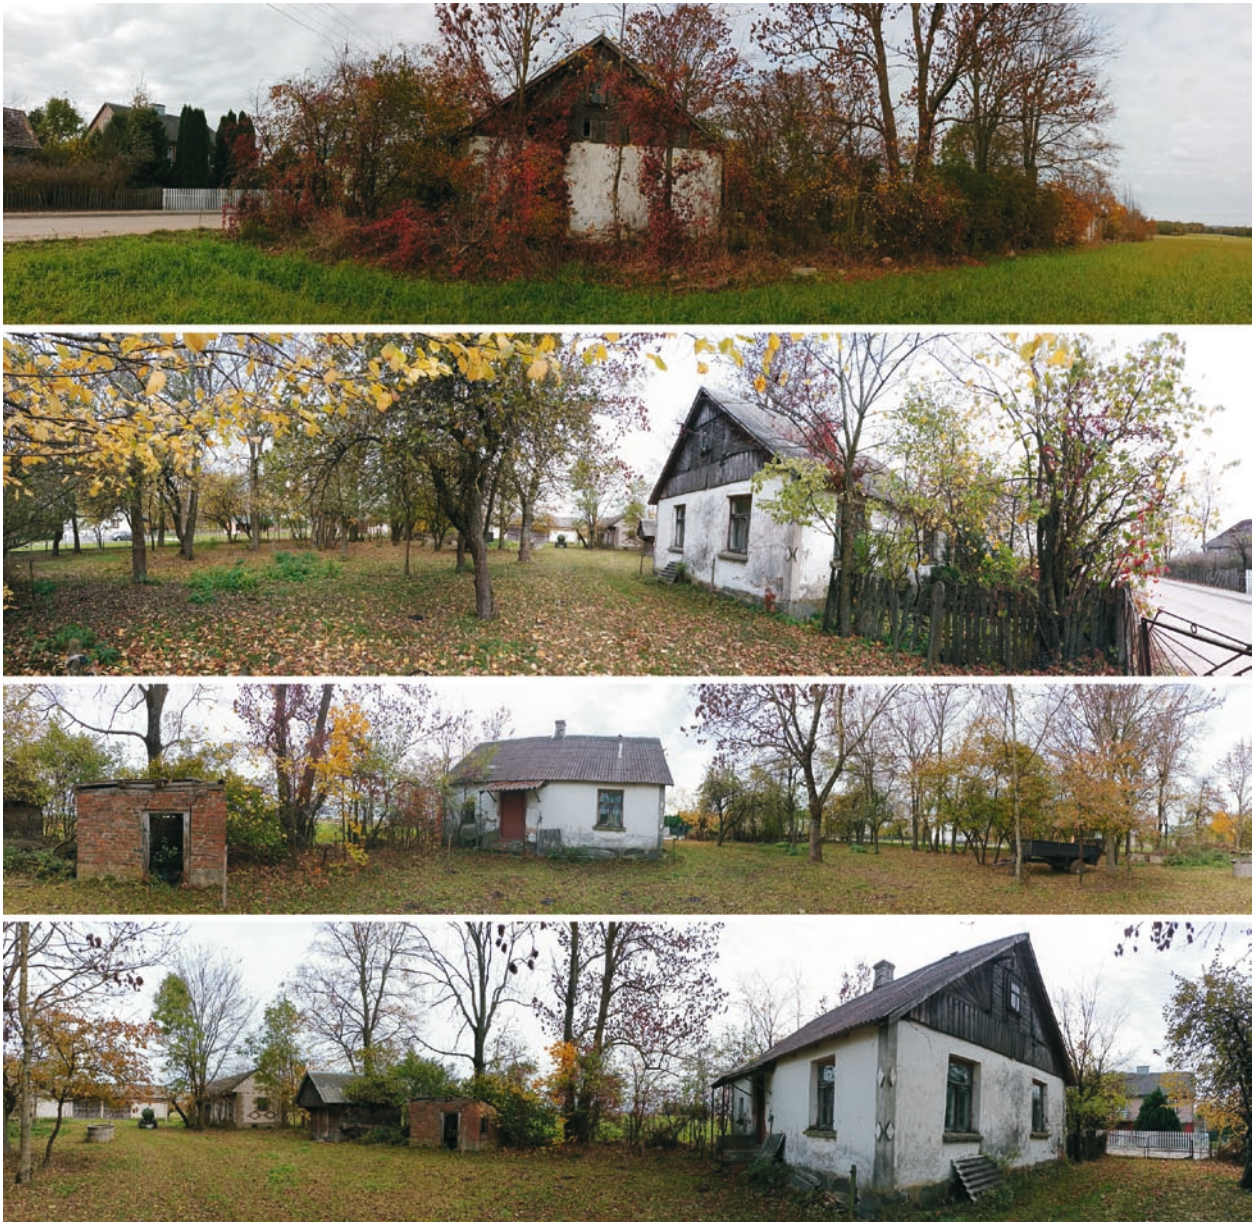
Fig. 3/a-d. The cordwood house in Olszewo, against its farmstead plot (panoramic views); source: the authors, 2021

It was rebuilt on the foundations of an earlier burnt wooden cottage, but using substitute building materials, including finely chopped cordwood logs, brushwood and clay (the choice of building materials was mainly due to their easy availability). However, no reliable information could be obtained as to the year of its reconstruction. It may have been erected only a few years after the village fire, which would be indicated by the careful and thoughtful construction of the house and the external ornamentation used on it. Nevertheless, some of the German wartime equipment (most likely cannons) that remained after the battle was used to build the fence gate. It is therefore possible that the house was also rebuilt quite quickly, probably as early as 1940. Nowadays, it survives together with several other buildings on a rather large plot of land (Fig. 3), but it is no longer used or heated.

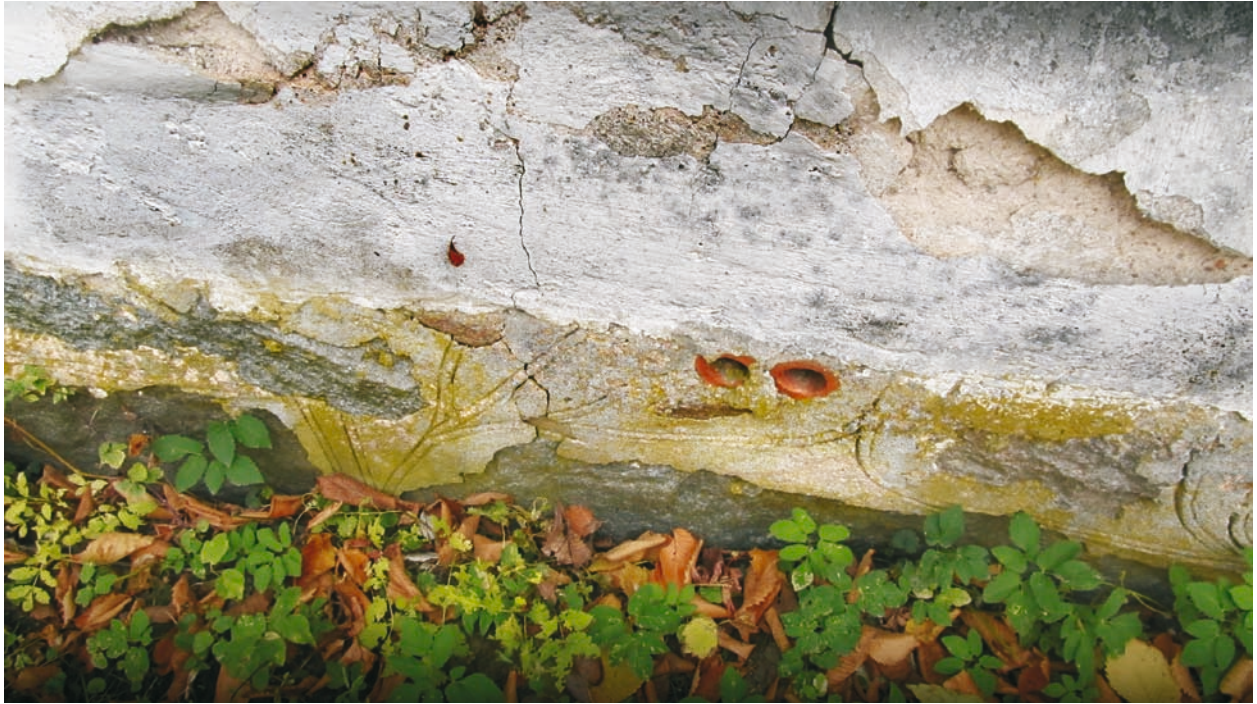
Fig. 4. A stone foundation of the house in Olszewo, its ornamented plaster and two ceramic tubes for wooden floor ventilation; source: the authors, 2021

The building rests on a solid foundation of large and carefully coursed stones (Fig. 4). It is likely that an existing foundation from a previous burnt building was used during construction, perhaps reinforcing it. The stone foundation wall, elevated 40 cm above ground level and pierced every metre and a half with drainage pipes acting as sub-floor ventilation, was covered with a thin layer of cement plaster with an imprinted relief ornament in the shape of plant tendrils (such foundation ornamentation had previously been found in small-town and urban construction in the Białystok region).

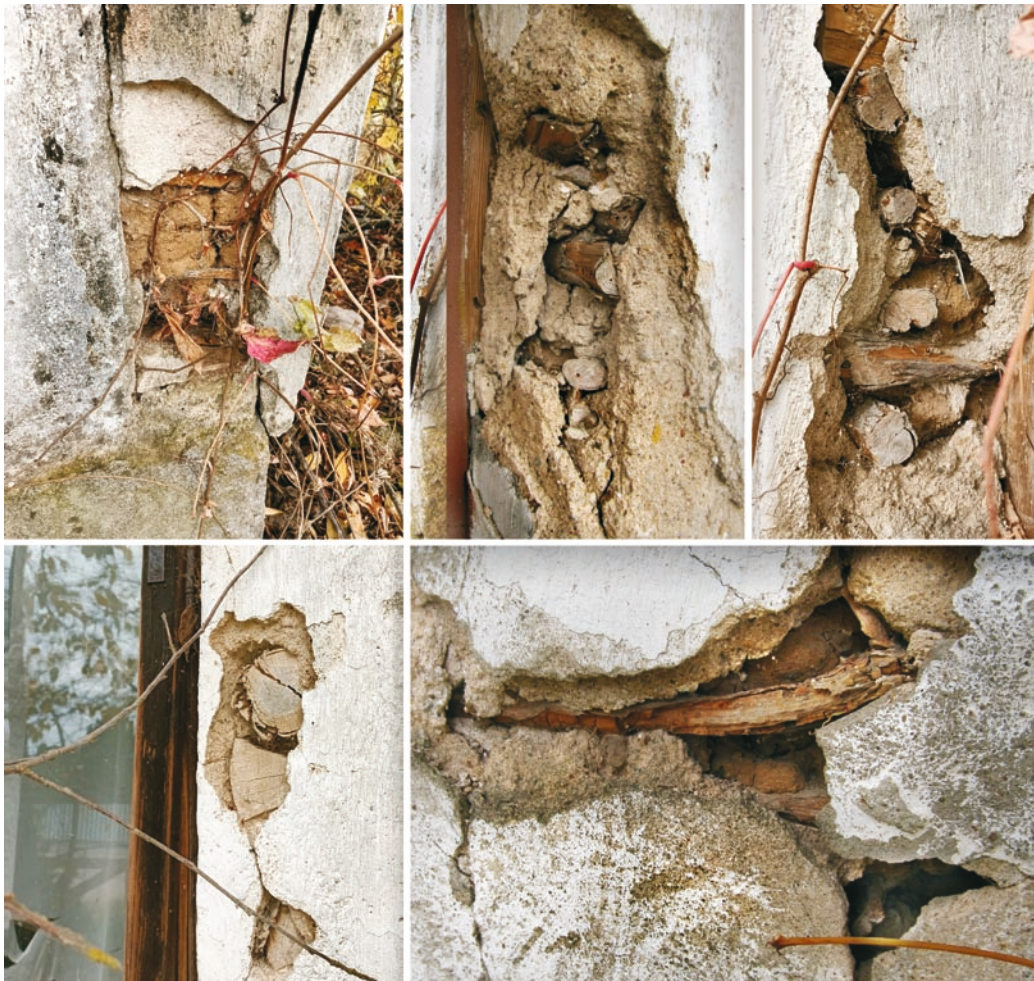
Fig. 5/a-e. Walls of the house in Olszewo: exposed clay core and stovewood pieces, embedded in thick lime mortar; source: the authors, 2021

coarser unbarked juniper brushwood and waste wood were used as 'reinforcement' for the clay wall (Fig. 5). Cut boards, perhaps remnants of wood salvaged from previously burnt buildings, were used to reinforce the corners. These have survived in fairly good condition.

The wall was plastered on both sides with a thick layer of cement-lime plaster. Unlike other buildings with cordwood walls erected in the surrounding villages, the object under investigation was probably plastered with one very thick layer of plaster (other buildings were plastered with two or three thinner layers, with only the outer layer containing cement, and the inner layers were lime mortar). This thick layer of plaster has not deteriorated to this day, because good adhesion to the timber-clay wall was achieved by the fact that the clay with the logs was applied without compacting, producing a very uneven wall with protruding log ends and brushwood into which the plaster mortar was later pressed.

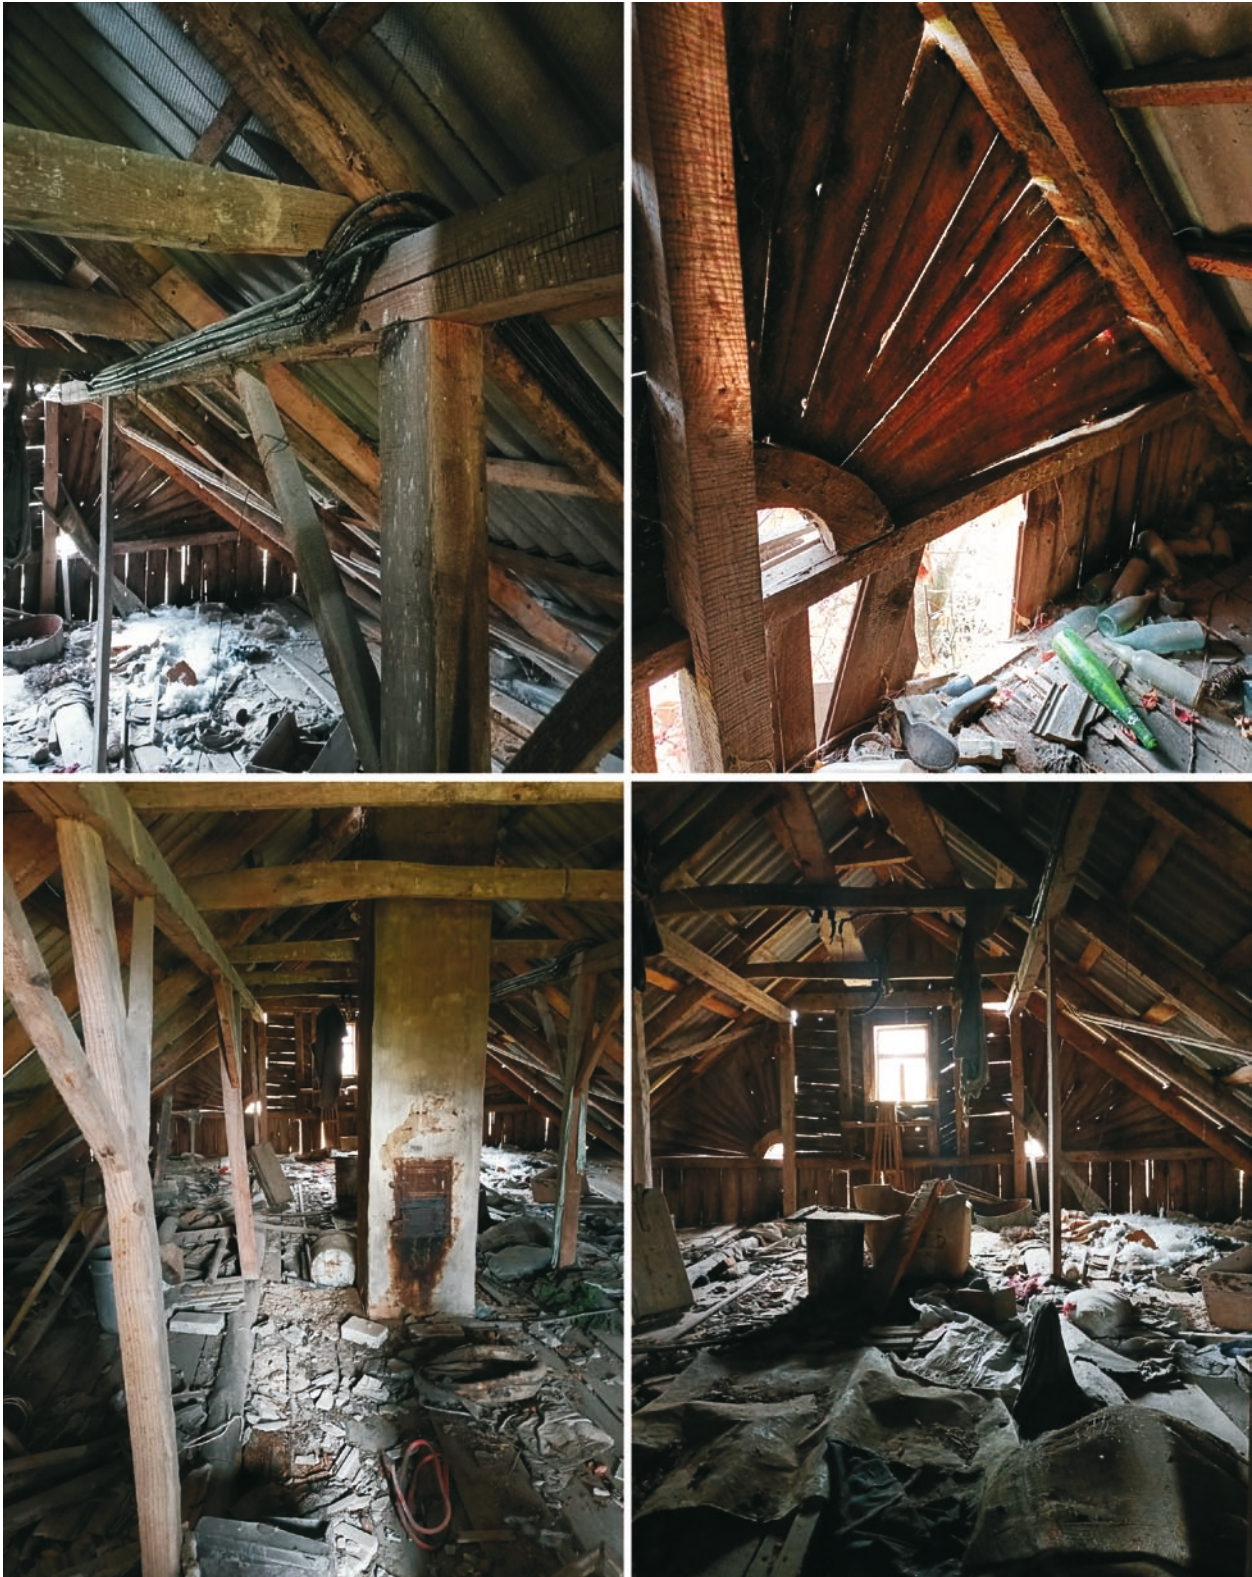
Fig. 6/a-d. A garret and roof construction; source: the authors, 2021

The roof truss was made as a collar-purlin construction, with each of the purlins resting on two outer-

most queen posts and two central posts with braces (Fig. 6). This construction is noteworthy insofar as it was usually used in small-town and urban construc-

tion, whereas the roofs of country cottages and houses almost always had the simplest rafter-collar construction. It is therefore puzzling to see the use of purlins and

queen posts here to support the rafters of a relatively small house on the edge of a small village, rebuilt after war damage. It is possible that these are later additions, made during the last replacement of the roofing with asbestos panels (the 1980s).

The boarding of the pediment triangles is also decoratively and carefully shaped. The extremities of the timber framing, to which the decorative radial boarding elements are nailed on the pediments, have an arched (curvilinear) shape, requiring greater care in workmanship, which is all the more noteworthy. As the building is situated with its ridge facing (parallel to the street), both gables were made with equal care and concern for aesthetics (Fig. 6/b).

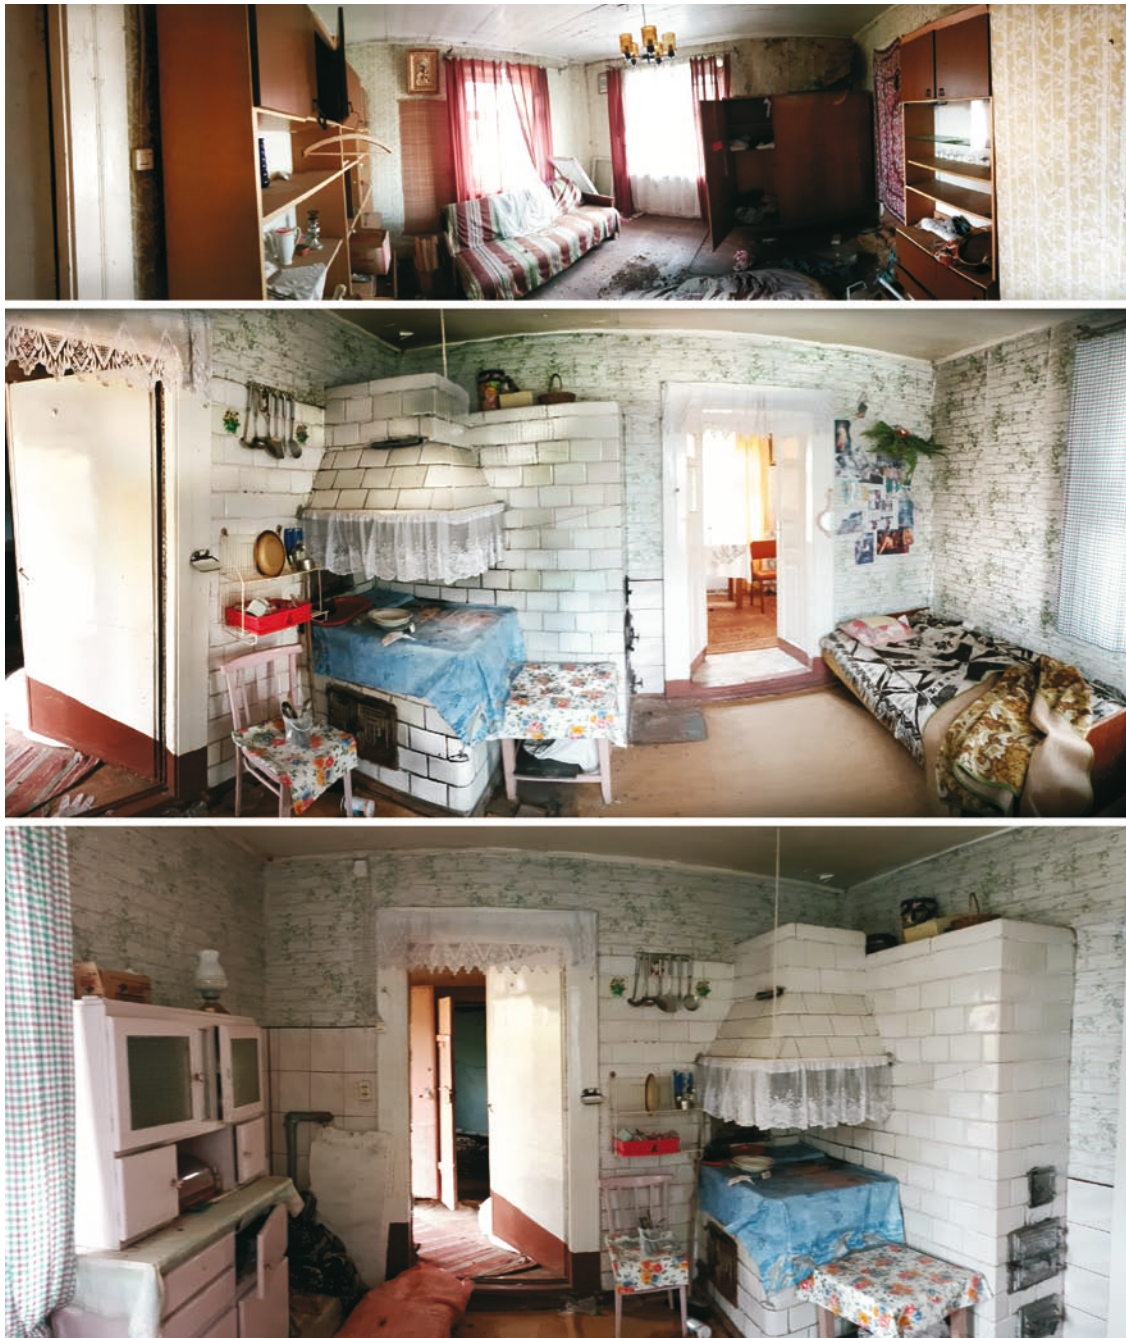
Fig. 7/a-c. Panoramic views of the living room (a) and the kitchen (b, c); source: the authors, 2021

The internal aesthetics of the house are the result of a build-up of successive fashions and aesthetics from the time the house was built (woodwork, stoves, some furniture) until it ceased to be used, i.e. until 2008, but with a predominance of elements (furnishings, decoration, wallpaper) from 1970-1990 (Fig. 7). The oldest furniture was discarded in the garret and in the storage room (room 5 on the plan), although a typical sideboard from the 1950s can still be found in the kitchen.

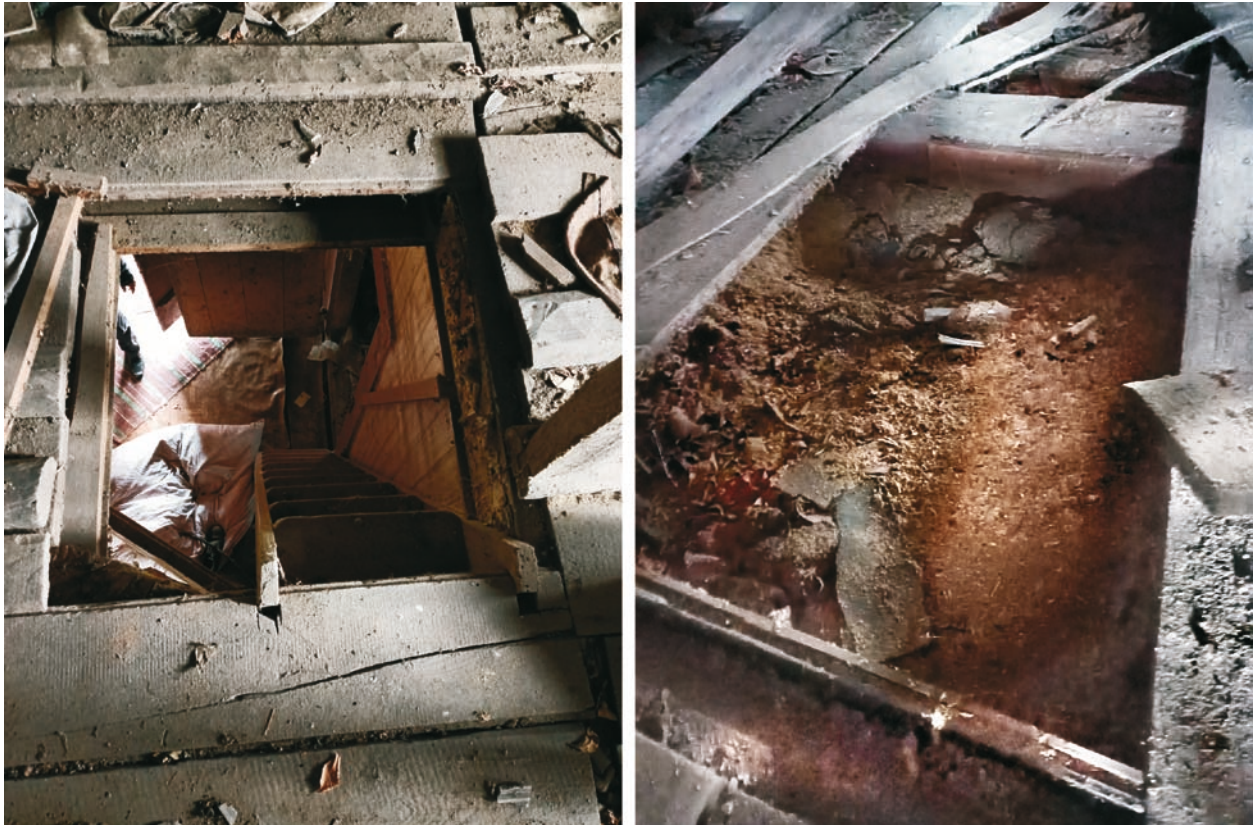
Fig. 11. Garret floor construction (a – ladder descending to the entrance hall; b – earthen insulation); source: the authors, 2021

A thick floor earthen insulation made of sawdust and chaff mixed with clay has survived (Fig. 11/b). In the past, this method of insulating the ceiling was common, but it has been mentioned here in order to highlight the wide range of clay used in this building: in addition to the above-mentioned sawdust-clay earthen insulation and clay chimney walls, clay mortar was used to build the stove and the chimney, and originally also instead of a wooden floor there was a clay earthen floor – if not in the whole house, then at least in the storeroom and the hall.

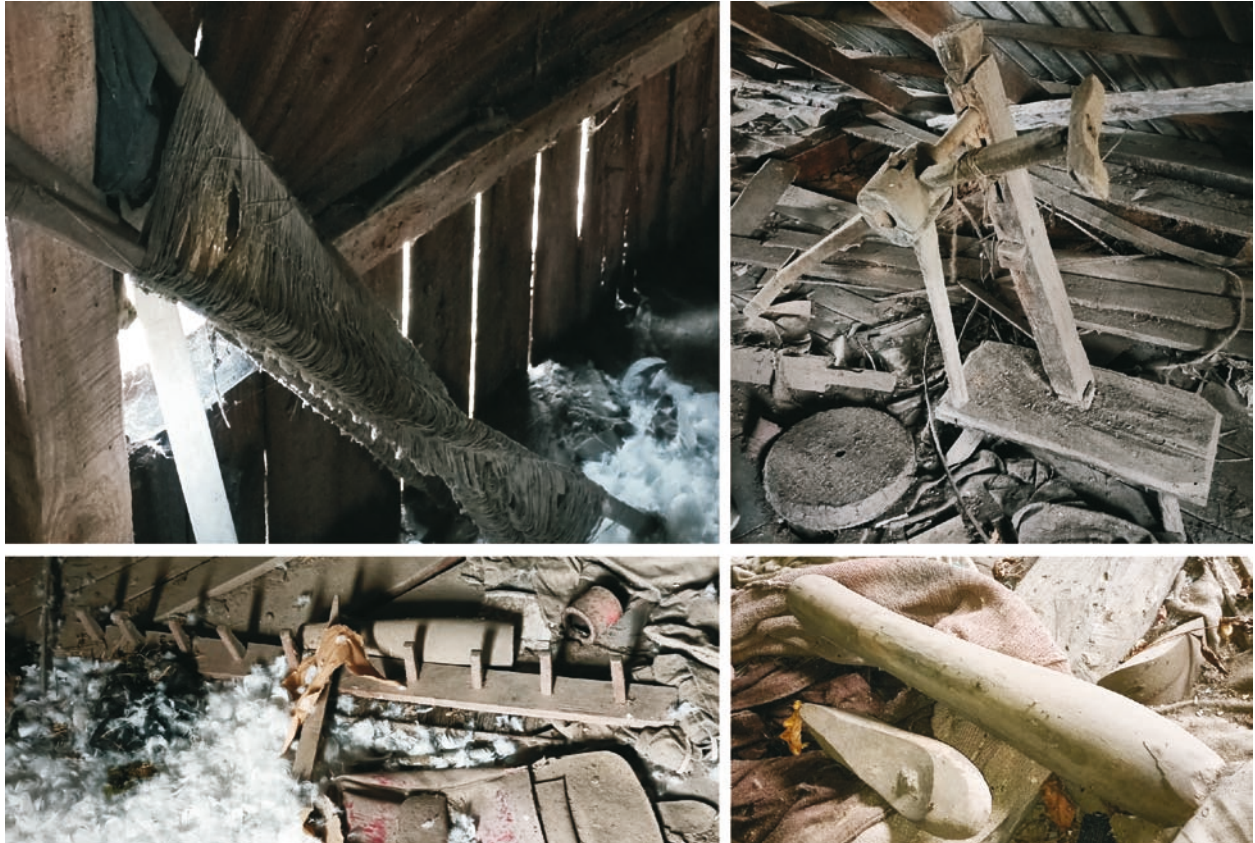
Fig. 12. Old artifacts of vernacular craft, left in the garret space; source: the authors, 2021

2018). Fig. 12 shows selected relics of the past found in the garret: a weaving warp, a spinning niddy niddy, an old-type (handmade) rake and wooden moulds for making felt shoes (*valonki*). In addition to the objects shown in these four photographs, the garret also still houses an old trunk with linen and books (in any case, not the only one), wooden and metal buckets, parts of weaving reels, old leather school bags and numerous contemporary utensils, crockery, tools and appliances. In the garret, the chimney has been fitted with an inspection and smoking door (visible in Fig. 6/c), allowing both easy cleaning of the chimney and facilitating the hanging of meats in it. Interestingly, this is not a regular single door, but a set of double hearth and ash doors, already heavily rusted, probably removed from the hearth during some tiled stove repair. In this way recycled material was used for free.

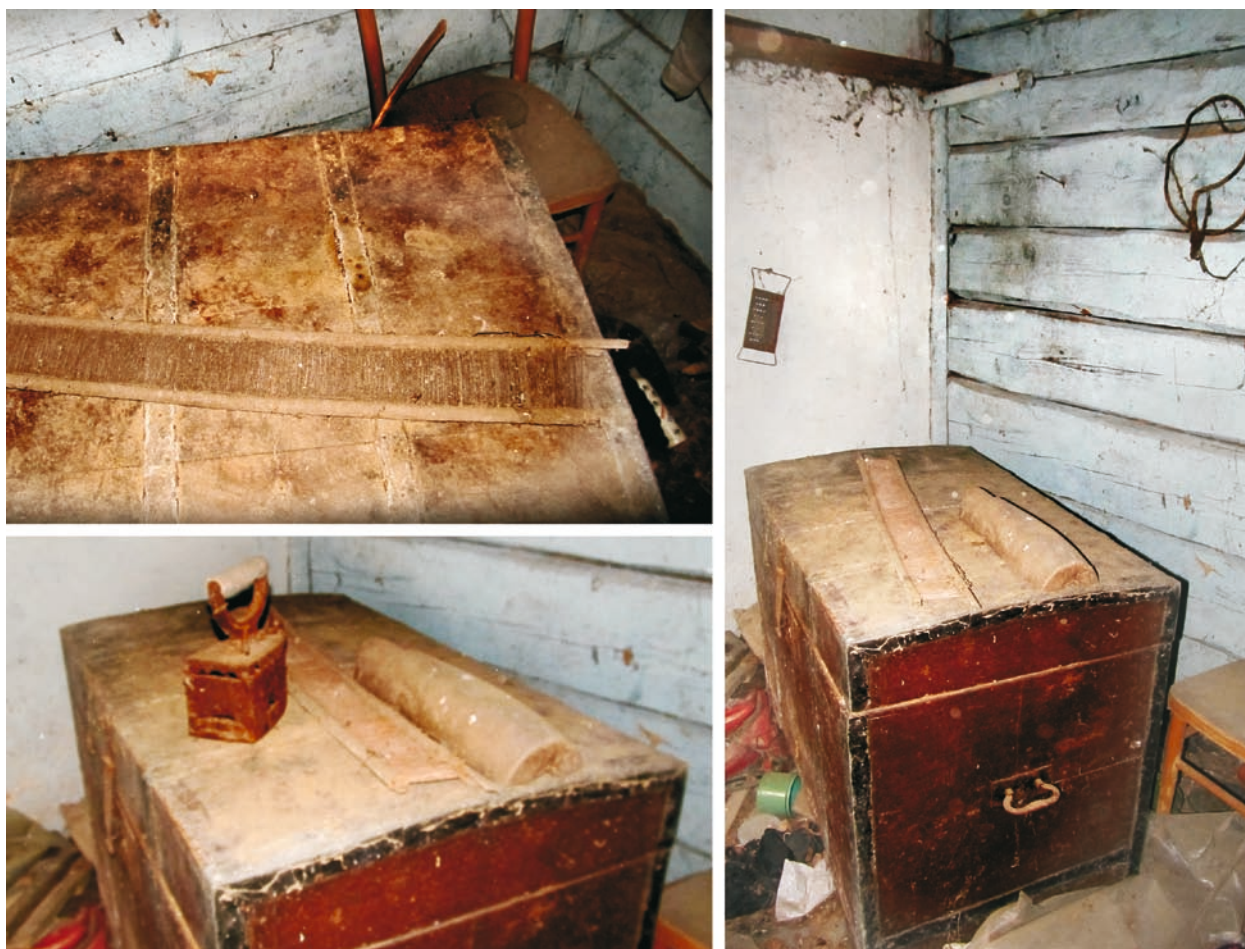
Fig. 13. A storage room with an old trunk and some old utensils; source: the authors, 2021

The storeroom, in turn, was secondarily separated from the hall by a wooden wall (not a clay wall; Fig. 13) and was also used for storage purposes, in which to this day – in fact, until the survey in December 2021 – are preserved, among other things, a trunk, a wooden mould for making *valonki*, a weaving warp hook and old-type shears for shearing sheep, and an old charcoal iron.
