# PRODUCTION ENGINEERING ARCHIVES

## Irregular operation of autonomous vehicles

Accident reconstruction,  
 Autonomous vehicle,  
 self-drive  
 crash  
 Vehicle Movement Simulation

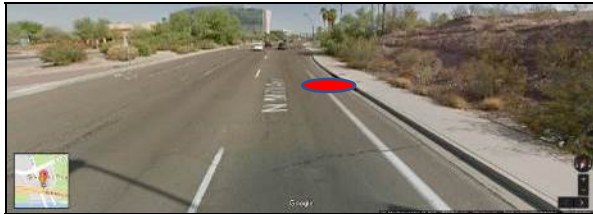
Fig. 2. The collision location (Google Earth)

Figure 2 shows the street view, where the location of the collision was specified.

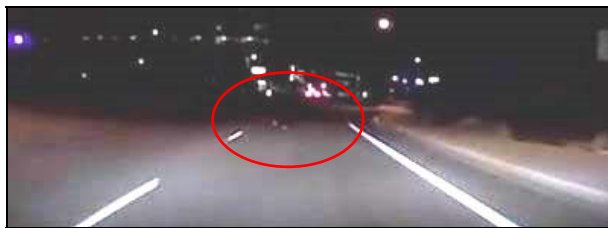
Fig. 3. The moment of pedestrian perception (Youtube, Abc Action News)

Figure 3 is a screenshot from the video when the pedestrian becomes visible to a driver.

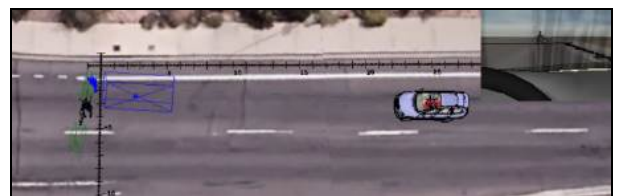
Fig. 6. The mutual position of the participant's T – 1,25 sec

Fig. 6 depicts a simulated moment corresponding to Fig. 5. The vehicle is then approx. 20 to 25 meters from the collision site. From this distance the vehicle with an emergency brake manoeuvre cannot be stopped before the pedestrian's travel path.

Based on this, it can be stated that the pedestrian became visible to the human driver within the braking distance. The collision was inevitable with normal operation.

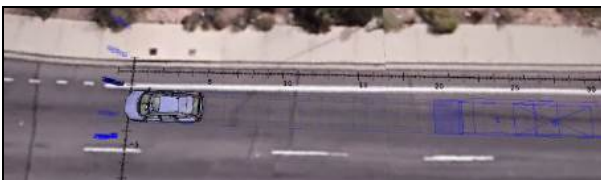
Fig. 8. The accident process in the case of adequate autonomous function

It can be calculated in case of 1,3 seconds before the occurrence, if, as a reaction point, the time when the pedestrian is seen on the video for the first time is chosen, or the self-drive system determined an emergency braking manoeuvre, and 0.1-0.3 seconds of self-drive system "reaction time" and the slowdown of emergency braking is taken into consideration, then Figure 8 depicts the simulated moment. In the case

under investigation, the pedestrian goes out of the path of the vehicle (time avoidance), but if the pedestrian had not even left the lane, then the speed of collision would have been one third of the real speed (about 18-25 km/h).

Based on the investigation of the avoidance of the accident, it can be stated that the detection and determining of the self-drive system was correct. According to own calculations, the Volvo could have been stopped before the pedestrian's travel path, 2.5 to 6 seconds prior to the accident.

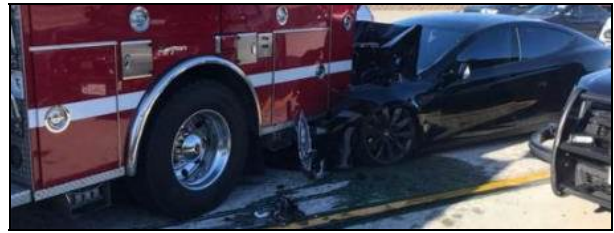
Fig. 9. The end position of the collision

Based on the speed of travel and collision, the Tesla started breaking at approx. 45 to 55 meters before the point of the impact. Figure 9 shows the end position of the collision.

In the case of the second accident, before the collision, the Tesla was travelling at 104 km/h. Based on the damage pictures, the collision speed can be estimated - approx. 40-45 km/h. It follows that the vehicle decelerated before the collision. There is no information available that the self-drive system or the human driver brake the vehicle.

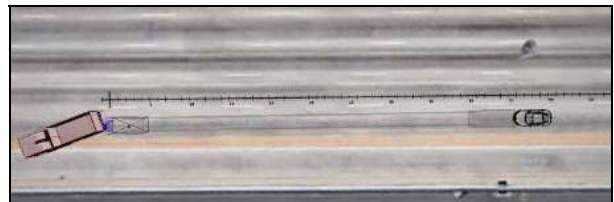
Fig. 10. The beginning of the car's braking  $T = -2,5$  sec

Figure 10 shows the start of braking.

Taking into account the reaction times, if the self-propelled system had started to brake, then the stationary car would have become recognizable 50-60 meters before the collision, if the human driver had recognized the emergency, then the reaction point would have been approx. 73 to 78 meters.

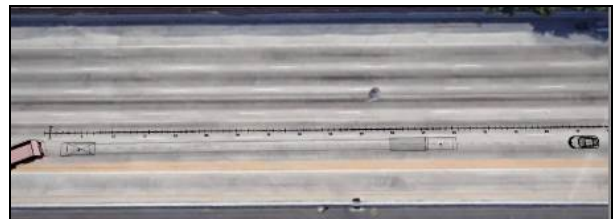
Fig. 11. The case of the safely standstill of the Tesla

In order for the Tesla car to stop safely behind the fire truck the self-drive system should have recognized the danger before the point of impact approx. from 62 to 67 meter, the human driver approx, from 82 to 87 meter. Figure 11. illustrates the breaking process with human reaction time.

It can be stated that the autonomous system detected the obstacle but approx. 15-20 meters, and approx. 1 to 1.5 seconds earlier would have been necessary to detect an emergency.
