## Technical Assessment of River Training Impact on the Raba River Bed Stability on the Selected Longitudinal Section

Marta Łapuszek<sup>1\*</sup>, Andrzej Wolak<sup>1</sup>

<sup>1</sup> Institute of Water Engineering and Water Management, Cracow University of Technology, ul. Warszawska 24, 31-155 Kraków, Poland

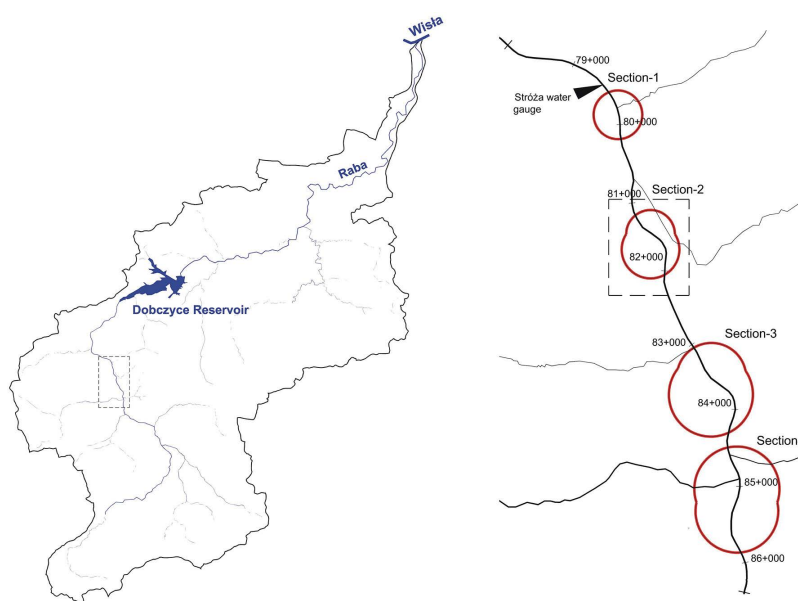
**Figure 1.** Raba river catchment and the study area location

**Section-3** – km: 83.056 – 84.308; **Section-4** – km: 84.491 – 85.872 (Fig. 1).

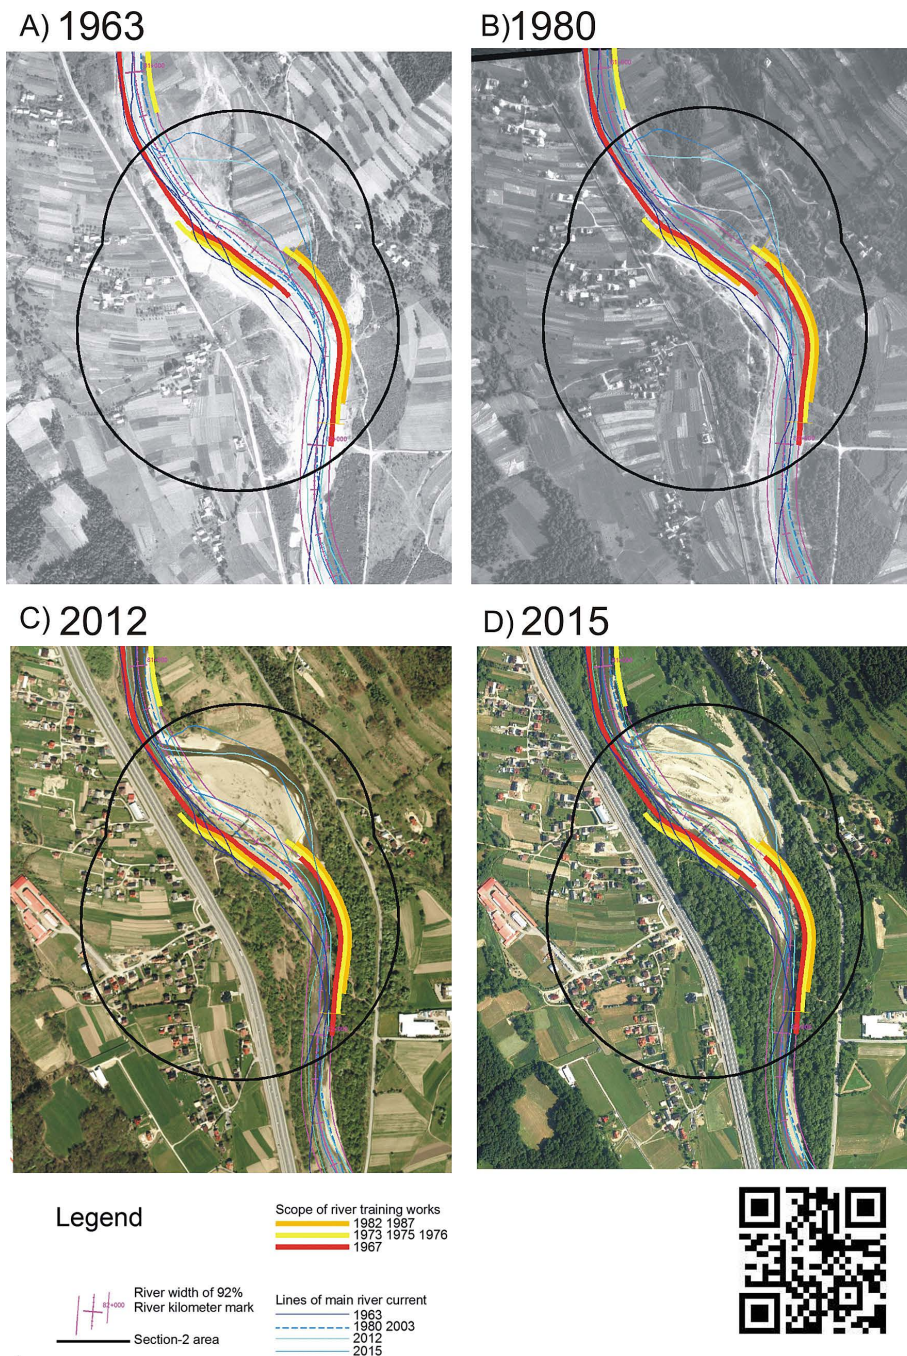
**Figure 2. Section-2** (km: 81.144 – 81.908): Raba river channel evolution in years: a) 1963, b) 1980, c) 2012, d) 2015 observed on the aerial photography with pointed out training works during observed time intervals. Position: 49°45'58.0"N 19°57'56.7"E (49.766112, 19.965758)

Currently, in **Section-2**, after almost 30 years, where the first training works have been done, the active channel with bars and bedforms was 100–140 m wide (Fig.2, 3), the channel has then rebuilt its previous state creating new bedforms. In the years 1987–2012, channel-forming discharge was  $Q_{\text{ch-form.}}=72 \text{ m}^3/\text{s}$  and it lasted with higher for 152 days.

On the basis of the aerial photo taken in 2012, the extreme erosion process of the right bank was noticed. A newly-formed wide river channel appeared there as well. The river was divided into two different courses, with the appearance of a large island (about 4 ha) between the two. Left bank erosion seems to have been effectively stopped. In the years, 2012–2015 channel-forming discharge was  $Q_{\text{ch-form.}}=76 \text{ m}^3/\text{s}$ , and lasted with higher flows for 6 days only. The maximum observed discharge was  $Q_{\text{max}}=361 \text{ m}^3/\text{s}$ . It is well seen in the aerial photo taken in 2012 that the island which has formed between two channels is divided by many small channels of various sizes. The river is restoring its bridged pattern (Fig.2).

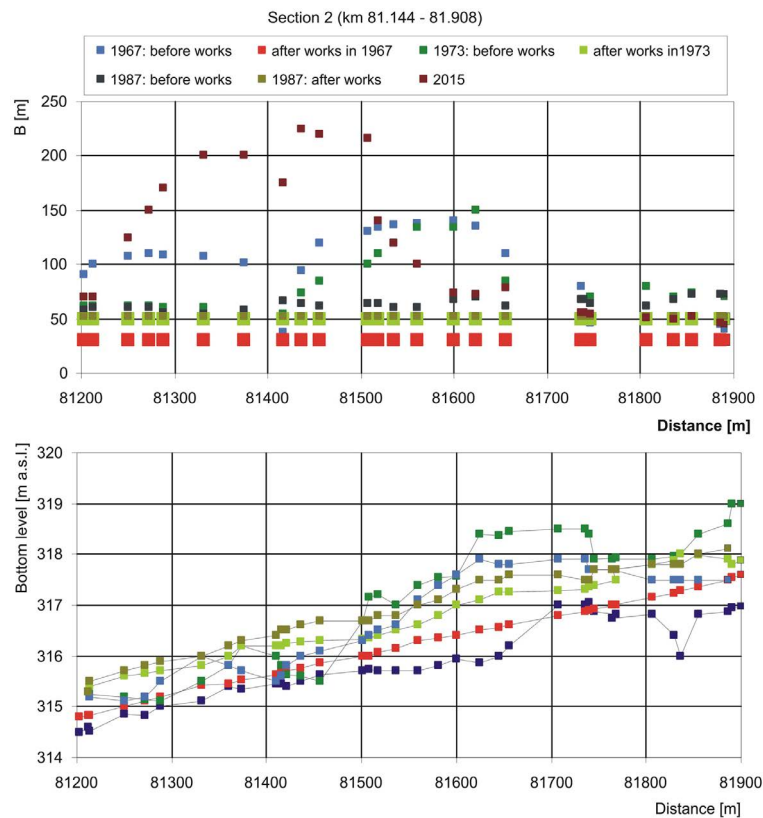
**Figure 3. Section-2 (km: 81.144 – 81.908): the active channel width and bottom level variability in analyzed time intervals (due to the technical projects)**

In **Section-2** trained technical channel in 1967 tends to have the bottom aggradations with the observed sediment layer of thickness between 1.0–1.8 m (Table 3, Fig. 3).

After river training carried out in 1973 (the channel width:  $B=50$  m, slope:  $J=0.004$ ) erosion and accumulation of sediment with intensity ranged from  $-0.6$  m (erosion) to  $+0.4$  m (deposition) was observed till the year 1987 (Table 3, Fig. 3).
