Archeological and architectural research of historic cellars in the western frontage of the Dukla market

Abstract

The article presents selected results and conclusions from archaeological and architectural research carried out within the market square of Dukla. Its purpose was to collect information and define the nature of threshold cellars located there. A part of the work was also to carry out test drillings around the town hall in order to verify the hypothesis about the presence of cellar chambers and underground passages.

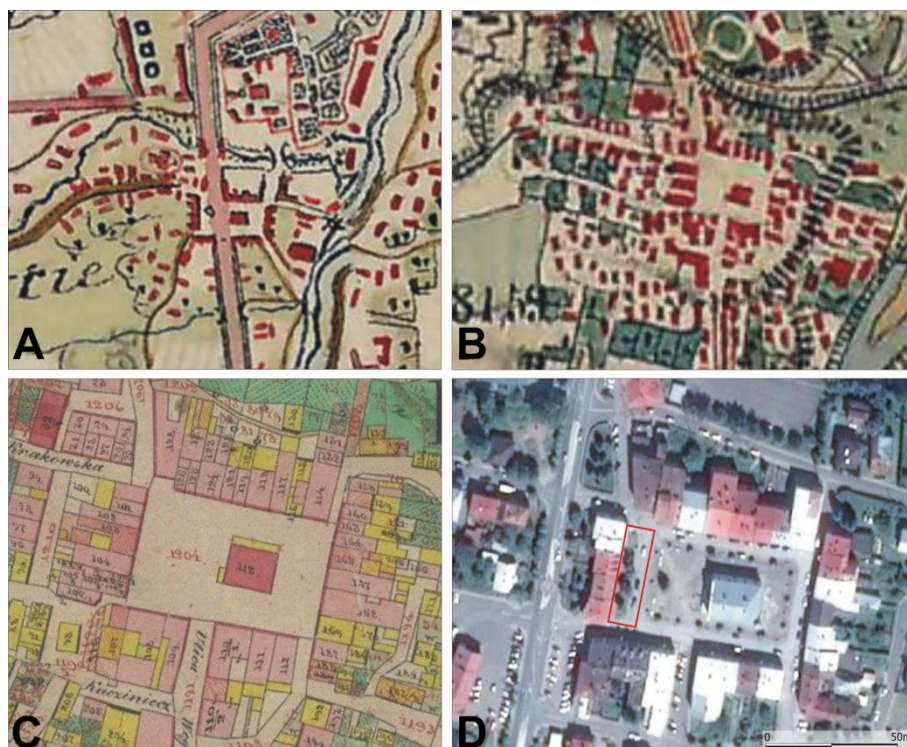
Fig. 2. A) The market square in Dukla on the so-called the “Mieg Map” from 1779-1783 (the scale of the original map 1:2880, source: <http://mapire.eu>); B) on the second military (Franciscan) photo from 1806-1862 (the scale of the original map 1:2880, source: <http://mapire.eu>); C) on a cadastral plan from 1851 (scale of the original map 1:2880, collections of the Historical Museum – Palace in Dukla); D) on a modern satellite map (a red rectangle indicates the location of cellars in the western frontage of the market square as a subject of the research, source: <https://www.google.pl/maps>)

coming from the mid-nineteenth century about the development of the town is provided by the cadastral map of Dukla, clearly showing the structural division of buildings into brick and wooden (in this period still constituting a significant percentage) structures. Within the market square, all frontage buildings were made of brick in the mid-19th century, sometimes provided with wooden annexes. Unfortunately, the map does not provide information about phases of functioning and changes of the market complex.

It was located near the facade of the tenement house No. 20 and had dimensions of 3×2 m. Directly below the layer of sod, at the level 20-30 cm, a concrete coat was revealed, which completely covered the cellar vault with an arch diameter exceeding 4.0 m (Fig. 4: B). According to information obtained from the employees of the Commune Office, it is likely the way that the whole cellar was protected after the collapse of the nearby street. In the place where the trench was extended, the end of the concrete layer was noted and below it the outside part – the cellar top wall. Through a small hole between the stones forming the wall, a fibre-optic camera was introduced inside, which made it possible to determine the state of preservation of the whole structure. It was confirmed that the vault did not collapse and the remaining parts, especially the western and fragmentary middle ones, were filled up. Near the eastern wall of the trench, the exploration went deeper revealing the sequence of layers. At a depth of 50 cm, a layer of burning in the form of burnt clay with a thickness of about 2-3 cm was recorded. Similar evidence of fire were also found deeper (80 cm), but this time in the form of dark grey soil with fine charcoal. With reference to the research on the urban layout of the western frontage of the market square in Dukla, it can be observed that the cellar, discovered in the excavation trench No. 4, can be one of the two cellars of the tenement house No. 105 visible on the cadastral map of Dukla from 1891 (Fig. 2: C).

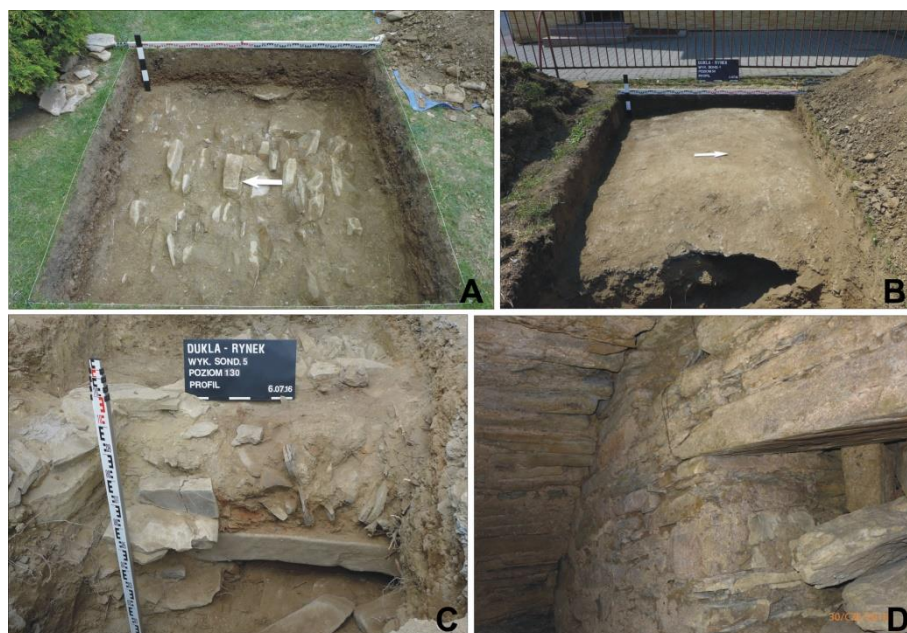
It was set up near the facade of the house No. 21 with dimensions of 2×2 m. Under the layer of sod with a thickness of a few centimetres there was a layer composed of river gravel mixed with a small amount of sand and silt. During the exploration, a fragment of the tap valve made of porcelite and single pottery sherds were noted. At a depth of 35-40 cm there was a layer of light grey clay mixed with a small amount of fine river gravel. At the level of 40 cm, the ridges of the stone slabs forming the cellar vault (Fig. 4: A) were found. They were about 25-30 cm long and were joined together tightly to form a self-clamping arched structure of the vault. In some places they were covered with horizontal stones, which may be a kind of ceiling cover or a backfill made of during the house collapse over the cellar. The state of the cellar preservation is very poor at present – some of stones from the vault were badly weathered and the mortar was washed away.

Fig. 4. Dukla, site 13. A) Cellar vault uncovered at the level of 50 cm in the sondage 1; B) a fragment of the cellar vault protected by a layer of concrete, explored in the sondage 4; C) a fragment of the portal uncovered in the sondage 5; D) the gable wall and the vault in the cellar in front of the building No. 21 and 22

In the spatial layout of the western frontage of housing complex, there are clear differences in the arrangement of cellars. The southern part, currently consisting of three chambers (two are not accessible from the modern cellars, one is accessible via a 1.5 m long corridor from the side of the building No. 21 but unused due to moisture), has the location along the longitudinal axis of the vault perpendicular to the market square (Fig. 2). The northern part, which starts in the approximate centre of the frontage, has a longitudinal arrangement and consists of three cellars, which have walled up transitions between them. These cellars have a width exceeding 4 m and a length of 9 m, with a vault height of 2.40 – 2.70 m. The vaults of the cellars are made of yellow-brown sandstone, which was probably obtained from the quarry located on the Kamień mountain near Jaśliska from the 16th century, in the south-eastern part of the Low Beskids [Krukar 1988]. Cellar chambers could be made by means of the negative method based on cutting out the arched shape of the matrix in the ground where the vault stones were laid. The subsequent removing of the ground material allowed for even settlement and solidification of the vault. Such a method of making the chambers can be evidenced by the lack of binding of the cellar top walls with the vault (Fig. 4: D). All vaults of the discovered cellars were covered partially with gravel and clay in order to load the arches (Fig. 6). However, no traces of floor remains were found. It is worth mentioning e.g. carefully made and still functioning dehydration of cellar chambers, made of broken stones in the form of covered channels in the middle of a flat cellar floor lined with large-sized plates (Fig. 6). The cellar entrances were originally from the side of the market square, which was confirmed in the case of the cellar chamber under the tenement house No. 21 (Fig. 4: C). Based on the collected evidence and premises, it can be argued
