The significance of extreme floods in the transformation of mountain valleys and causing flood risk, on the example of the July 2001 flood that occurred in the upper catchment of the river Skawa

Paweł Franczak*

University of Applied Sciences in Tarnow, Faculty of Mathematical and Natural Sciences, ul. Mickiewicza 8, 33-100 Tarnów, Poland

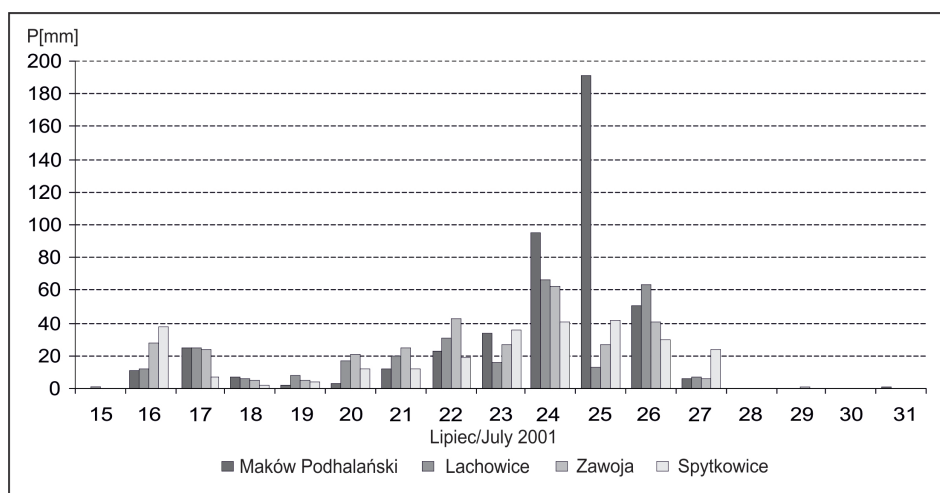
Figure 2. Daily precipitation on 15-31 July 2001 in the study area

On 24 July, in the source part of the Skawa, the rainfall amounted (35–40 mm), whereas in its other parts it reached much higher values, from 61.9 mm in Zawoja to 94.6 mm in Maków Podhalański. On the next day (25 July), the rainfall in most parts of the catchment amounted from 12.4 mm in Lachowice to 41.8 mm in its source fragment. However, its central part has been subject to a catastrophic showering rain reaching up to 190.8 mm in Maków Podhalański [30, 31, 44, 46]. The most extensive rainfall from the atmospheric centre located above Makowska Góra was observed between 3:00 and 6:00 p.m. – circa 150 mm [47]. In the station in Bogdanówka, situated at the edge of the centre (7 km to the east), the 24-hour sum of rainfall was 68.7 mm. The next few days the rainfall continued, reaching 64 mm the very next day, lasting until 28 July (Fig. 2).

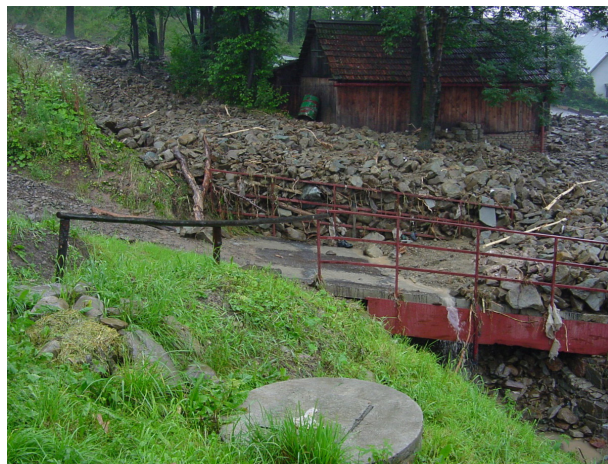
Figure 6. Alluvial fans in the Księży Potok catchment

In the upper Skawa catchment area, the greatest geomorphological transformations occurred in the Paleczka catchment area and on several short right-bank tributaries of the Skawa flowing into it between Maków Podhalański and Sucha Beskidzka. Numerous fresh erosive undercuts and sandbanks up to 50 m² in size were created within these watercourses. The largest transformations took place in the river bed of the regulated Księży Potok flowing in its lower section through the centre of Maków Podhalański. Within the narrow valley bottom, the concrete and stone retaining walls protecting the shore and the communication routes leading alongside it, from which the material was accumulated below, were destroyed. Numerous erosive undercut up to 5 m high was formed, and erosion gutters up to 20 m long and 1 m deep were created within the valley bottom. Waterfall thresholds ranging in height from 0.5 to 1.5 m have formed in the longitudinal profile of the bed on the shoals of Magura sandstones. Meanwhile, in the lower sections of streams flowing down the Makowska Góra in sections with a smaller longitudinal decrease and in the areas of rapid change in the direction of the river bed (transformed by humans), wide alluvial fans with an area of up to 5100 m² were formed (Fig. 6).
