## IDENTIFICATION AND EVALUATION OF ERGONOMIC INCONSISTENCIES IN THE MANNER OF PERFORMING CONTROL ACTIVITIES BY THE GLIDER PILOT

Marcin BERLIK

**Category of the paper:** Research paper.

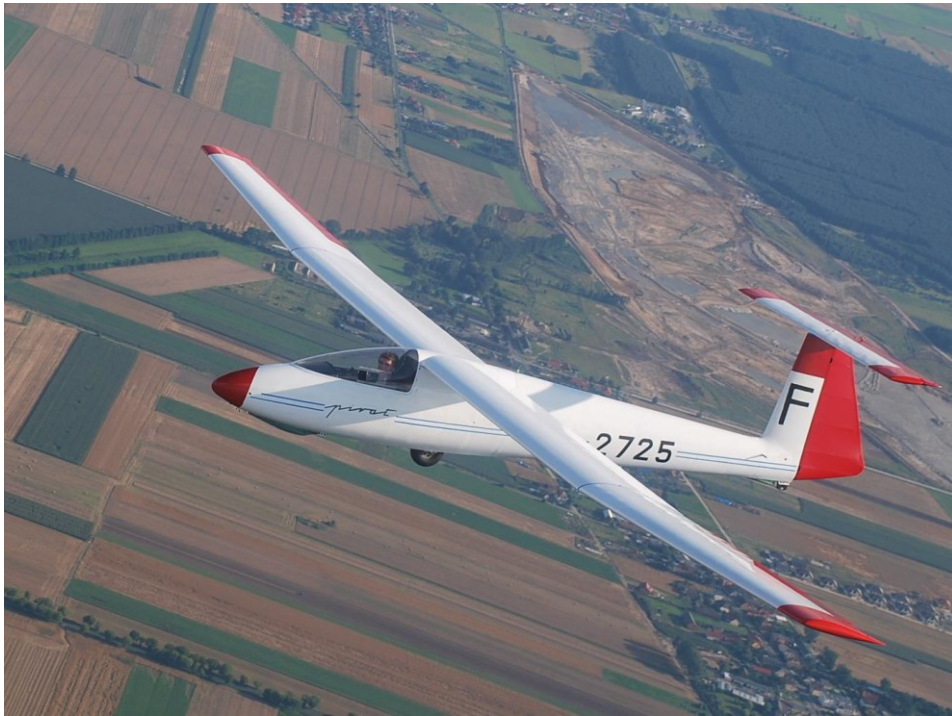
**Figure 1.** View of the SZD-30 “Pirat” glider in flight. Source: photo from the author's collection.

The research was carried out on the SZD-30 “Pirat” glider with the marks SP-2741. The SZD-30 “Pirat” glider is a single-seat training glider. Originally, it was allowed to perform acrobatics. The cabin comfortably accommodates a pilot up to 2 m tall with a back parachute. Before taking a proper position in the cabin, the backrest of the seat should be adjusted according to your height and weight. The position of the pedals can be changed before and during the flight. The pilot fastened with belts should be able to make full deflections of the stick, fully press the pedals and have full reach to the panel with instruments by hand (Flight manual for the SZD-30 “Pirat” glider).

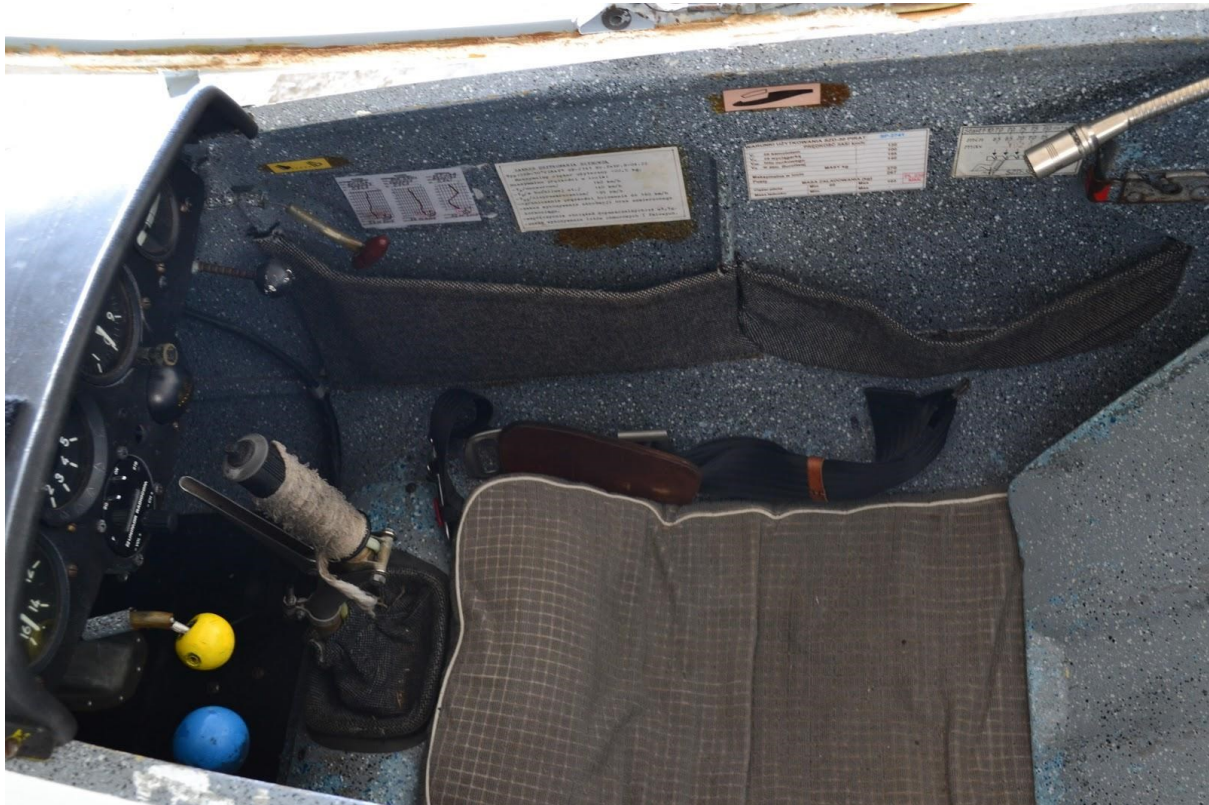
**Figure 2.** View of the interior of the cabin of the SZD-30 “Pirat” glider, in which the research was carried out. Source: author's photo.

During the flight, a glider pilot performs many activities that have a very large impact on the safety of flight operations. Performing each activity changes the position of the pilot, and thus generates a change in the load on the musculoskeletal system. The tests carried out in the glider cockpit (Figure 1) included 15 activities performed by the pilot with the left and right upper limbs during the flight (Table 1). Example of analysis for description of activities – Elevator "to yourself", ailerons to the left was presented in Table 2.

The pilot is usually equipped with a back parachute at time of the performed flight. The research was carried out with the use of the ATL 88 rescue parachute, which is currently the most commonly used rescue parachute for the flying crew in Poland.

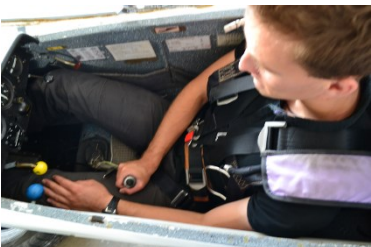
Locomotor system segments	Description of the position acc. to ISO 11226 and PN-EN 1005-4	
Torso	tilted backwards without support convex lumbar spine

Shoulder(s)	front rise exceeding 60 degrees	
Forearm(s) with hand(s)	maximally extended elbow (angle approx. 150 degrees) Twisted inwards (angle approx. 60 degrees) bent up (to the limit of mobility)	
Head and neck	tilted forward up to 25 degrees Tilted forward exceeding 25 degrees	
Legs	while sitting, the leg is bent at an angle of 90-135 degrees

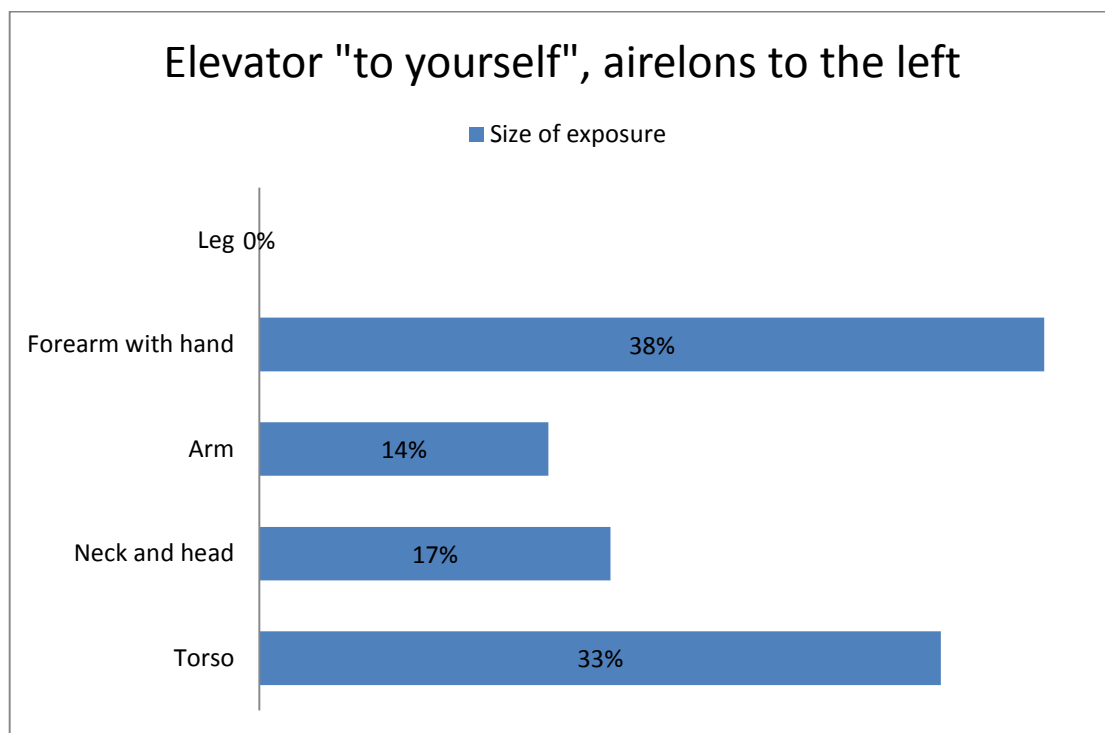
**Figure 3.** Results of the study of the percentage of exposure to ailments of individual segments of the locomotor system for the “Pirat” glider pilot. Activity - elevator "to yourself", ailerons to the left. Source: own study based on research.

The diagram shows the percentage exposure levels to individual segments of the locomotor system in relation to static positions analysed with means of the questionnaire method. The following is included in the detailed evaluation: torso, neck with head, arm, forearm with hand, and legs.

In this position, the greatest exposure (up to 38%) concerns the forearm with hand of the pilot. Whereas, for the torso, similarly to most other cases, exposure value is 33%. The neck with head are exposed in 17%. The arm is subject to a lower exposure, constituting approx. 14%. The legs are not exposed, which may be due to the neutral position of the rudder.

The analysed position is very unfavourable for the pilot. The total value of exposures is the second largest among all the analysed positions taken by the pilot during the flight with the "Pirate" glider.
