**Zbigniew KARASZEWSKI, Agnieszka ŁACKA, Piotr S. MEDERSKI,
Andrzej NOSKOWIAK, Mariusz BEMBENEK**

DAMAGE CAUSED BY HARVESTER HEAD FEED ROLLERS TO ALDER, PINE AND SPRUCE

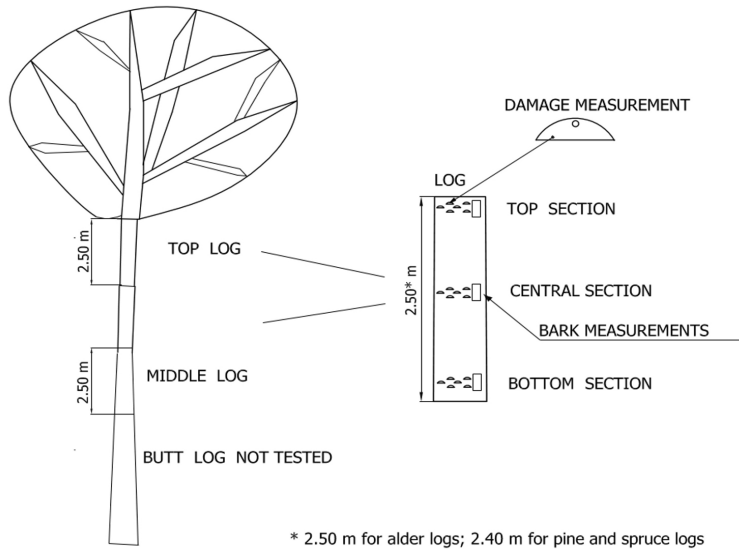
Fig. 1. Log damage measurement points

The depth of the damage on the logs was measured using the depth gauge on a Mitutoyo digital caliper (30 cm jaw length) connected to a portable computer. In order to achieve the most accurate results possible, the chip of wood damaged by the feed roller spikes was removed with a chisel. As the trunk moved through the harvester head, one spike cut three ‘walls’ of a wood chip. The fourth ‘wall’ of the chip was cut manually with a chisel and the wood chip was removed using a small screwdriver. Measurements were taken at the deepest point of damage next to the semi-circular wall cut by the steel spikes (fig. 1). The depth of the damage was measured in three sections of each log: at the bottom (the biggest diameter), in the central section and at the top (the smallest diameter). In order to get a full picture of the damage, six measurements were taken within a given section of the roundwood, in four rows created by the spikes along the log (fig. 1). The measurements were taken on both sides of the log, thereby assessing both sides of the feed rollers. The thickness of the bark (together with the phloem), detached from near the point of the depth measurement, was also measured using the Mitutoyo digital caliper. Three measurements of bark thickness were made at each point where depth of damage was measured.

The results of the depth of damage study were analysed according to two criteria: 1) mean depth for a log, where all the measurements in a given set (e.g. the results from a top log) were used to calculate the mean, and 2) maximum depth, where the mean of the maximum depth was taken from three measurement points along the log – top, middle and bottom. Three variables were taken into account: 1) tree species, 2) trunk section – logs cut from the middle or top section of the stem: middle logs and top logs, and 3) in the case of the alder, trees from two stands/locations were analysed - alder I and alder II.

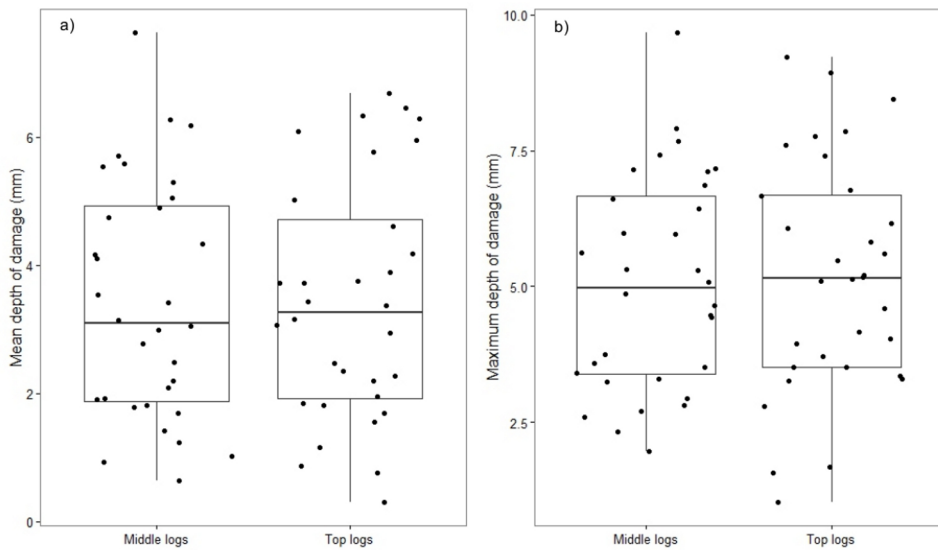
Fig. 2. Mean (a) and maximum (b) depth of damage to middle and top logs

Elements in box-plots: ● – single observations; lower whisker is the smallest observation greater than or equal to lower hinge – $1.5 * \text{IQR}$ (the inter-quartile range); lower edge of notch is a median – $1.58 * \text{IQR} / \sqrt{n}$; middle is a median; upper edge of notch is a median + $1.58 * \text{IQR} / \sqrt{n}$; upper whisker is the largest observation less than or equal to upper hinge + $1.5 * \text{IQR}$

In total, 32 trees (16 alder, 8 pine and 8 spruce) and 64 logs were measured (32 alder, 16 pine and 16 spruce), and 2304 depth of damage measurements were taken. Due to the lack of variation between the mean and maximum depth of damage on the middle and top logs for each species, this division was not considered in the models and in further analysis (figs. 2a, 2b).

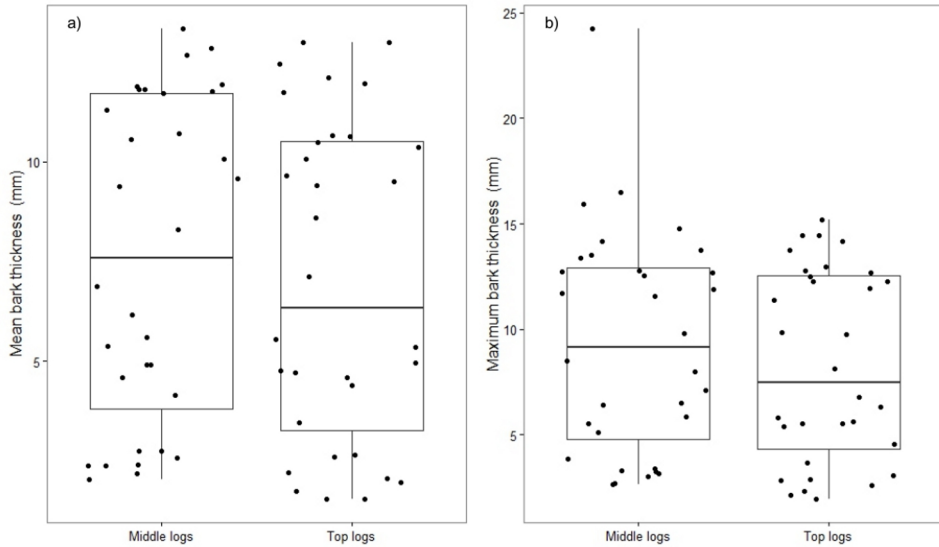
Fig. 3. Mean (a) and maximum (b) bark thickness of middle and top logs

Elements in box-plots: ● – single observations; lower whisker is the smallest observation greater than or equal to lower hinge – 1.5 * IQR (the inter-quartile range); lower edge of notch is a median – 1.58 * IQR / sqrt(n); middle is a median; upper edge of notch is a median + 1.58 * IQR / sqrt(n); upper whisker is the largest observation less than or equal to upper hinge + 1.5 * IQR

Likewise, there was no significant difference in the mean ($\text{Pr}(>F) = 0.064$) and maximum ($\text{Pr}(>F) = 0.053$) bark thickness between the middle and top logs (figs. 3a, 3b). There was a statistically significant difference between the bark thickness of the analysed species ($\text{Pr}(>F) < 2e^{-16***}$). The analysis of contrasts revealed that the alder bark was the thickest of all the species ($\text{Pr}(>|t|) < 2e^{-16***}$) and that the pine bark was thinner than the spruce bark ($\text{Pr}(>|t|) = 2.07e^{-09***}$).

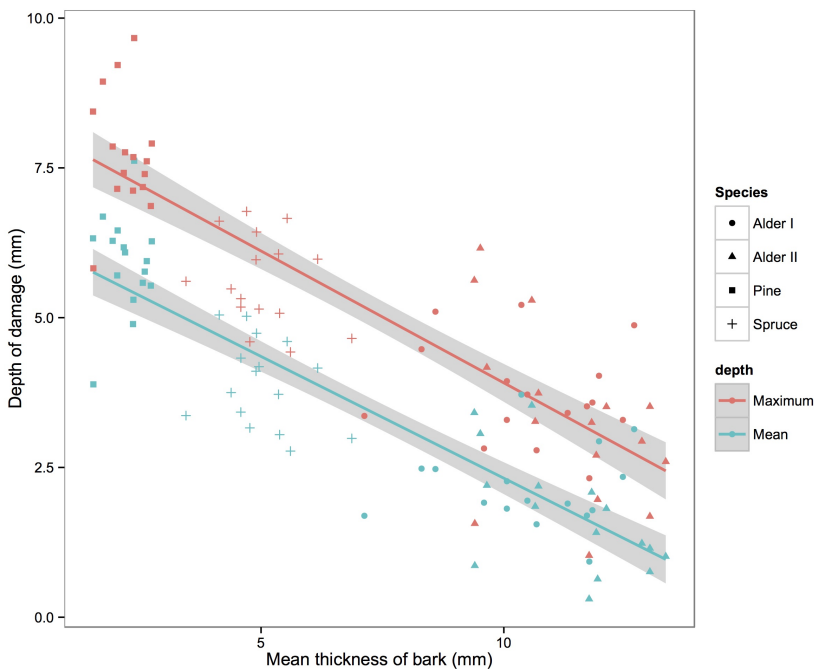
Fig. 4. Relation between mean and maximum depth of damage and mean thickness of bark for all the analysed species

The comparison of all the species measured revealed a clear linear relation between the depth of damage and bark thickness, in both mean and maximum damage results (fig. 4).

Regression analysis of the dependent variables reflected the linear models for depth of damage:

$$\text{Mean depth of damage} = 6.386 - 0.406 \times \text{ToB}_{\text{mean}} \quad (1)$$

$$\text{Maximum depth of damage} = 8.315 - 0.440 \times \text{ToB}_{\text{mean}} \quad (2)$$

For the depth of damage models, the coefficients of determination R^2 were 0.776 and 0.742 for the mean and maximum, respectively. The significance of
