Determining of a passenger car fire temperature

Abstract

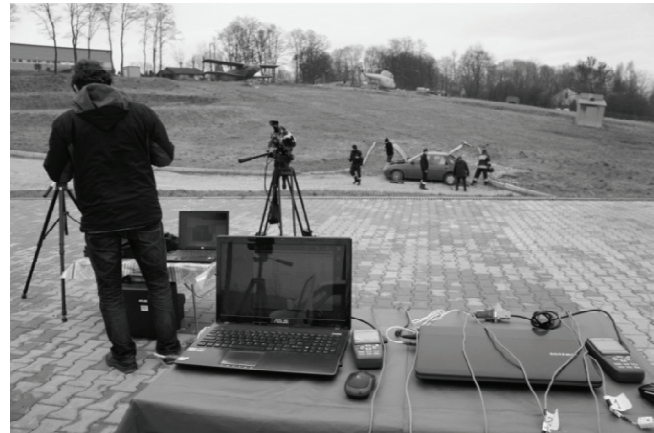
The fire test was carried out on the field of the Fire Service College of the State Fire Service in Krakow, in the place prepared for firefighters practical training. The experiment was secured by firefighters unit with a fire engine. For safety reasons, the measurement stand was located in significant distance from the burning car (Fig. 1).

Fig. 1. The measurement stand

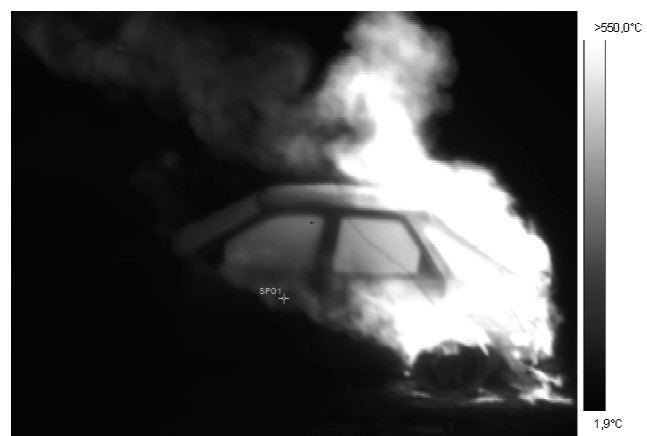
Measurement area was selected on the surface of the body, where measurements were made using a thermal camera and a thermocouple. This area was located near the door handle, on the driver side (Fig. 2).

Fig. 2. Thermal image of the car with the measurement point marked

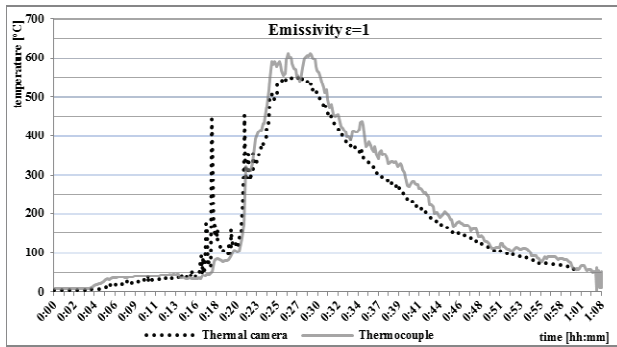
Fig. 3. shows graphs of the temperature measured with a SC640 camera and a thermocouple at the specific measurement area. The graphs don't overlap. Such results are caused by measurements taken for incorrect value of emissivity coefficient $\epsilon=1$. The emissivity coefficient of the car body in high temperature was not known. Its value was determined by ThermoCAM Researcher programme by Flir. Results of maximum readings of the thermocouple and the camera were compared (for $\epsilon=1$). The value of emissivity coefficient determined this way equals $\epsilon=0.78$. Fig. 4 present a temperature graph corrected for $\epsilon=0.78$. After this

Fig. 3. Graph of the car body temperature [°C] measured by a thermocouple and a camera, for $\epsilon=1$

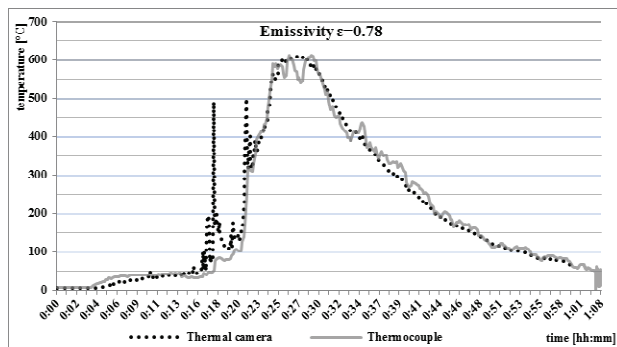
procedure a good correlation between the results gathered from the camera and the thermocouple was achieved. This indicates that the emissivity coefficient was calculated correctly.

Fig. 4. Graph of the car body temperature [°C] measured by a thermocouple and a camera, for $\epsilon=0.78$

Rapid temperature peaks visible in Fig. 4. are marked with numbers. Peaks marked with 1, 2, 3, 5 were caused by flames moved by wind gusts.

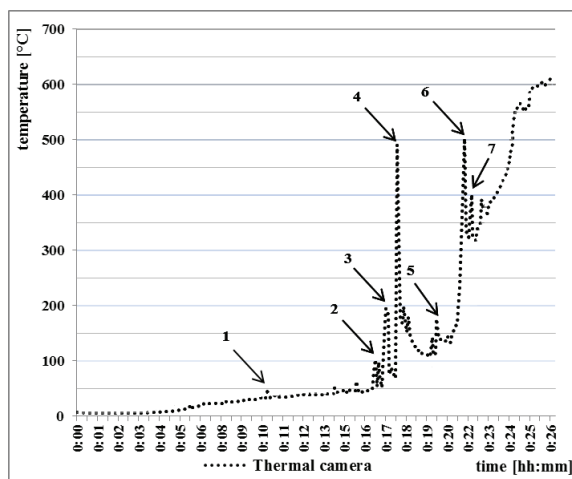
Fig. 5. Graph of the temperature measured by a thermal camera

Temperature peak marked by 4 was caused by explosion of the gas-oil actuator supporting the hatch on the left side. Next, actuator oil emission occurred. Oil being under high pressure was sprayed to the air. A cloud of combustible aerosol caught fire and caused a temporary temperature peak.

Temperature peak marked as 6 occurred after unsealing the fuel tank. At the time of ignition of fuel leaking from the tank, flames shortly came into a camera measurement area. The camera recorded the temperature of flames, not the car body.

Temperature peak marked as 7 was caused by flames coming from the door handle, near the measurement area. The handle made of plastic caught fire and the flames entered the measurement area causing temperature peak. Short flames movement didn't influence thermocouple readings. A thermocouple has multisecond thermal inertia that stops it from reacting to quick temperature changes. A camera records temperature change almost immediately. Flames don't always reach the car body but they may cover the area controlled by a camera without coming close to the car body.

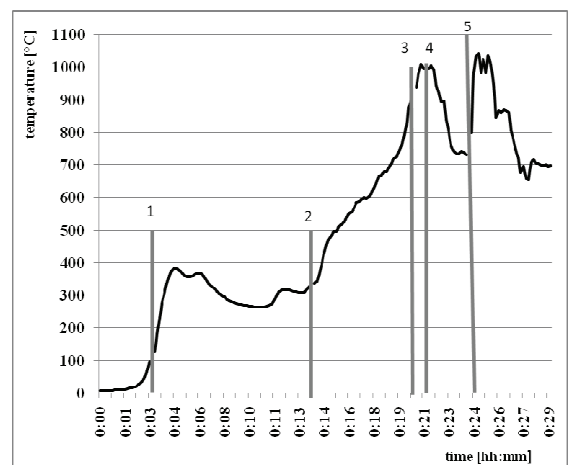
Fig. 6. presents graphs of temperature measured with a thermocouple mounted in the middle of the roof, in passenger compartment. Temperature peak caused pressure rise in the powder extinguisher located in the boot. The extinguisher exploded and powder was dispersed in the boot and passenger compartment. The pressure was so high that the powder came out of the car through the gaps and created white cloud of aerosol. The extinguisher powder impeded the temperature rise inside the car for about 10 min. This process is visible on the temperature graph, in Fig. 6.

Fig. 6. Graph of the temperature [°C] in specific areas: passenger compartment beneath the roof, boot compartment and engine compartment

The temperature graph pictured in Fig. 6. includes the following effects occurred during the car fire and marked by numbers.

- 1 – explosion of the extinguisher,
- 2 – falling out the rear pane in the hatch,
- 3 – falling out the windscreen,
- 4 – unsealing the fuel tank,
- 5 – emission of LPG gas.

Unsealing the fuel tank and burning of fuel spilled under the car did not cause the temperature rise in the passenger compartment. This resulted in the fire transferring into the engine.

Fuel burnt out quickly and the temperature began to drop. After that gas from a LPG cylinder started to escape. Multivalve of LPG container worked properly. A stream of burning gas was running inside the vehicle through the safety valve. The temperature beneath the roof reached the maximum value of 1043°C.
