Peter BIGOŠ<sup>1</sup>, Martin MANTIČ<sup>2</sup>, Melichar KOPAS<sup>3</sup>

## IDENTIFICATION OF TECHNICAL STATE AND OPTIMISATION OF OPERATION OF TRANSPORT-HANDLING EQUIPMENT

**Summary.** This paper describes a real example from the practice concerning an analysis of technical state and operational optimisation of the given transport-handling equipment, which is installed in a trans-shipment station specified for transport and handling of bulk materials. By means of identification of a faulty technical state of this transport equipment there was determined the main cause of a damage process, which occurred during current operation. Consequently, it was possible to perform an optimisation of the relevant technical parameters in order to eliminate the negative phenomena.

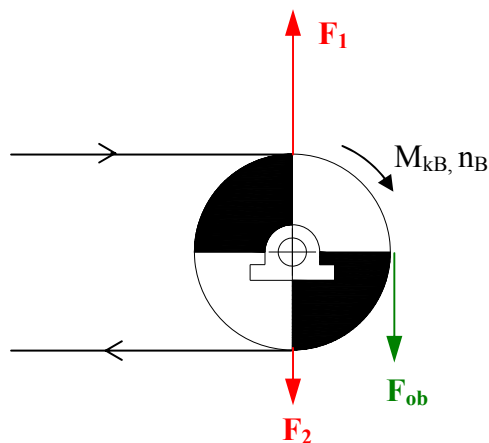
The first necessary step was a control calculation of tension forces in the belt conveyor. The driving pulley is situated in the point of maximum tension force. Therefore the belt tension forces are analysed in the driving station, according to the Fig. 1 [3].

$F_1$  – maximum tension force,  
 $F_2$  – minimum tension force,  
 $F_{ob}$  – circumferential driving force,  
 $M_{kB}$  – driving pulley torque,  
 $n_B$  – speed of driving pulley

Fig. 1. Force situation on driving pulley

By the calculation there were determined the individual values according to the Fig. 1 that are presented in the Table 1.

$F_1$ (N)	$F_2$ (N)	$F_{ob}$ (N)	$M_{kB}$ (N.m)	$n_B$ (s <sup>-1</sup> )
56 428	8 046	48 382	30239	0,55

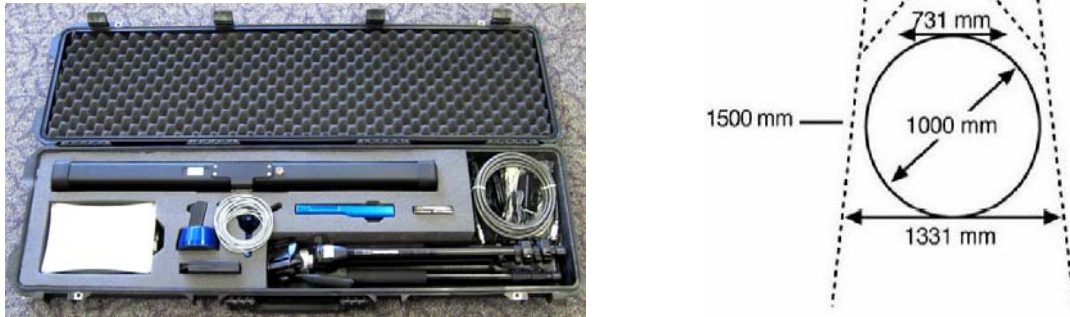
Thus, there was actual a question how to perform the required measuring with the necessary accuracy. Taking into consideration all the relevant facts there was selected an innovative sensing method using the 3D scanner. It was applied a contact scanner with the infrared data transmission between the measuring probe and the sensing camera 3D Creator, which is a product of the company Boulder Innovation Group, Inc., Fig. 2.

Fig. 2. Measuring device and operational radius of the 800 mm scanner sensor  
Rys. 2. Urządzenie pomiarowe oraz promień działania 800 mm czujnika skanera

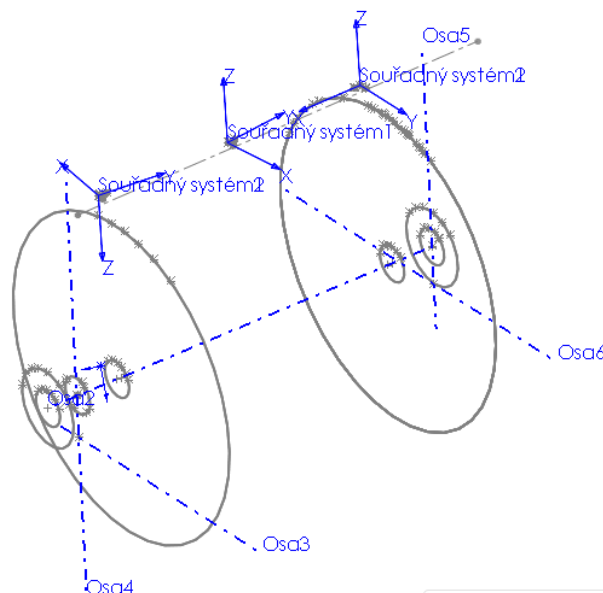
From this reason it was necessary to develop a new sensing methodology by means of the exactly positioned reference point, which was situated in the range of the measuring sensor. This arrangement was applied for the bilateral sensing of the bearing house and running diameter of the guiding cylinder so that the sensing sensor was moved from the left side to the right side of the given surveyed object without a loss of accuracy. The output from the measuring performed by means of digitisation equipment is illustrated in the Fig. 3.

Fig. 3. Display of measured data from the equipment 3D Creator  
Rys. 3. Przedstawienie wartości zarejestrowanych przez urządzenie 3D Creator

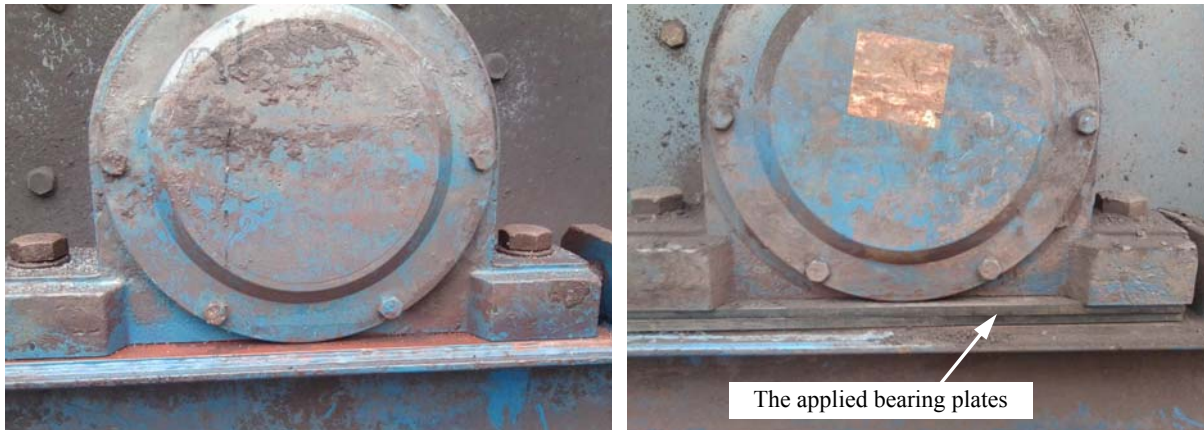
Fig. 5. Elimination of the angular deviation in the vertical plane

Finally, it is possible to say that the chosen measuring methodology, together with the applied measurement equipment, was very effective for solving of the given task. According to the measured values of the angular deviations the original geometrical position of two guiding cylinders was corrected by means of bearing plates that were placed under the bearing houses, Fig. 5.

It is possible to say, according to the information obtained from operator of the given conveyor, concerning the following operation after a half-year of standard running, that all the relevant parameters were improved and, consequently, the initial negative phenomena were eliminated. Thus, the original methodology, which was developed by our team and described in this article, proved good and successfully.
