# Effectiveness of reinforcing an earth structure with a system of counterfort drains over a long-term use

**Abstract:** The paper evaluates the effectiveness of reinforcing a damaged earth structure with making counterfort drains in its slope. The system of counterfort drains changed the soil properties significantly over a long-term use. The evaluation was based on many years of field and laboratory tests and stability analysis. The field tests concerned the observation of  $N_{WST}$  probing resistance change, and the laboratory tests concerned the change in soil consistency and water content. The paper presents the results of tests that were conducted over 13 years.

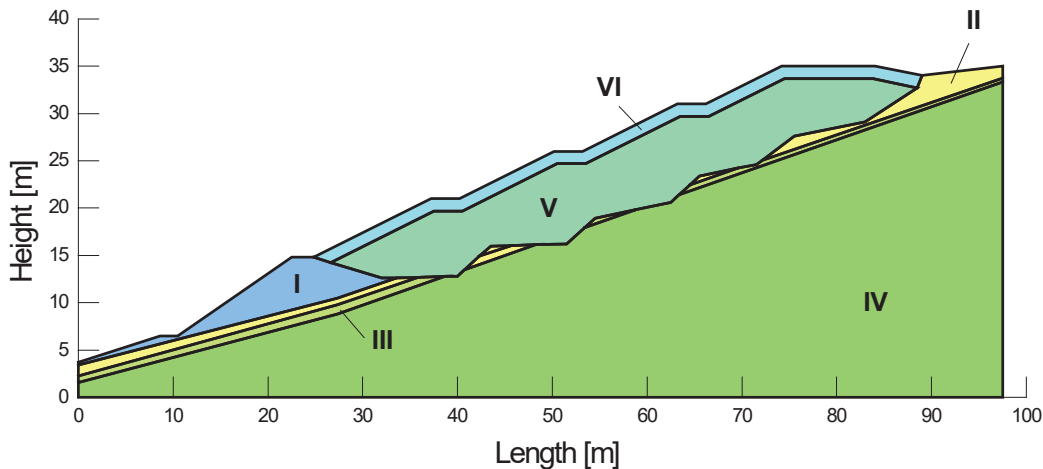
**Figure 1:** Landfill cross-section. I – retaining embankment, II – geotechnical layer II, III – geotechnical layer III, IV – geotechnical layer IV, V – municipal waste and VI – organic layer

Figure 1 presents the landfill cross-section. In order to obtain a sufficient capacity of the landfill in a natural slope (II, III, IV), a hillside has been cut that comprised a few slopes and shelves. A retaining embankment (I) was built on the landfill front, forming the landfill trough. The outer retaining embankment side consists of two slopes and a shelf on which a technological road is located. The earth structure height varies from 8 to 12 m, with a general inclination of about 30–32° (1:1.5). The upper slope inclination reaches 38°. In such a designed landfill, the retaining embankment performs the retaining function to protect the final hillside shape, which is filled with municipal waste (V) and closed with the organic layer (VI).

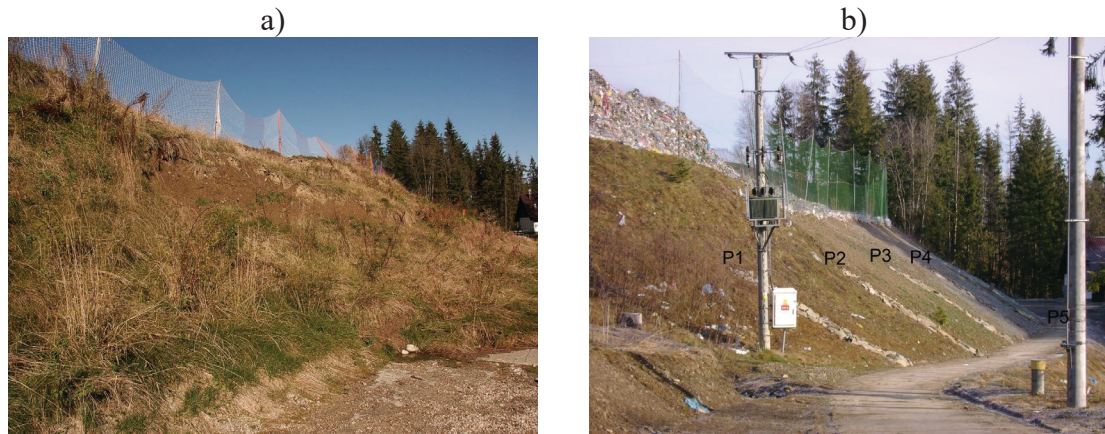
Figure 2: Landfill retaining embankment: a) damaged, 2004, and b) after repairs with counterforts P1–P5, 2005.

Six months after the landfill opening (July 2004), after an intensive rainfall, a landslide in the retaining embankment occurred. The landslide included the top, outer embankment slope at the length of >40 m and was asequent (Fig. 2a). The total loss of retaining embankment stability could lead to a construction and environmental disaster as a result of which the landfill would have had to be closed.

The final protection was not made for reasons of economy [8, 19]; only a temporary protection was made that comprised a system of counterfort drains at the entire retaining embankment length (Fig. 2b). The counterfort drains were made by cutting eight trenches (P1–P8) 1.0 m wide and 5.0–7.0 m deep perpendicular to the slope. The distance between the counterforts was 15.0 m. A drainage line was made below the counterforts to remove the groundwater to a nearby water course. The retaining embankment repair was completed in 2005.

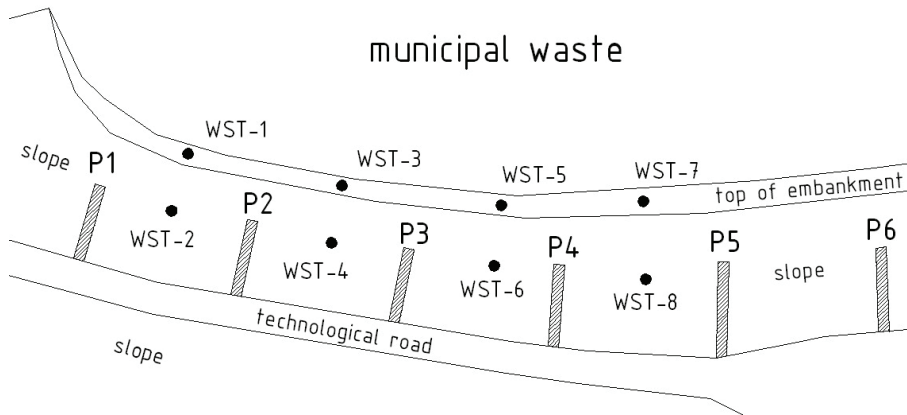
Figure 3: Location of the WST probing.

The WST probing was performed at six points in the area of the largest embankment damage in 2004, at a halfway distance between the counterforts P1/P2, P2/P3 and P3/P4. Three probes were made into the soil from the top of embankment WST-1, WST-3 and WST-5, and the other three were made at a half-height of the top embankment slope WST-2, WST-4 and WST-6. Additional WST probing was made between counterforts P4/P5, WST-7 and WST-8 since 2007 (Fig. 3).

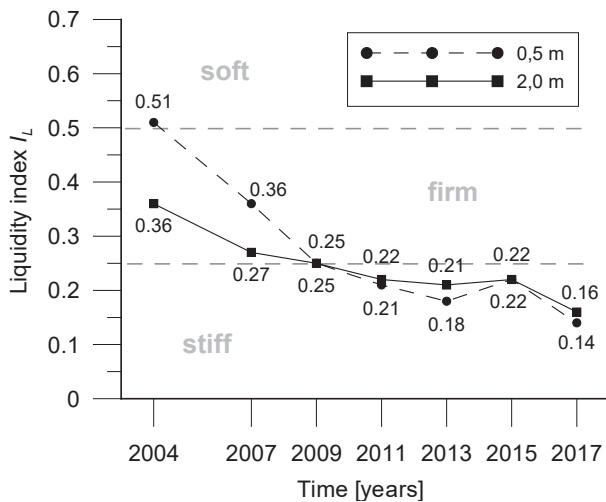
Figure 8: Changes in the retaining embankment soil liquidity index (mean values from three boreholes).

the WST1, WST-2 and WST-3 probing locations. During the laboratory tests in successive years, the following retaining embankment soil properties were determined: water content  $w$ , plastic limit  $w_p$  and liquid limit  $w_L$  using the Casagrande method (Table 1). These values were the basis for determining the changes in soil liquidity index  $I_L$  (Fig. 8) and consistency.

The results of the laboratory tests confirm the improvement of retaining embankment soil consistency. Stabilisation of the water content and liquidity index is visible as early as in 2011.

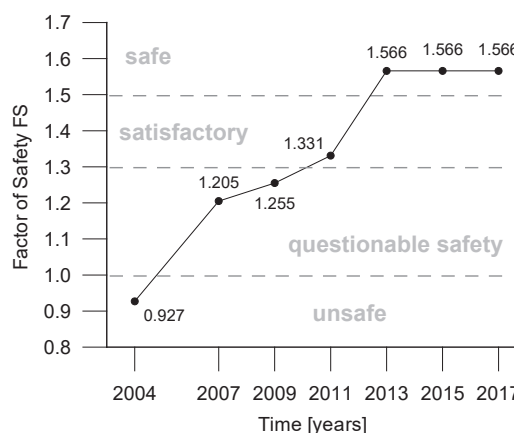
**Figure 9:** Stability analysis results (Bishop's method)

The calculations for each time variant were performed for the situation when the landfill was full of waste and covered with the organic layer. The stability analysis results are given in Fig. 9.

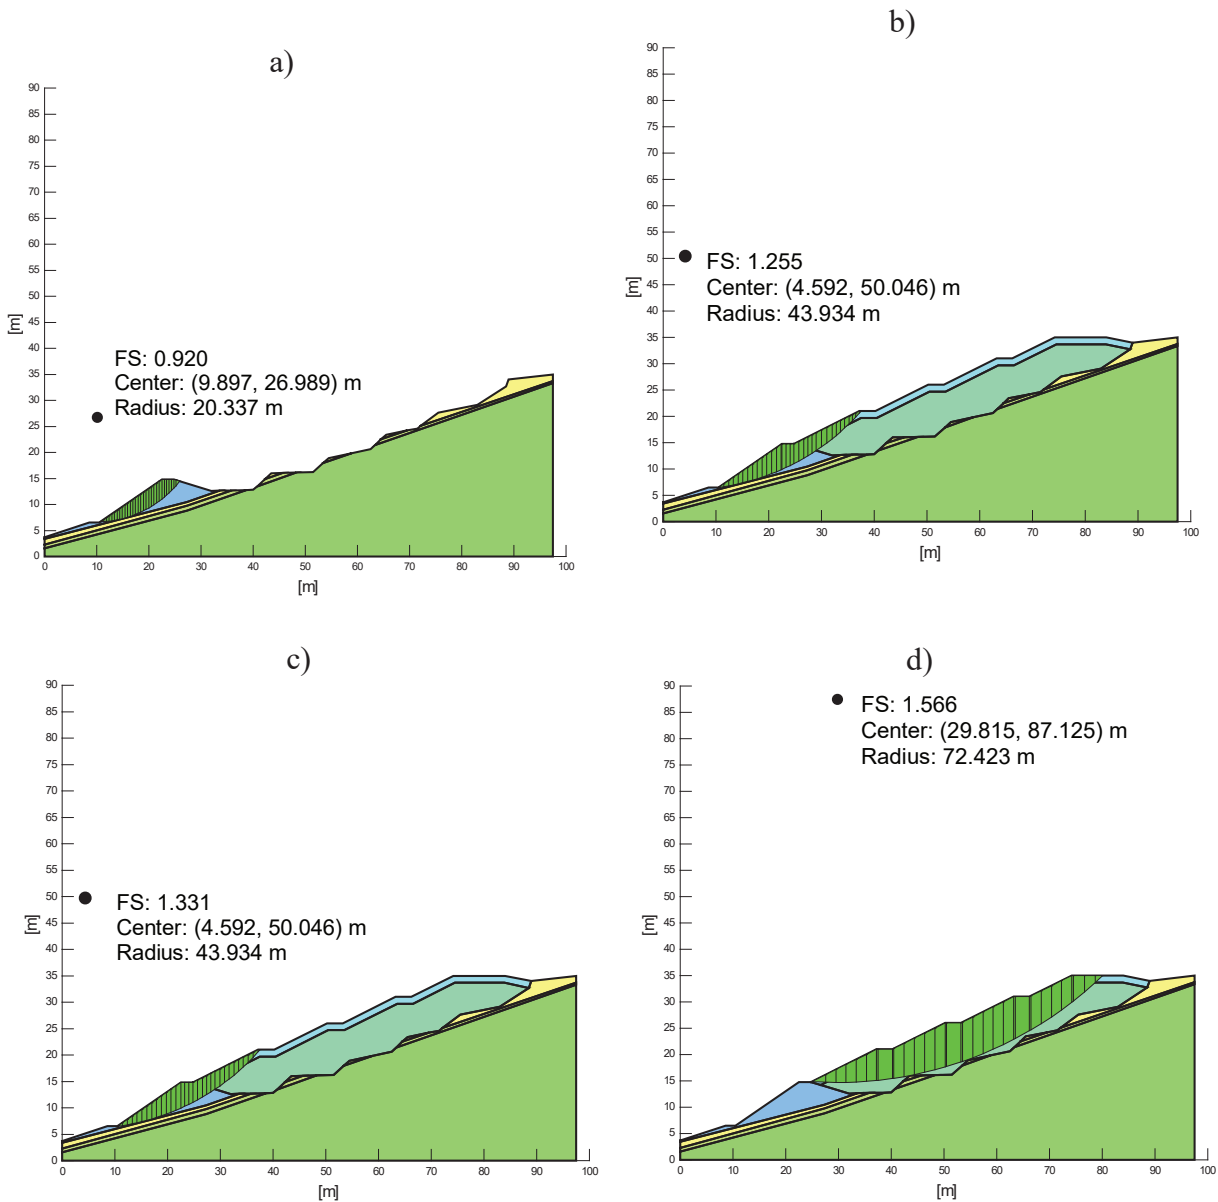
**Figure 10:** Selected stability analysis results (Bishop’s method): a) only the retaining embankment 2004, b) 2009, c) 2011 and d) 2013, 2015 and 2017 (identical results).

The empty landfill stability analysis was performed for the situation in July 2004 (Fig. 10a). The factor of safety (FS = 0.920) confirms the stability loss of the retaining embankment.

(FS < 1.3) are unsatisfactory from the point of view of landfill stability. The corresponding failure planes run through the retaining embankment (Fig. 10b). From 2011 onwards, when the retaining embankment soil is of a stiff consistency (FS > 1.3), the results are satisfactory and the landslide processes are unlikely (Fig. 10c). The analysis of the last three cases (FS > 1.5) indicates that the results are very satisfactory, and the corresponding failure planes are located in the slope part with the municipal waste (Fig. 10d).
