**PROBLEMS OF WEAR OF THE CHAINS USED IN MINE SCRAPER
CONVEYORS, CAUSED BY FRICTION AND CORROSION**

Summary. Scraper chains are the main transport cables of scraper conveyors. Problems related to the processes of destruction of link chains used in these conveyors are described. Design of scraper chains and their division into different types for use in scraper conveyors are presented. The most common damages to chains used in scraper conveyors are presented and the reasons of their wear are discussed.

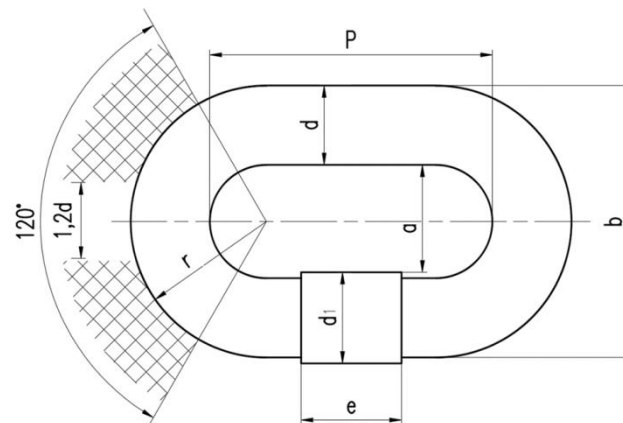
Fig. 1. Dimensions of a link in the mine chain; P- chain pitch; d - chain rod diameter; d_1 - rod diameter at the welding point; e - maximum weld width; a - minimum clearance width; b - maximum width of the link; r - radius of the link rounding (external) [10]

Medium-link chains are used in flight-bar conveyors. That means that the ratio of the chain pitch to the diameter of the bar from which it is made is between 3 and 4. The dimensions of the conveyor chains have been standardized. The Polish Mining Standard PN-G-46701:1997 - "Mine link chains" [10] is the current document characterizing link chains used in scraper conveyors. The links of chains are of dimensions determined by the aforementioned standard. They are shown in Fig. 1 below.

The Polish Mining Standard, based on ISO 610:1990 and DIN 22252, describes the size of the link by specifying the size $d \times p$ in mm (d - diameter of the link rod; p - pitch of the link). On this basis, a series of types of link chains for various loads was created.

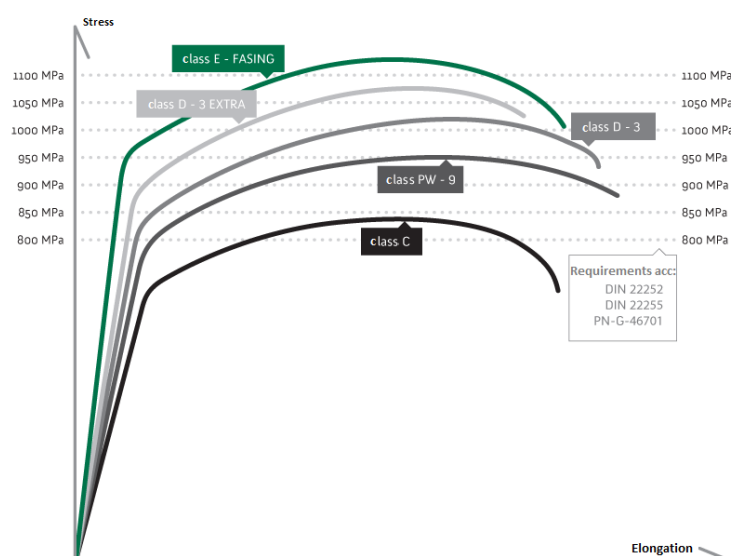
Fig. 2. Sample diagrams of breaking the mine chains of different manufacture classes [16]

The breaking load is defined as the maximum force that a chain sample can bear during a breaking test on a testing machine. Examples of chain link breakage charts of various sizes are shown in Fig. 2.

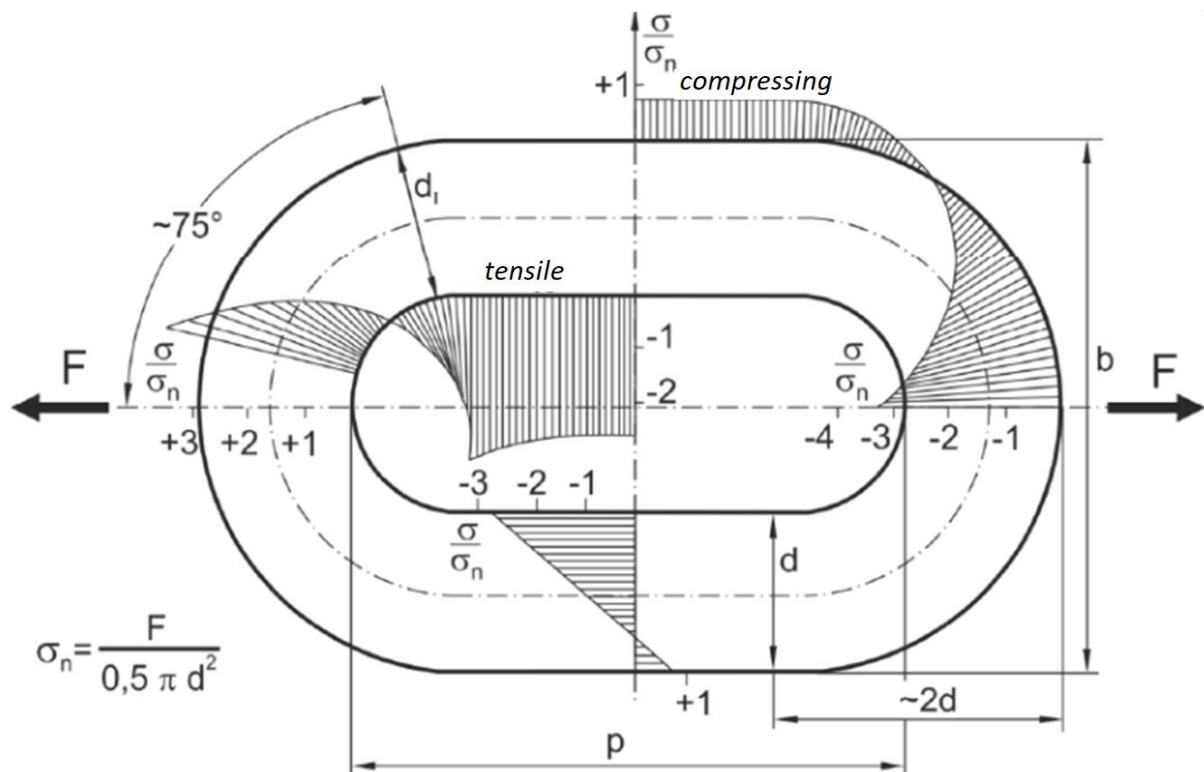
Fig. 3. Distribution of stresses in a mine chain link [9]

Distribution of stresses in link chains (Fig. 3) is an interesting issue related to the operation of chain systems. In addition to the stresses generated by the forces tensioning the chain during the run-of-mine transport, there are also internal stresses in the links. These stresses result from the process of calibrating them, which is characteristic for the production of chains. Calibration is understood as the application of a force tensioning the chain (the so-called calibrating force), the purpose of which is to deform the links resulting in elongation of the pitch and setting it at the required level. After removing the calibrating force, a partial shrinkage of the material occurs, resulting in internal compressive stresses that have a beneficial effect on the fatigue life of the chains. In addition to determining the pitch, there are also geometric changes, especially in the joint area, which positively affects the tribological cooperation between links. The calibration load is not included in the standard and is the "know how" of mine chains manufacturers [1, 4, 11].

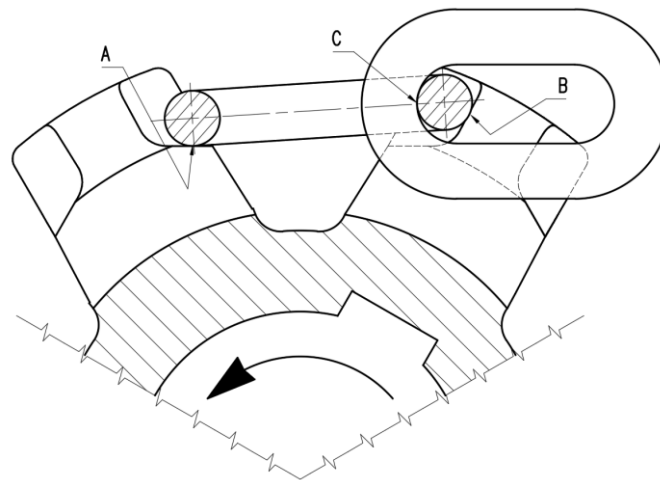
Fig. 4. Friction nodes in the chain-chain drum kinematic system
(Item A - front torus in the bottom of the drum, Item B - rear torus on the tooth flank,
Item C - cooperation of links in the joint) [15]

During the cooperation of links with the drum and cooperation among the links in the joint area, abrasive wear is the dominant cause of degradation. When analyzing the chain-chain drum kinematic system, three following basic friction nodes can be distinguished (Fig. 4):

- area of cooperation of the front torus of the horizontal link with the bottom of the drum (Item A),
- area of cooperation of the horizontal rear link torus with the flank of the tooth (Item B),
- chain joint area - horizontal and vertical link contact zone (Item C) [15].

For each of the mentioned friction nodes, tribological wear is observed, caused by the cooperation of contacting surfaces, often additionally intensified by rock dust abrasion. In the case of contact at Items A and C (Fig. 4), wear is caused by the rolling of the links in the joint and positioning the front horizontal torus of the link in the bottom of the socket. During the cooperation among the links in the chain joint, the contact point of the links moves, which results in the lowering of the vertical link in the inter-tooth groove. This causes a rolling motion as part of two links in cooperation with the simultaneous slipping of the front torus in the bottom of the socket. In addition, lowering the vertical link is accompanied by rolling and partly

Cooperation in the area of the joint and abrasion of these zones, in turn, causes an increase in the pitch of the link chain. This results in the rear torus (Fig. 4, B) resting on the tooth flank instead on the bottom, which often leads to the rear torus sliding over the tooth flank towards the bottom of the drum, resulting in wear of the tooth flank and the referring contact zone on the link. The literature [13, 14] distinguishes three following classes of cooperation of the link in the pocket of the sprocket wheel:

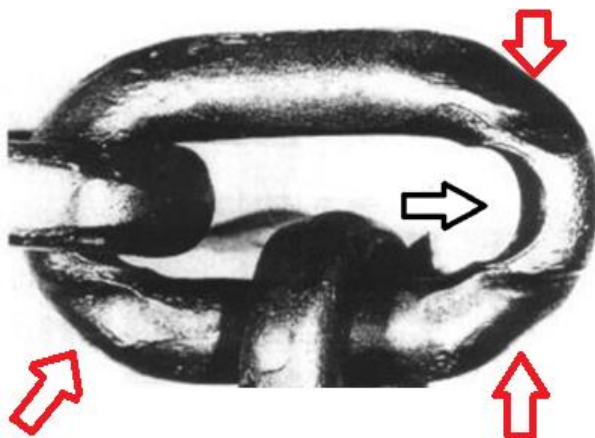
Fig. 5. Wear area of chain link joint (black arrow) and wear area of chain link contact zone (red arrows) [8]

slipping in the chain joint. The long-term effect of the described phenomena is a wear deforming the seat bottom, tooth flank and the corresponding zones on the horizontal link (Fig. 5).

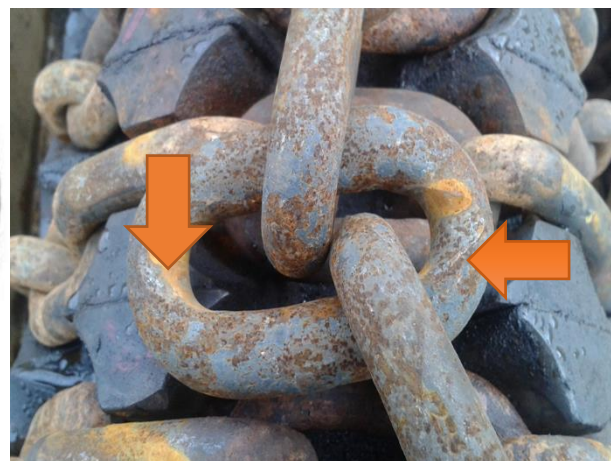
Fig. 6. Visible areas of abrasive wear in the area of the link joint

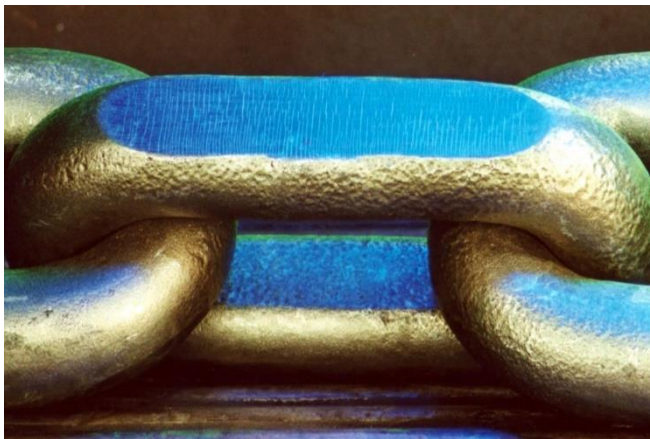
Fig. 7. Cracks meshing formed as a result of the formation of the so-called friction martensite [8]

In the case of vertical links, apart from the abrasion processes (against the conveyor trough – Fig. 8), there are also changes in the structure of the link material. The rubbing surface of the chain links warms up as a result of friction processes and then cools down intensively as a result of transferring heat energy to the other parts of the machine and as a result of cooling with water-laden run-of-mine (or the environment). The cyclical heating and cooling in favourable conditions causes the formation of a martensite layer (called in the literature the friction martensite) characterized by high hardness and brittleness, and thus susceptible to cracks when the link is overloaded. These damages have numerous surface cracks perpendicular to the surface and to the slip direction (Fig. 7). These cracks are often sharp notches, and they are the beginning of cracks leading to the link destruction [11].

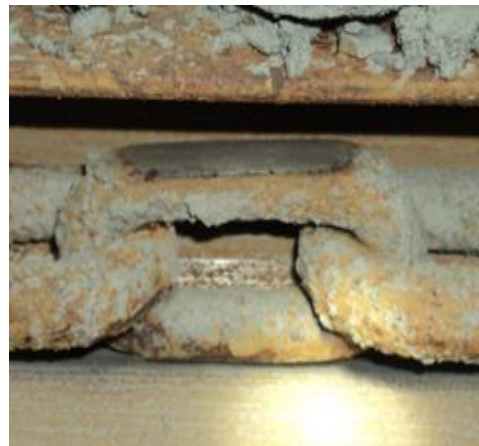
Fig. 8. Link abrasion on the conveyor trough [15]

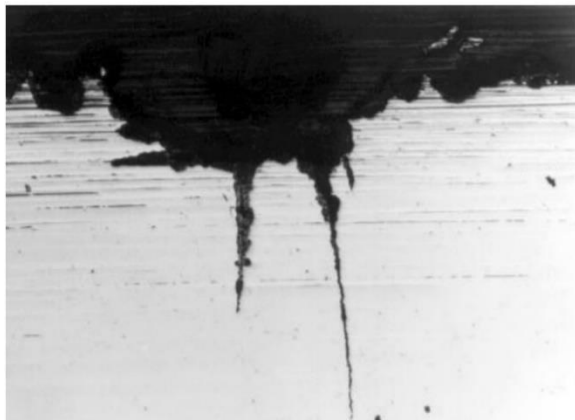
Fig. 9. An example of a corrosion pit on a cross-section through the parent material of a chain link [8]

Chain link corrosion is especially dangerous if the fatigue cracks appear on the link's surface. In such a case, extensive corrosion pits may appear, the propagation of which is further intensified by the increased chemical activity of the work environment (Fig. 9). The result of this process are corrosive separation cracks in the links. In addition, in a strongly corrosive environment, a significant decrease in the critical stresses that initiate development of cracks is observed. Therefore, the fatigue wear of links operating in a corrosive environment progresses faster. Examples of corrosive effects on mine chain links are presented in Fig. 10 [9].

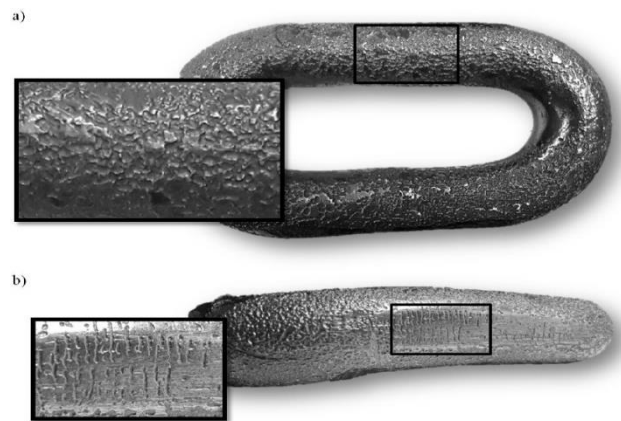
Fig. 10. Chain link corrosion: a) surface pitting, b) fatigue cracks intensified by corrosive environment [11]

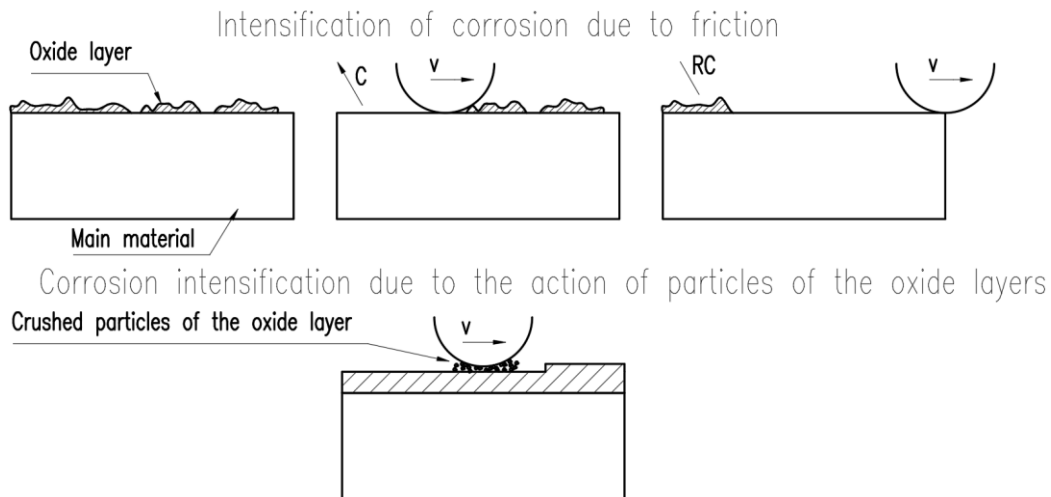
Fig. 11. Mechanism of tribocorrosion wear (v -speed vector, C -corrosion; RC -reoxidation) [2]

Tribo-chemical wear is another known wear mechanism for conveyor chain links. It is defined as the formation of surface reaction layers as a result of tribo-chemical reactions. These surfaces, due to the abrasive mechanisms, are removed opening the newly reacting surface with the environmental substances (e.g. mine water). This reactivity is explained by the plastic deformation of the friction surface, which generates local density changes, causing the migration of electrons from places with shear stresses to the places with tensile stresses (where the potential is negative). Temperature may be another catalyst for tribo-chemical reactions of differences resulting from the heating of rubbing surfaces. Electrons then migrate from the regions of higher temperature to regions of lower temperature. As part of the tribo-chemical wear, the oxide layer is removed and then recreated on the surfaces of the cooperating components. It is classified as a normal type of wear, and its intensity is insignificant in stabilized conditions. With the increasing corrosiveness of the environment of the cooperating components (e.g. in the presence of saline water), this process is significantly intensified by the impact of hard products of wear, which take the role of hard abrasive grains. In the literature, the term tribocorrosion wear is used to describe the form of combined wear intensified by the synergistic action of abrasive and corrosive agents (fig. 11). There is a synergy of factors that jointly enhance chain degradation, what significantly accelerates its damage. The presence of hard metal oxides getting into the abrasive as a result of the joint action of abrasive and corrosive processes causes the synergy effect [3, 12, 15].

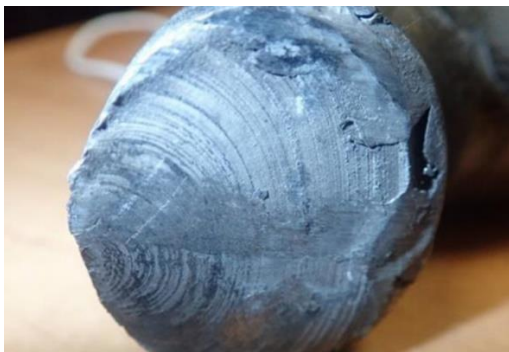
Fig. 12. Fatigue fracture of a chain link [8]

Corrosion pitting, micro-cracks or abrasion-mechanical damage are usually the initiators of fatigue degradation of links. There are several phases in the fatigue failure process. The first phase is the incubation of microcracks formed during the operation of conveyor chains. The next phase is development (deepening) of microcracks until the so-called critical value. After reaching the micro-cracks critical value, a stage of their rapid progress takes place, finally leading to the next phase, i.e. to a fracture in the critical cross-section (Fig. 12). In the aspect of

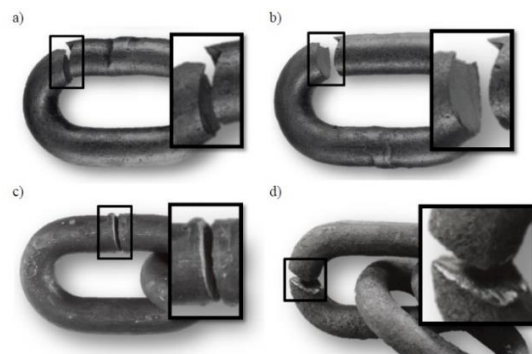
Fig. 13. Typical places of fractures :
 a) fracture in the arc on the side of the weld (approx. 50%),
 b) fracture in the arc on the opposite side (approx. 30%),
 c) fracture in the weld (approx. 15%),
 d) fracture in the link axis and other forms of fractures (about 5%) [11]

mine link chains, these fractures usually occur in several characteristic places (Fig. 13), which results from the distribution of stresses caused by significant tensile forces [6, 9].
