INFLUENCE OF METEOROLOGICAL CONDITIONS IN AUTUMN/WINTER 2021–2022 ON THE DEVELOPMENT OF STORM SURGES AND THE DUNE EROSION ON THE POLISH BALTIC COAST AS A RESULT OF CLIMATE CHANGES

Tomasz Arkadiusz Łabuz

*Institute of Marine and Environmental Sciences, University of Szczecin, Mickiewicza St. 16, 70-383 Szczecin, Poland;
e-mail: tomasz.labuz@usz.edu.pl*

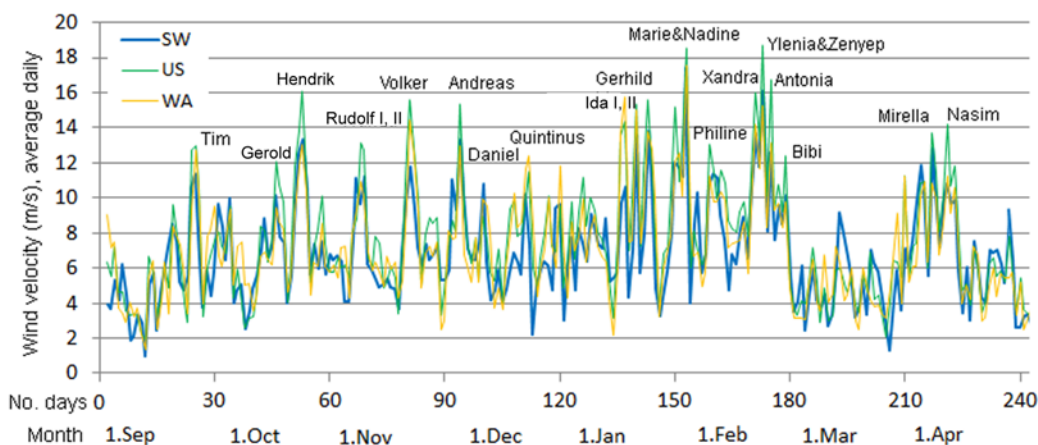
Fig. 3. Average daily wind velocity for the period 09.2021 to 04.2022 with names of main low-pressure systems. Wind station: SW – Świnoujście, US – Ustka, WA – Władysławowo. Data source of own graph: IMGW.

the Polish Baltic coast were defined as winds with a speed exceeding 10 m/s (Trzeciak, 2001; Sztobryn *et al.*, 2005). During the study period, a wind with $V > 10$ m/s occurred more frequently from the SW than from the NW direction. High wind speeds were observed in Świnoujście (SW), Ustka (US) and Władysławowo (WA) from the end of August 2021 until the end of February 2022, and then in the first half of April (Fig. 3). It was frequently higher by approx. 2 m/s at

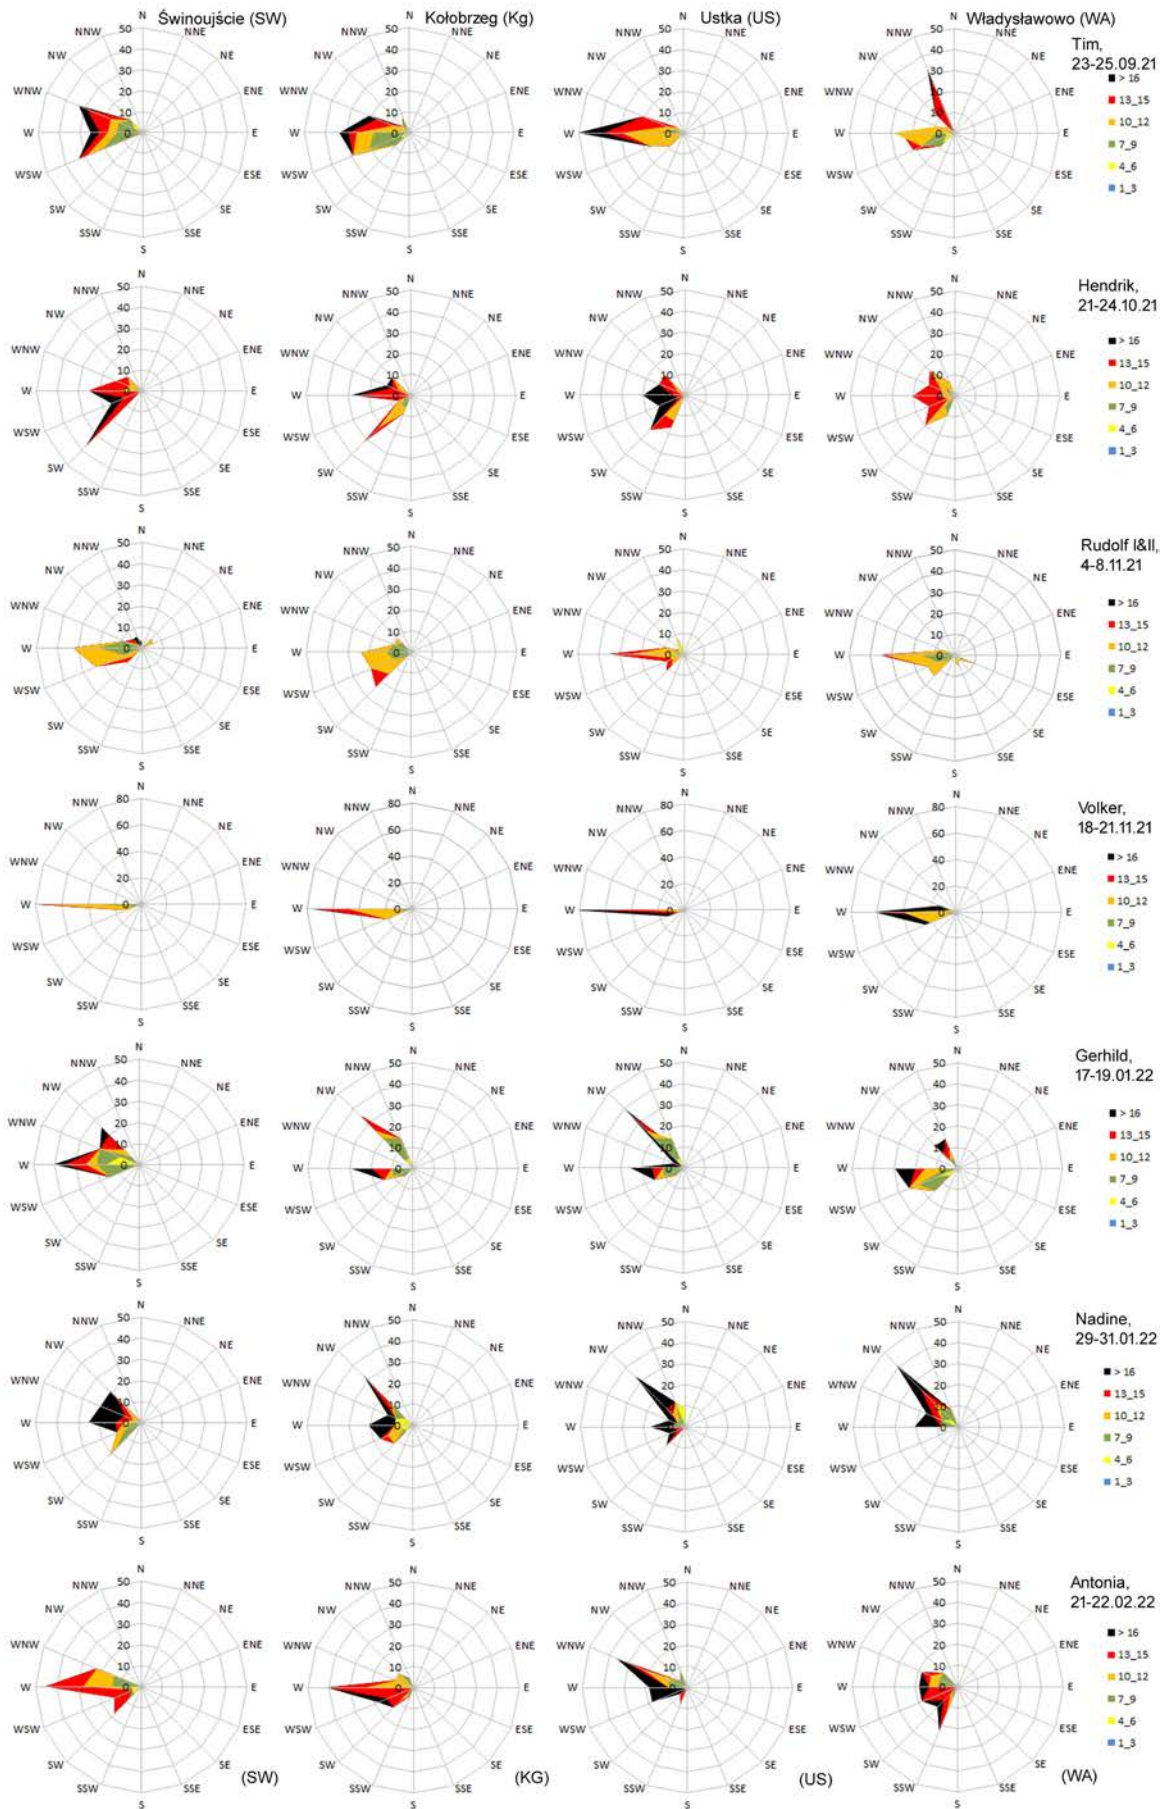
Fig. 6. Comparison of wind roses for storm surges with prevailing SW, W or NW winds (see table 1). Data source of own graphs: IMGW.

Volker) and slightly the direction (storm Rudolf). Figure 6 presents the difference in wind parameters during selected surges along the Polish Baltic coast (Świnoujście, Kołobrzeg, Ustka and Władysławowo). This contributed to the observed variations in sea level over time and along the shore. Due to varying directions of wind passing over the southern Baltic Sea, surge phases were distinguished for each storm lasting over 2 days. They corresponded with the time of sea level rise and its fluctuations due to the wind direction and speed changes. Figure 8 shows the relationship between the changes in wind speed and sea level. In the T0 phase, the wind usually had an offshore SW to SSW direction. In the T1 phase, a W to NW (NNW) wind led to a quick sea level rise to its maximum. This phase usually lasted from 10 to 24 hours. The maximum sea level was reached faster at the western coast (Świnoujście) than in the east (Władysławowo). In the T1 to T2 phase, NW to NNW (N) winds resulted in a persisting high sea level. During that time, the wind speed increased or decreased, resulting in a further sea level rise or drop. The T3 phase was related to a drop in sea level. In many cases, the wind direction change was related to its higher speed, resulting in the sea level rising again. For this reason, the storm surge was doubled. The water level rose on one occasion with a W to NW wind, and then with an NNW to N or NNE wind.

In the autumn/winter 2021–2022, between the second half of September and the middle of April, a prevailing western circulation with SW to NW winds was observed (Fig. 6). During that period, 37 storms emerged on the Polish coast, including 32 caused by low-pressure systems passing from the SW to NW (Fig. 8, Table 1). They were

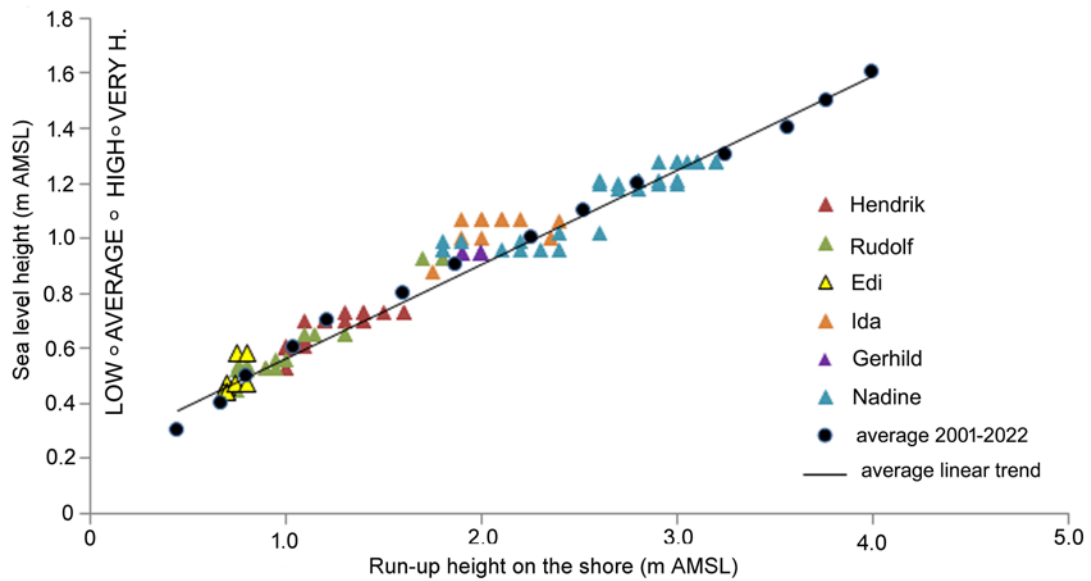
Fig. 10. Relation of the sea level (HSL) to the measured max. run-up (HSLr) to the shore during selected surges against the average relation trend. Data source of own graph: Maritime Office, field investigation.

Figure 10 presents a relation of selected storm surge sea elevation to observed run-up compared to an average of previous studies. The surges, with water elevation up to 0.6 m AMSL did not threaten the shore due to low run-up, not exceeding 1 m. Usually, beaches of the southern Baltic coast are higher than 1.5 m, but excluding erosive coast sections with a permanent low-lying beach. During surges with a sea level of 0.6 to 0.8 m AMSL, the water run-up reached in average an elevation of 1.0–1.6 m AMSL. In the 2021–2022 storm season, the most frequent surge run-up reached 1 to 2 m AMSL. This means that water was threatening the shore up to 2.0 m AMSL. During surges of up to 1–1.1 m, the run-up reached 2.5 m AMSL (Gerhild, Ida). While the surge Nadine with the highest sea level of 1.28 m, the run-up reached 3.1–3.4 m at the eastern coast.

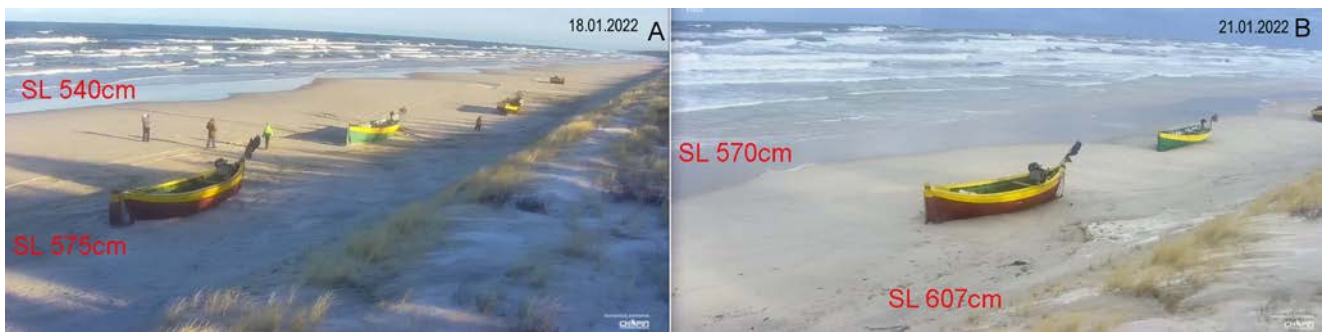
Fig. 11. Short-term sea level change vs run-up range on the beach (photos from the camera: <https://nadmorski24.pl/kamery/>). A – situation after surge Gerhild with max. SL = 575 cm. B – a situation during surge Ida II, after Ida I with max. SL = 607 cm.

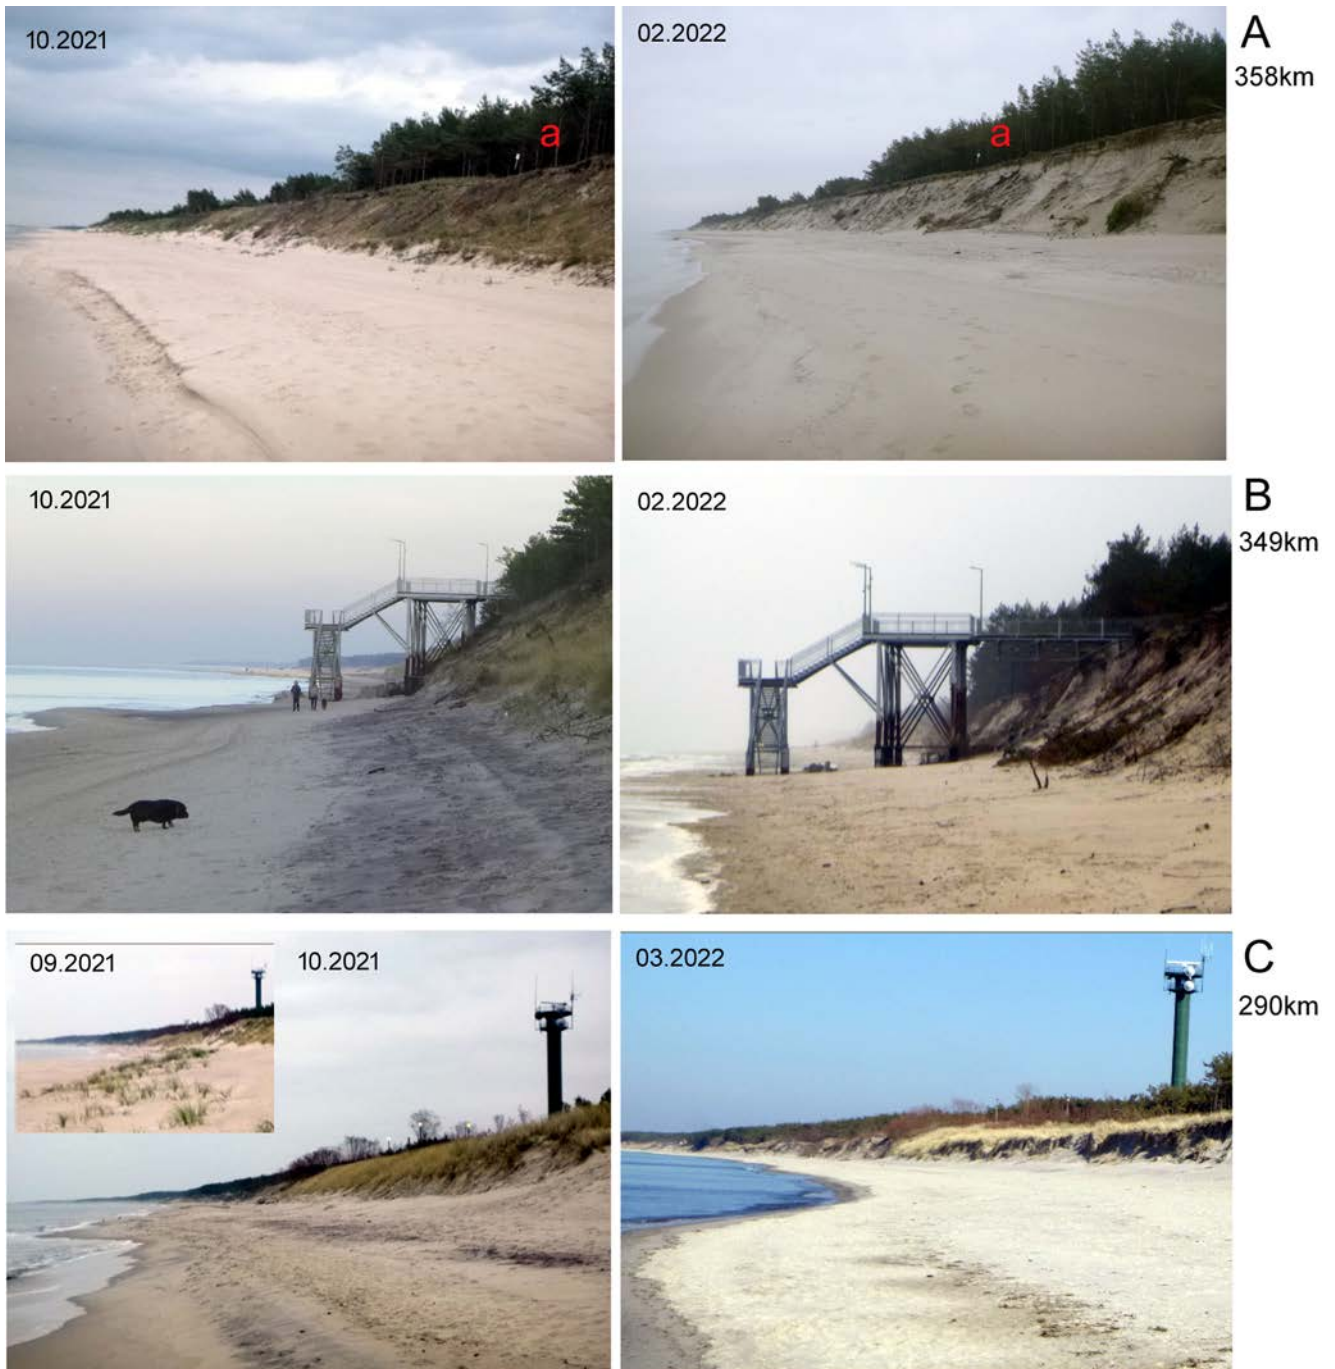
Fig. 13. Comparison of coast retreat after smaller surges in Autumn 2021 and big Nadine in January 2022 on the West coast. Photos from 10.2021 show the coast after Hendrik & Rudolf surges in October 2021. A – lowered beach and then retreat of 3–5 m of a dune toe on the Rega River Sandbar, km 358, a – kilometrage sign. B – lowered beach with heavy minerals and then dune retreat of 6–8 m on the promontory on the Resko Lake Sandbar, km 349. C – embryo dune erosion after October surges, then dune retreat 2–3 m after Nadine surge, Jamno Lake Sandbar, km 290.

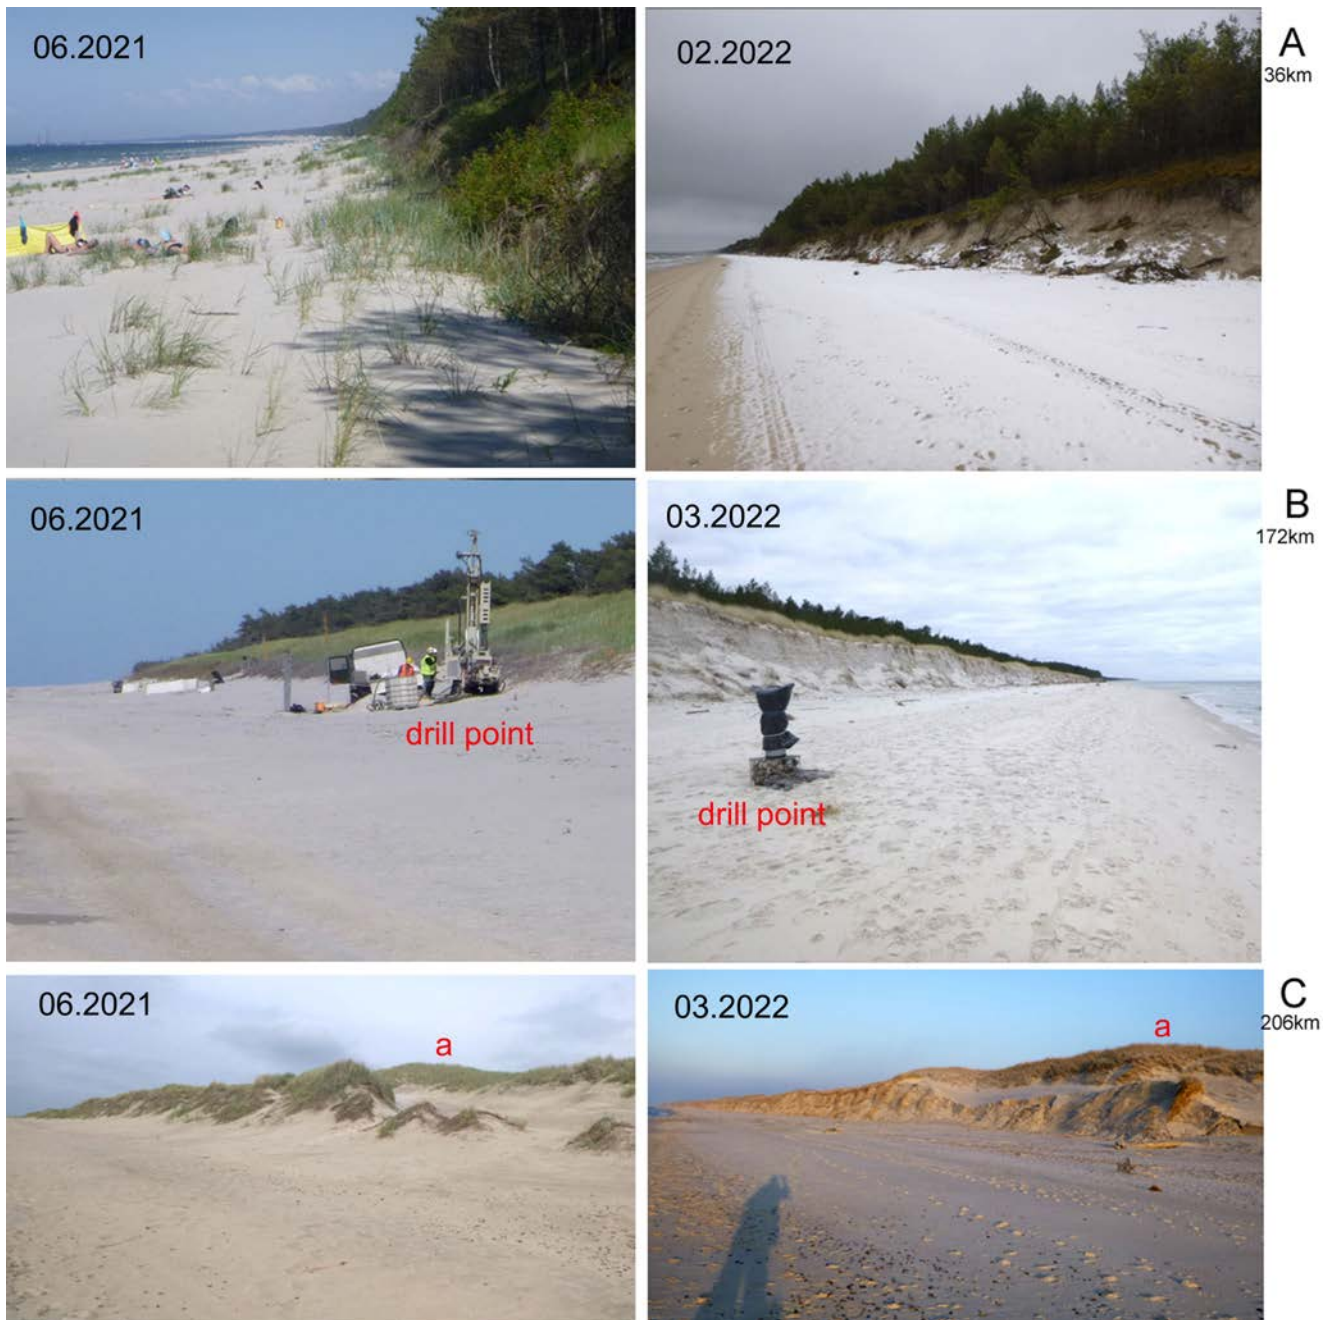
Fig. 14. Examples of average dune retreat after Nadine surge in January 2022 on the East coast. A – the erosion of embryo dune, small foredune and 3–6 m retreat of a high dune, Vistula Sandbar, km 30. B – 6 m retreat of foredune on the Kashubian Sandbar, km 172, visible retreat in place of geological drilling for the future location of the nuclear power plant. C – washed out foredune of 8–10 m width on the Lebsko Lake Sandbar, km 206, a – the same dune peak.
