THE TEMPLE OF EPICURIOUS APOLLO AT BASSAE: PRESERVE THE STONE OR UNCOVER ITS TRUE NATURE?

KAPADOUKAKI Eva¹ SOUMAS Michail¹

¹ MA Architecture National Technical University of Athens 2017; e.kapadoukaki@gmail.com
<https://orcid.org/0000-0003-2345-7655>

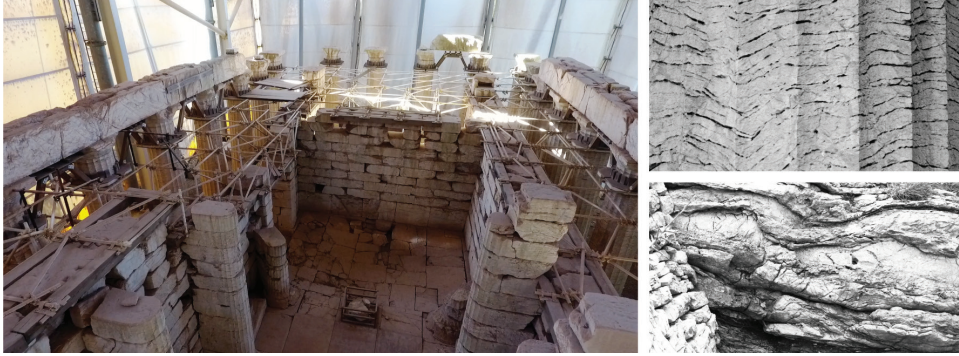
Fig. 2 Deterioration Modes of the Stone (personal archive of the authors, 2017)

The temple, being isolated in the mountainous landscape, has managed to finally be one of the best-preserved structures of Antiquity in terms of the amount of original material (60%) that remains in situ, undergone no intervention until the 20th century. It is built mostly of local sedimentary limestone (Maastrichtian), originating from the rock formation in the immediate vicinity of the monument. The stone, set in the high altitude of 1130m a.s.l., suffers severe deterioration mainly due to frost in the winter and large diurnal temperature width in autumn-spring (8-0°C, humidity 80-100%, summer 20°C-humidity 60-30%, generally NW or NE winds). The numerous discontinuities, weak planes or superimposed weak veins facilitate ingress of rainwater (CO₂ included) within the pores and external mechanical stresses such as earthquakes have a shear effect whenever discontinuities run parallel to the exposed surface. The result is a capillary cracking pattern, gradually widening and ending up in detachment of flat pieces (Theoulakis, 1995). Today's conservation-restoration works combine stabilising clay mixture, pozzolanic cement grout and lead sheets (C.C.T.A.E., Papadopoulos, 2015).

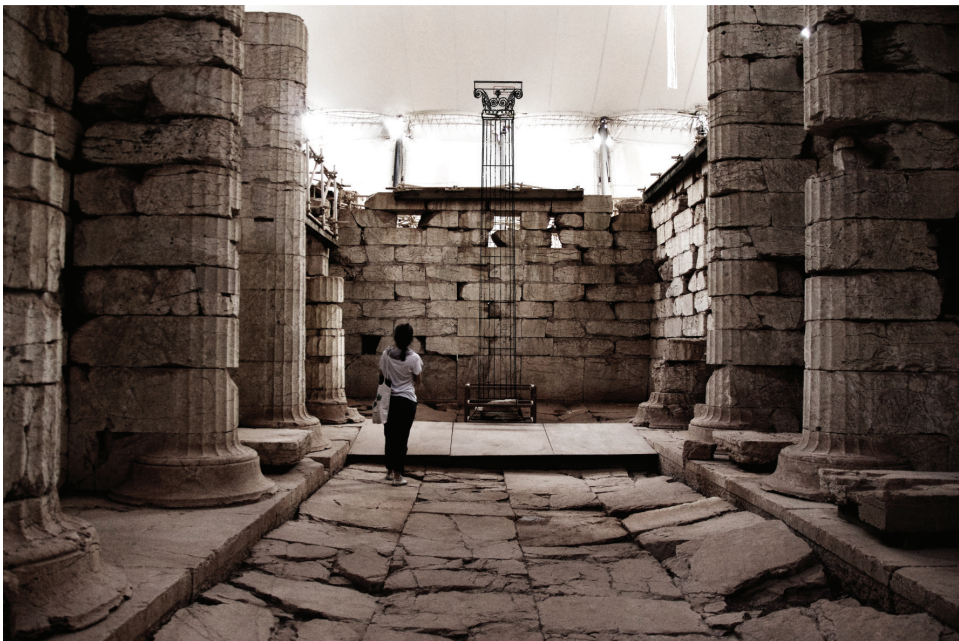
Fig. 3 The Materiality of the Temple, Cella (Kapadoukaki E., Soumas M., 2017)

The contemporary synthetic PVC canopy levels out the temperature fluctuations (+1-2oC) but has a serious misleading effect upon the building's features. The temple's colour as seen in open-air conditions has a wide tone variety from grey to orange and violet, even with deep blue shadows (F.A. Cooper, 1996) meant to stay naked, without stucco or paint. While today's scattered parts of the temple on site are decolorised by white spots due to the microfauna, the standing parts of the temple undergo a very different discoloration. The shelter filters the sunlight, applying a yellowish shade on the original grey stone, giving an extremely false impression to the visitor, while the new stone supplements, which are used for the conservation-restoration, are whiter.

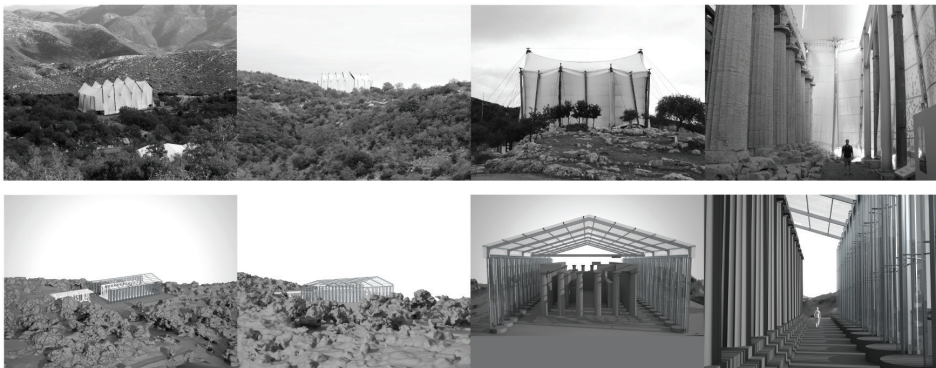
Fig. 8 Comparison of Current and Proposed Shelter, Critical Views (Kapadoukaki E., Soumas M., 2017)

The present dilemma is that of keeping the temple covered destroying its connection with the stone ridge, or letting it stand visible in its landscape conserving its integrity as a whole artifact. The current management plan stands weak as there has been no alternative suggestion since 1987, supporting the “temple-canopy differentiated image” concept. Regarding the authors’ proposal for a new shelter, the selection of transparent material for keeping the temple visible is considered necessary. While side covering isn’t critical for temperature balancing, the short flanks of the temple can and should have their original visual contact with the ridge. As the temple’s plan is open and inviting but also sets a limit as the eye slips between the column shafts and tries to enter the cella, the proposed superstructure is offering a similar filtered view macroscopically, modifying the circular column plan into a hollow semi-circle. It’s hollow in order to accommodate each of the full-height columns during their conservation-restoration (current restoration methodology, C.C.T.A.E., Papadopoulos, 2015). This way not only they are respectively placed to their relative position helping the observer to visually reform the temple, but also one can examine each column as an independent sculptural unit. Vertical blade-like beams assemble together the long stripes of glass, as an abstract reference to the flutings. Furthermore, the overhead crane for the temple’s parts relocation is integrated fully into the shelter’s structure.
