ANALYSIS OF ROAD SAFETY IN THE CONTEXT OF HORIZONTAL VISIBILITY WITHIN INTERSECTIONS – FIELD STUDIES

Abstract: One of the important factors on which road safety depends is adequate visibility. This article analyses horizontal visibility within road intersections. The visibility condition depends on many factors, primarily on the geometric parameters of road elements and the location of buildings, fences, vegetation etc., neighboring the road. The aim of the research presented in the study was to determine the current condition of horizontal visibility, on the example of twenty two intersections located mostly in built-up rural area along a provincial road near Czestochowa. The research was carried out by two methods (the analysis of satellite photographs and the visual method) and the obtained results were compared. The assessment of the security level was based on applicable regulations and technical guidelines. It was found that the results of the visibility assessment based only on the analysis of maps and satellite photographs are in many cases overestimated, due to the fact that many small elements not visible in the photographs are not taken into account and the occurrence o

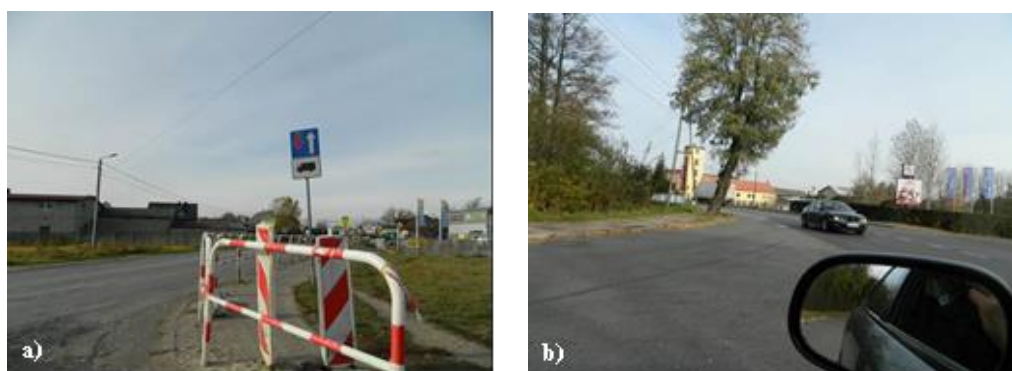
During the research, photographs were taken, based on which the examples below illustrate the actual visibility conditions within the analyzed road. An example of visibility being limited by the sidewalk barrier is shown in Figure 3a. A sidewalk barrier improves pedestrians' safety by making it difficult for them to enter the road, but at the same time it significantly worsens the drivers'. A driver driving on the subordinate road is in a sitting position and the barrier is at his eye level. In this case, the sidewalk barrier was not identified on satellite photographs, which resulted in a decrease in visibility rating from "4" (method I) to "1"(method II).

Limited visibility caused by the location of the intersection on the inside of the horizontal road arch of the main road is shown in Fig. 3b. Due to too small radius of the arch on the main road, as well as roadside vegetation, it is very difficult to get into the road traffic safely, especially when turning left. In addition, the problem is the high speed of vehicles coming from the left, which, moving "downhill" often exceed the speed limit on this section.

Fig. 3. Limited visibility caused by:

a) a sidewalk barrier, b) location of the intersection on a road arch

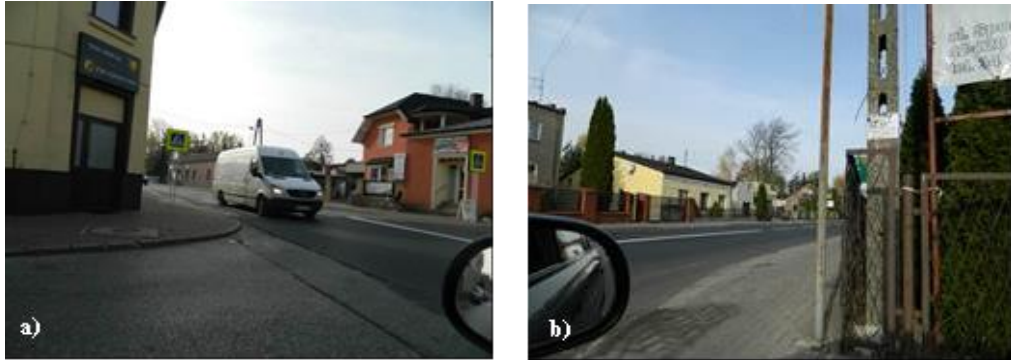
The examples of almost complete lack of visibility caused by a building (Fig. 4a) or a fence, an electricity pole and vegetation (Fig. 4b) adjacent to the road, are shown in Fig. 4. In both cases, an outward-facing arch of the main road is located directly behind the intersection. The examples of visibility limited by a convex vertical road arch are shown in Fig. 5a. An unfavorable longitudinal profile of the road obstructs the field of visibility, which means that the driver must be particularly careful here – fast moving vehicles on the main road (non-built-up area) appear in the field of vision suddenly. Visibility may also be impeded by roads signs and panels and roadside trees (Fig. 5b). Existing roads are mostly located on the track of old unpaved roads and there was no fast traffic of vehicles. These roads were planted with trees, mainly to protect travelers from the sun. Currently, roadside trees located close to the edge

Fig. 4. Limited visibility caused by: a) a building and a road arch, b) a fence and vegetation

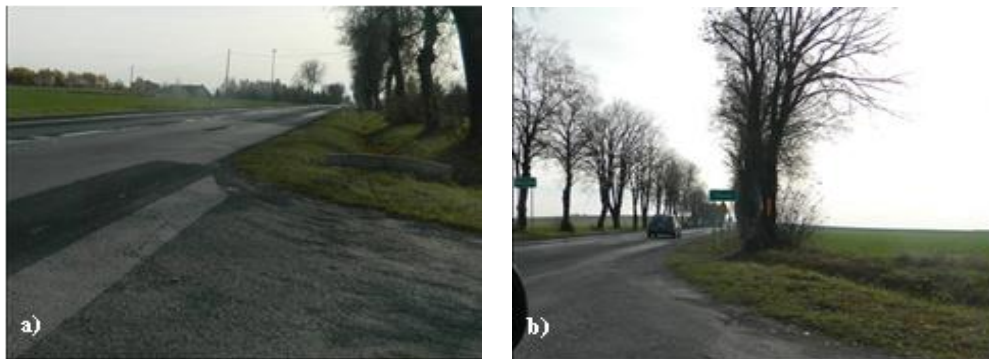
Fig. 5. Limited visibility caused by: a) an unfavorable vertical profile of the main road, b) location of road signs and roadside trees

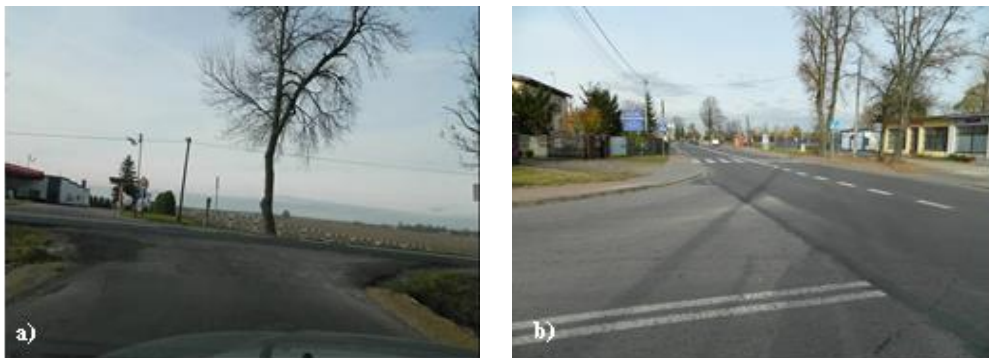
The common example of uneven pavement on a subordinate road within the connection with the main road is shown in Fig. 6a (this is also seen in Fig. 5a). The reasons here are some administrative barriers - the renovation of the municipal road (the new pavement) was brought only to the border of the provincial road lane. There is also no conditional stop line. The described shortcomings do not have a direct impact on a visibility at this intersection, which is correct, but constitute a certain difficulty in the context of comfortable entry into the traffic. An example of a correct field of visibility is shown in Fig. 6b. The lack of obstacles and road curves makes it easier to entry into the traffic.

Fig. 6. Intersections: a) with uneven surfaces, b) with a correct horizontal visibility field
