Fatigue assessment of existing riveted truss bridges: case study

T. SIWOWSKI*

Roads & Bridges Department, Rzeszow University of Technology, 12 Powstańców Warszawy Ave., 35-959 Rzeszów, Poland

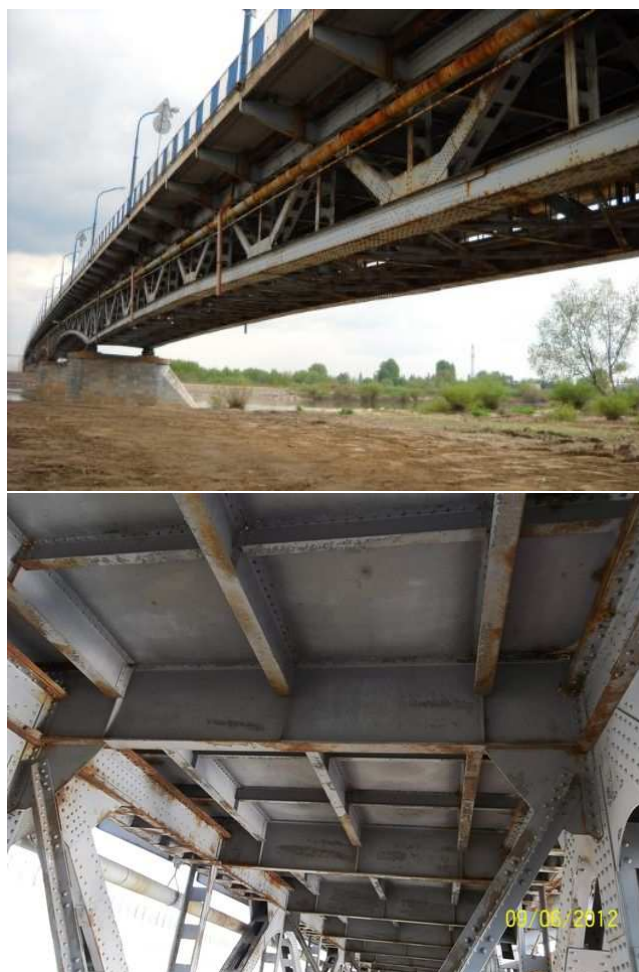
Fig. 1. The existing riveted truss bridge and its deck system

depth from 3.10 m (span) to 5.70 m (support). The girders are braced with the riveted cross-beams on which the deck grid is supported, made up of the longitudinal stringers and the secondary cross-beams. The rolled stringers are locally stiffened with welded ribs and there are the only welded joints in the structural system. The grid is covered with the 10-mm stay-in-place steel pan form connected to the grid with rivets and filled with asphalt concrete. The conventional two-course surface is placed on the deck. The total width of the deck is 6.45 m. The concrete bridge supports are founded on caissons (pillars) and driven wooden piles (abutments).

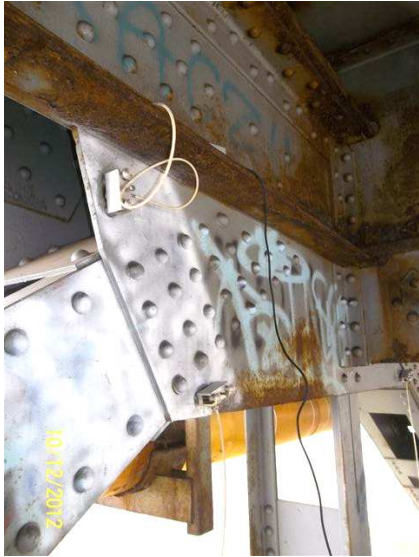
The main goal of the quantitative NDT inspection was to identify “active” cracks propagating under service load and posing a risk to the bridge. Therefore the acoustic emission technique (AE) was chosen as the best method for “active” as well as subsurface cracks (Fig. 7). Since the probability of crack detection increases by loading the examined members with a high but still admissible load on the bridge which results in opening possible cracks, the testing has been carried out under normal traffic on the bridge. The applied method relies on the analysis of acoustic waves generated by active destructive processes that develop in a bridge under service loads [19, 20]. The signals received by the acoustic sensors located on the structure are compared with reference signal database compiled beforehand for specific destructive processes. Thus identified destructive processes are located due to the analysis of differences in time-of-arrival of signals at individual sensors. Identification and location of active destructive processes provides a basis for monitoring which makes it possible to evaluate the technical condition of a bridge. The advantage of the method lies in the fact that it is possible to space sensors in such a way that their measurement ranges cover the whole of the examined bridge structure.

Fig. 7. Acoustic sensors mounted on the gusset plate of the critical diagonal

The intensive AE testing campaign revealed, that a few fatigue microcracks could be initiated in the vicinity of the gusset plates in the truss members [21]. The corrosion destructive processes in riveted connections were also identified as the potential source of microcracks. The signals received by the acoustic sensors indicated that cracks were active only under heavy traffic (lorries). Despite the small number of recorded signals, it is highly probable that fatigue microcracks will propagate in the near future. The most severe destruction was discovered in the members located close to the bridge expansion joints, which are in very bad state of repair. It may constitute a threat when no maintenance measures are implemented on the bridge in next 10 years of required service life.

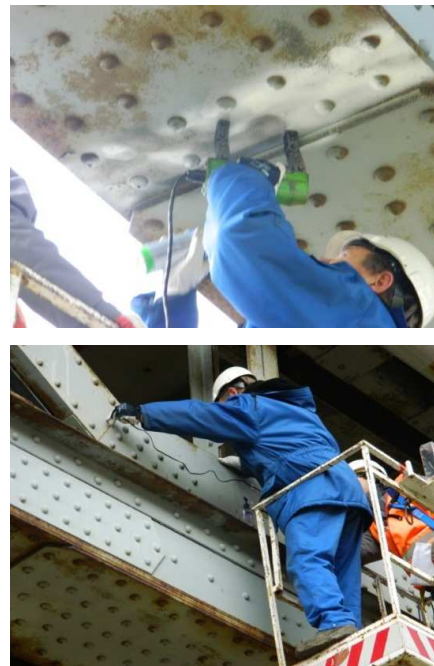
The qualitative NDT inspection of the critical members and cross-sections was carried out by means of magnetic particle inspection (MT) as well as ultrasonic testing (US). The

first method was used to detect any surface cracks of questionable cross-sections. This method is of high accuracy so very small surface cracks can be detected if the surface has been prepared thoroughly. All surfaces under consideration were cleaned with a wire brush. Since the method is not applicable for subsurface damage, the testing extension by means of ultrasonic inspection was required. It is the only method to detect the crack depth and size needed in the prospective fracture mechanics calculation. The commercial ultrasonic equipment with adapted ultrasonic sensors and the oscilloscope was used for inspection (Fig. 8). All hot spots in the rolled sections (stringers) and gusset plates in riveted connections of diagonals were accurately checked against cracks. However, no cracks were found in this comprehensive inspection campaign.

Fig. 8. The qualitative NDT inspection of the critical members and cross-sections
