TEJAS BHATKAR*, ALTAF USMANI*[#], ANIRBAN MANDAL*[#], ATUL NANDA***WEDGE FAILURE ANALYSIS AND REMEDIAL MEASURES IN LARGE UNLINED
ROCK CAVERN: A CASE STUDY****ANALIZA PĘKNIĘCIA KLINA W DUŻEJ, NIEOBUDOWANEJ KOMORZE SKALNEJ
ORAZ PODJĘTE KROKI NAPRAWCZE: STUDIUM PRZYPADKU**

This article presents a case study of a large wedge failure. It took place during excavation of the last bench of storage cavern with an approximate dimension of 80 m long having a depth of 8 m. The adopted intervention followed a structured approach, which included immediate rock support, geotechnical and geological investigations in the failure zone and design modifications. Back analyses of the failure zone were also carried out to assess design parameters with observed geological conditions. Re assessment in the failure zone was carried out using modified design parameters, which included shorter benches, rock support installation schemes such as longer rock bolts, reinforced ribs of shotcrete and reduced construction advances. Geotechnical monitoring in and around failure zone were carried out for recording any alarming movements in the rock mass. Initially, geotechnical monitoring was carried out in the recen

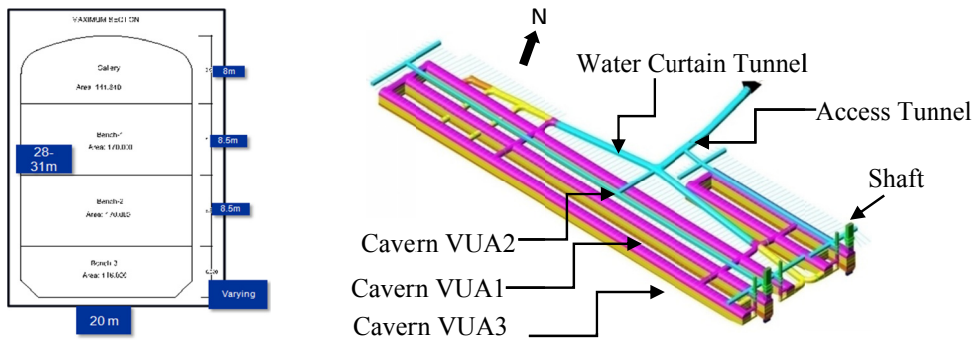
Fig. 1. Schematic layout of the underground storage facility

The rock cavern taken for the present case study is being used as Strategic Crude oil Storage project in east coast of India. The project consist of caverns of U-shaped in plan, D shaped in cross section and are kept parallel to each other. Orientation (trend) of the underground cavern is kept at N70°E. The underground facilities as shown in Fig. 1, essentially consist of access tunnel, main cavern (30 m height, 20 m width and about 840 m length) and water curtain tunnels running parallel to and 20 m above each U shaped cavern with a series of water curtain boreholes drilled perpendicular to it. Excavation of cavern was carried out in different stages (Fig. 1) to reduce the unsupported span thus to increased the stability of excavation (Mandal et al., 2013).

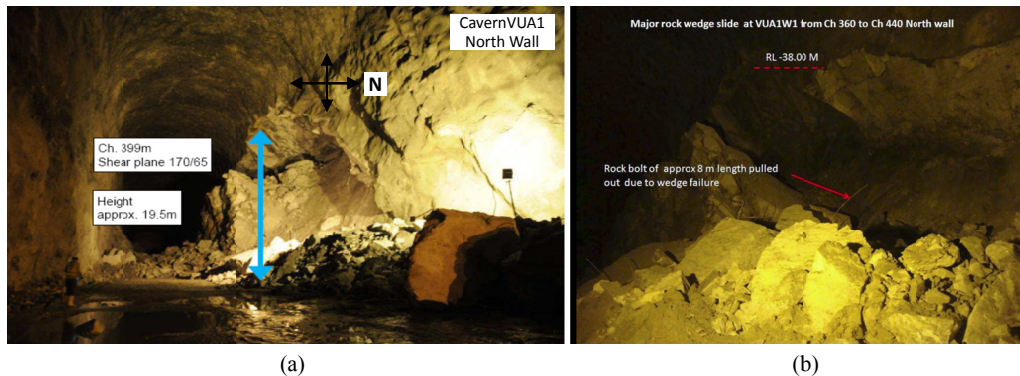
during the construction of one of the cavern (VUA1), a large wedge failure as shown in Figure 2 (a,b) took place. It occurred between the chainage of 360-420 on the northern side wall of the central cavern VUA1 during excavation of the last bench (bench 3) with an approximate dimension of 80 m long with a height of 20 m and extended upto 7-8 m inside the cavern wall. Scaling on the north wall at the said location was completed and mucking operation was on when failure occurred. The rock wedge slide started from the bottom of the top heading (Reduced Level-38.0 m) and continued till the bottom of the third bench (Reduced Level-58.0 m). All the installed steel rock bolts were completely yielded, however the interface of grout was intact as shown in Fig. 2(a,b).

Fig. 2. (a) Wedge failure in VUA1 cavern as seen from the east looking west (b) Yielded rock bolt

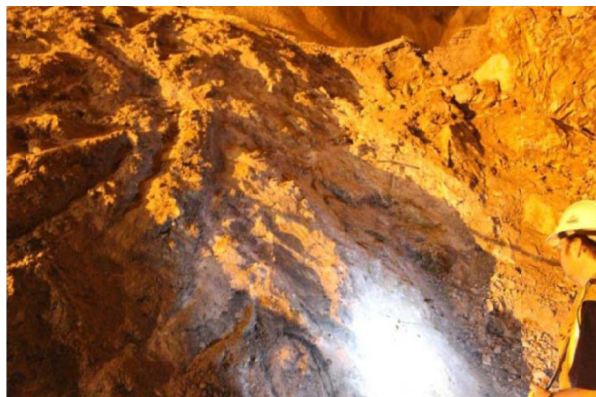
During site inspection of the wedge failure, it appeared that one of the shear failure planes (Fig. 3) found during the course of investigations, intersected north wall of cavern VUA1, causing

Fig. 3. Shear zone exposed after failure

significant impact on the wall stability resulting in wedge failure. This shear plane had although crossed the cavern earlier at different chainage, on both north and south wall sides, did not cause any damage. It further continued sub parallel to north wall for a longer distance before dipping towards cavern north wall. The dip was observed to be about 75 degrees and the shear appeared to run about 20 m beyond the wall at heading level which moved closer and hit closely bench 3 of the north wall. It was observed that during excavation of the 3rd bench, the toe of the wedge on which the shear plane was resting, got removed and thus got destabilized leading to a major wedge failure.

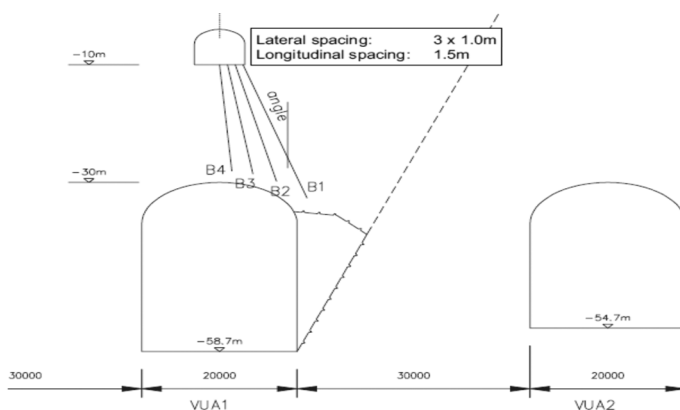
Fig. 4. Rock support from water curtain tunnel located over the affected zone

Eight numbers of core drilling from Cavern VUA2 south wall through the pillar to Cavern VUA1 north wall was done to establish reason that could have triggered wedge failure and to ascertain other comparable features that could be encountered or not in the remaining excavation portion of VUA1 bench 3 region. Since after the wedge failure, there was also concern about the stability of roof, additional rock support in form of anchor rock bolts from the water curtain tunnel as shown in Figure 4 (B₁, B₂, B₃, B₄) into the cavern crown was installed to provide additional lateral confinement stress to the rock arch above the cavern crown. This was also intended to provide adequate safety for the man and machine that would be deployed for undertaking final

remedial rock support inside the cavern. Access ramp in VUA1 failure zone was built up to reach to the top of the failure wedge for installation of permanent rock support. Some additional optical targets were also installed in this zone.

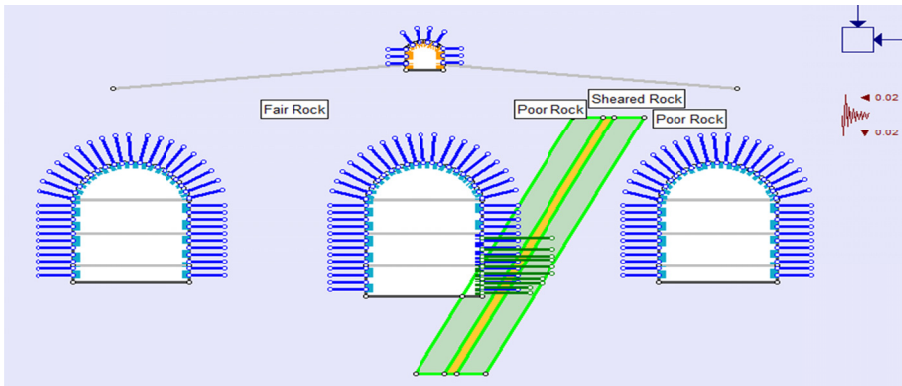
This section represents section just before the failure zone and thus stability of this zone was re-assessed following revised rock mass assessments arising due to sheared zone. Model for Chainage 360, representing revised rock mass conditions is shown in Figure 5. Model shows three cavern units VUA1 in the centre and VUA2 & VUA3 on either side.

Fig. 5. Model representing Chainage 360, post failure condition

Initial rock support for benches was applied in terms of grouted rock bolts and Steel fibre reinforced shotcrete (SFRS) on cavern wall and heading. Fully grouted rock bolts (applied normal to the excavated boundary face) of 25 mm diameter and minimum yield strength of 500 MPa along with SFRS of minimum compressive strength of 40 MPa and shear strength of 1 MPa were

used in model. Rock-bolt lengths measuring 5-6 m long in the crown and walls at an average spacing of 2.0/1.5/1 m in good/fair/poor rocks were typically provided based on rock-support chart recommendations using the Q-system of Barton (2002). Steel SFRS was applied in thicknesses of 50 mm as per the encountered rock classes.

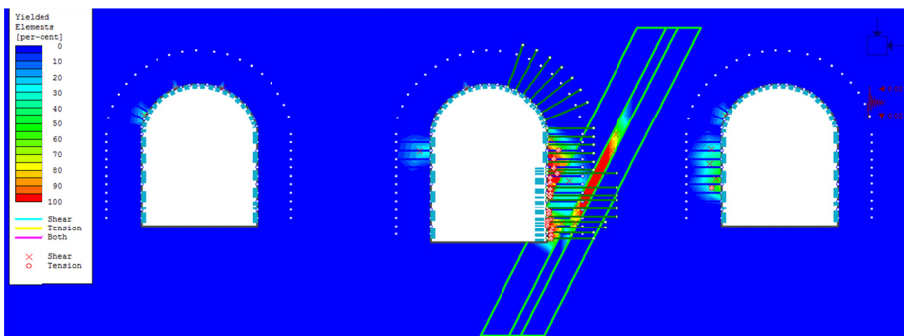
During analysis, it was observed that rock bolts installed earlier (25 mm diameter and 6 m length) in Bench 2 and 3 were found to be fully stressed to their ultimate capacities and yielding was observed to be extending beyond rock bolt length (5/6 m) as shown in Figure 6. Based on these findings and owing to encountered poor/sheared rock conditions, strengthening of rock mass around Bench 2 & 3 was carried out using 32 mm diameter rock bolts with lengths varying between 8-12 metres, as shown in Figure 6.

Fig. 6. Yielded zones around Bench 2 and 3, post failure condition

These additional long bolts served dual purpose of stabilizing the yielded zone as well as stitching the poor rock mass around the cavern north walls. Maximum displacement around the walls was estimated to be around 15 mm, well within the permissible limit of allowable displacement of 0.1 % of cavern height (Zhao & Cai, 2010). As part of the geotechnical monitoring car-

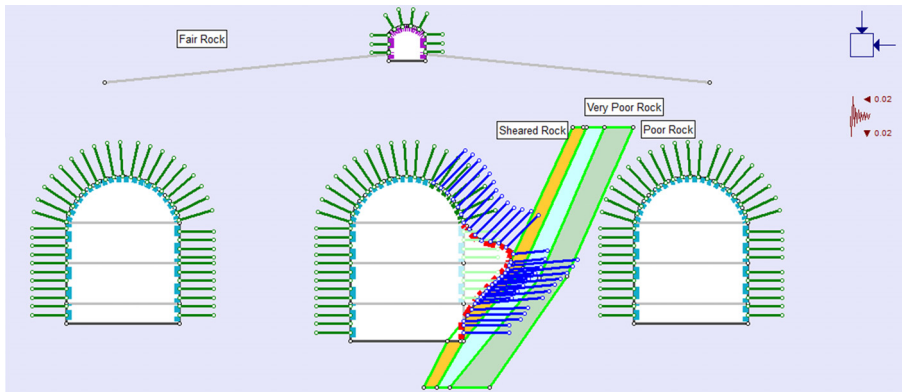
This section as shown in Figure 7 represents actual failure zone and thus revised model was developed as per the actual failure zone geometry and encountered poor rock conditions around walls for VUA1 cavern.

Fig. 7. Model representing Chainage 400, post failure condition

Since at the time of failure, bench 3 was incomplete and big wedge on north wall collapsed while taking a blast in Bench 3, these two sections (Bench 3 and additional wedge area) were excavated together in this model to study post failure stability conditions. As part of this revised model, initial rock supports in the failure zone were completely removed owing to part of the failed rock mass and revised rock supports in reference to poor and sheared rock conditions were applied. Based on the revised analysis, long grouted rock bolts of diameter 32 mm and lengths varying from 10 to 12 m along with 250 mm SFRS and additionally a vertical SFRS columns (width \times depth = 650 \times 400 mm) were sprayed additionally over the initial thickness of SFRS. This SFRS column was modelled as rock support liner with higher modulus values compared to previous SFRS layer. Zone of shear, poor rock and very poor rock were modelled around the caverns as per the results of cored investigation holes as shown in Figure 7.

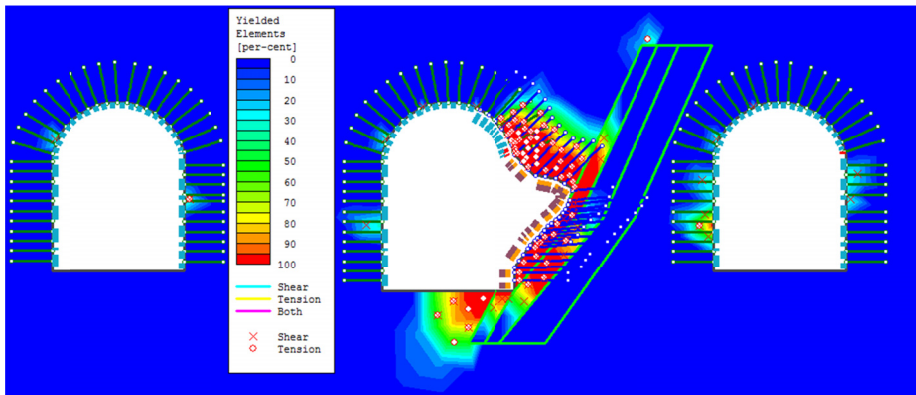
It was observed from the analysis that revised support system installed in terms of long rock bolts and Steel fibre reinforced shotcrete (SFRS) were able to take up additional stresses build up on account of sheared rock mass conditions around the failure zone. Most of the yielding observed (Fig. 8) was confined to zone of around 4-5 m from excavated cavern boundaries. Stress levels around the cavern, and in particular above the failure zone, were moderate and in acceptable limits. The overall total displacements are relatively small and in the range of 15-20 mm which was well within acceptable limit of 0.1% of cavern dimension.

Fig. 8. Yielded zones around north sidewall, post failure condition

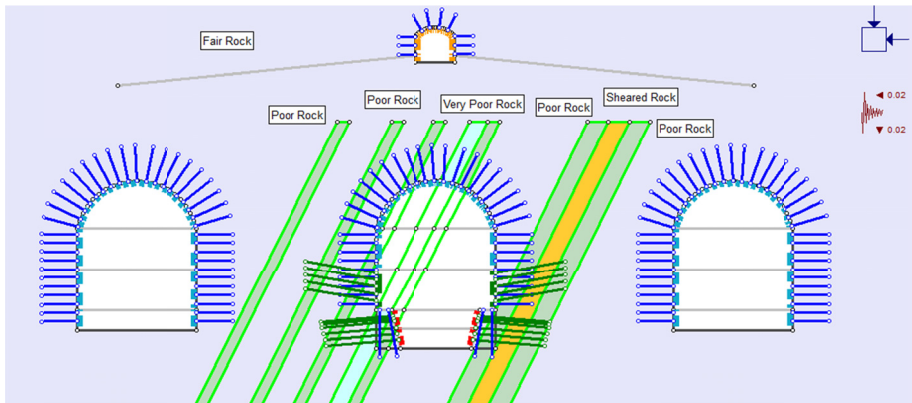
Thus referring to the stereo plot of the zone, slope of the third bench was restricted to 45 degrees. Model of this section as shown in Figure 9 indicates third benches with side slashing (top width of 2.5 m) intact for presence of shear zone on either side.

Fig. 9. Model representing Chainage 560, post failure condition

Rock support installed in the revised model included 32 mm diameter rock bolt of length varying from 10 to 12 m with a spacing of 1.5 m c/c along with steel fibre reinforced shotcrete (SFRS) of thickness 250 mm with one layer of wire mesh, as well as additional column of SFRS (650 mm width, 400 mm depth, spacing 2-2.4 m c/c fully extended over bench 2 side wall height. Further additionally, 8 m long spiling rock bolts of 25 mm diameter were also provided for protection of left-in place bench 3 side slashing.

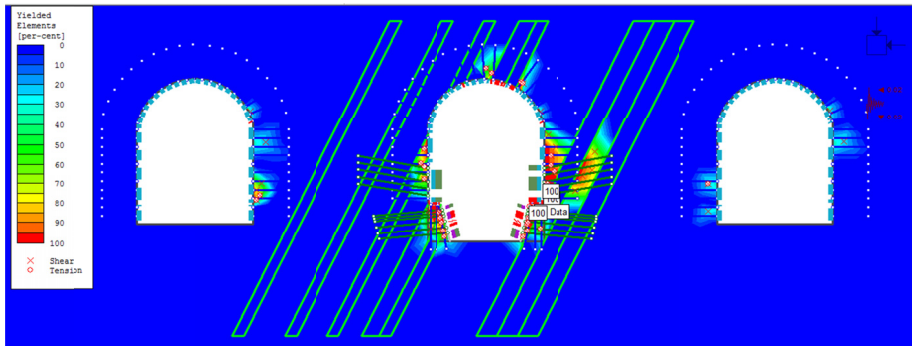
The results indicated that along the side walls, yielding were mostly concentrated in the intact bench part with some fractions also observed near Bench 2 (Fig. 10). Yielding coupled with some stressing of the earlier rock bolts led to installation of additional rock bolts of 32 mm diameter and 10-12 m lengths in this zone for both northern as well as the southern side wall.

Fig. 10. Yielded zones around north & south side wall, post failure condition
