Protection of settlements from floods and debris flow on the example of tragedy in Tbilisi on 13-14 June of 2015

Abstract. This article presents material about the flood on the Vere River on 13-14 June, 2015. It caused significant economic and ecological damage to the country, and there were also human victims. The reasons for the ecological disaster are evaluated and appropriate hydrological calculations have been carried out. It has been particularly established that the predictable (forecasting) maximal discharges of 0,1% value for Vere River is 520 m³/sec and not 410 m³/sec, that was calculated water conduct tunnels in the entrance of city before the Mtkvari River.

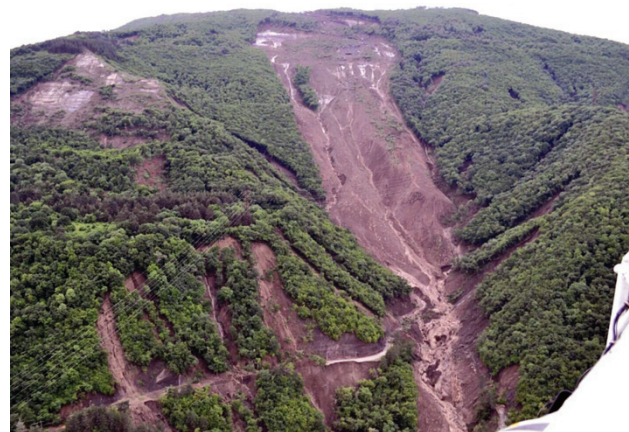
Fig. 2. General view of a landslide formed on the vulnerable slope of the Jokhoniskkevi River, right tributary of the Vere River (photography by Robert Diakonidze)

the formation of a landslide on the vulnerable slope of the Jokhoniskhevi River, temporary outlets of infiltrated water present on the slope surface are clearly visible (see Fig. 2).

In our opinion, one of the reasons for the landslide development in the Akhaldabiskhevi and Jokhaniskhevi Rivers (there are many potential landslide centers in the region), in addition to many other factors, is the motorway, clearly a manmade structure. The mass of landslide and debris flow amounted to approximately 1 million m^3 .

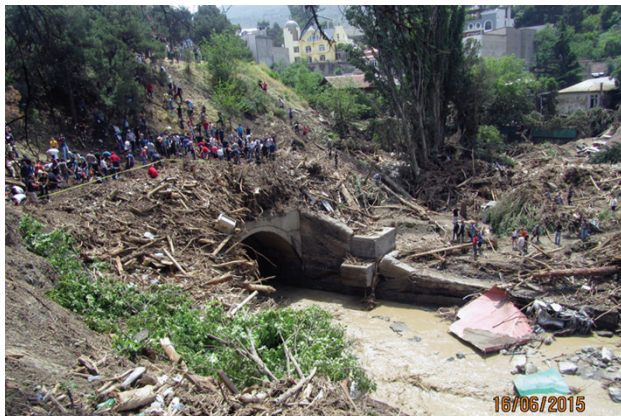
Fig. 3. Oval tunnel positioned under the Vake-Saburtalo motorway and the place of flooding (photography by Robert Diakonidze)

It is already known that the Vere River, after flooding in Tbilisi territory, first rushed through the bridge-tunnel (length 126 m) that connects two neighbouring districts (Vake and Saburtalo), and then, before joining the Mtkvari River, it flew into a closed water tunnel. The distance from the confluence to the first bridge-tunnel is 4,8 km. The water permeability of the first bridge-tunnel, according materials in the project framework, is intended for 460 m^3/sec water transfer, and the closed tunnel located after the above tunnels is intended for 410 m^3/sec (Kereselidze et al. 2015).

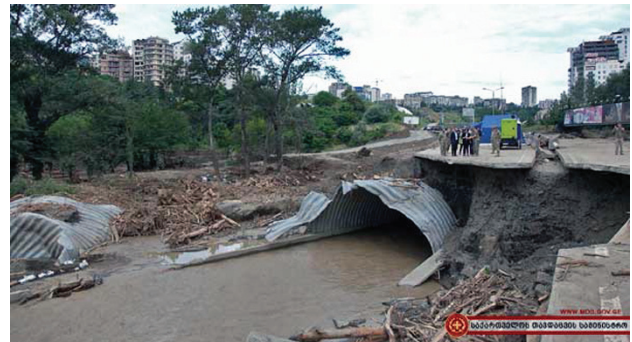
Fig. 4. Newly built tunnel broken by water flow (photography by Robert Diakonidze)

- In urban settlements it is inappropriate to build a closed type of water permeable construction (in this case – tunnels); if it is necessary to build such constructions due to specific geographical conditions, the strict requirements of first class construction should be considered.

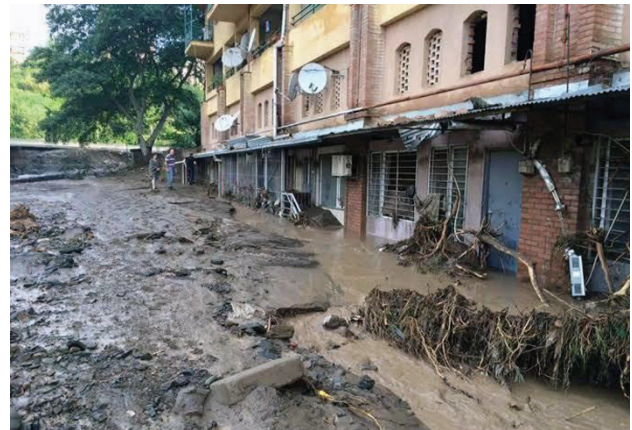
Fig. 5. Flooded settlement territory as a result of broken newly built tunnel (photography by Robert Diakonidze)

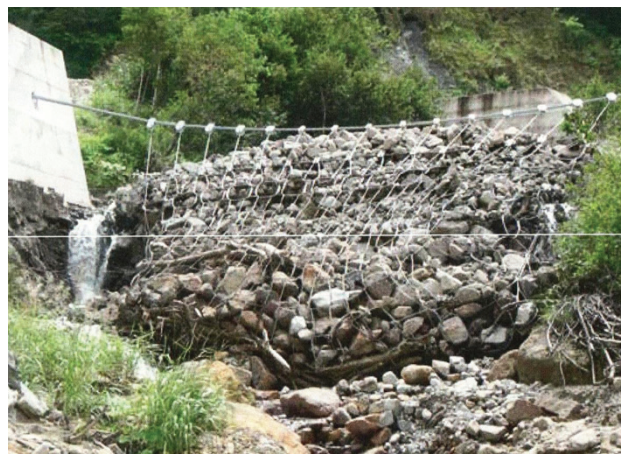
- To avoiding such tragedies as occurred in Tbilisi and to protect similar geographical environments from floods and mud flow we recommend installing a lattice-like structure to serve as a sediment trap; the first prototype of this was developed in the Georgian Scientific Research Institute of Hydraulic Engineering and Reclamation (now the Tsoetne Mirtskhulava Water Management Institute of the Georgian Technical University), and has been developed into its modern version by the Swiss firm Geobrug (Fig. 6).

Fig. 6. Construction of lattice type metal networked sediment trap

The proposed premise has many positive aspects: it will save resources, offer high performance and multiple operational ability.
