Retrieval activities on the Franken shipwreck

Benedykt Hac

Maritime Institute in Gdańsk, Operational Oceanography Department, Poland

Abstract: On April 23-28, 2018, an expedition was carried out to the German tanker FRANKEN, located in the central part of the Gdańsk Bay. The purpose of this expedition was to gather as many photos, videos and information as possible, which after processing could be used to produce a coherent, technical description of the wreck. The main purpose of the project is to present the outcome of the expedition. This outcome is a compilation of the measurement data, photographic material as well as samples collected at the sea bottom, next to the Franken wreck, according to the objective set out in the project. The analysis of activities carried out and the research results are intended to contribute to achieving the two main objectives of the project: • to reduce the possibility of an ecological disaster in the Gdańsk Bay through the development and preparation of the best technical and environmentally safe recovery plan of the oil remaining in the Franken shipwreck and, • to mobilize the political will of the maritime administration in the region, where

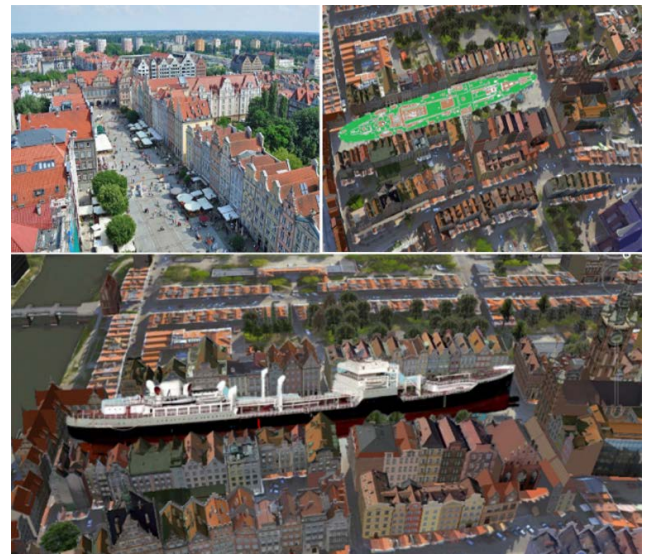
Fig2. T/S FRANKEN – View of the Długi Targ in Gdańsk, projection of the decks (below T/S FRANKEN on the square in Długi Targ in Gdańsk (B. Hac/ Google Earth).

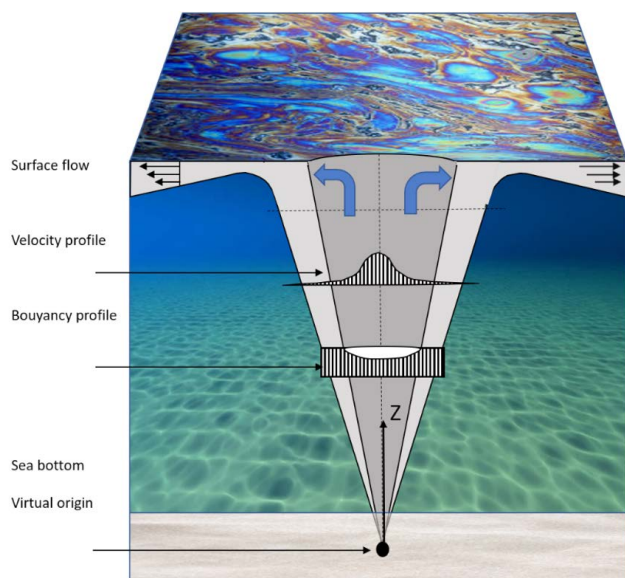
Fig 4. Distribution of oil spills from the wreck.

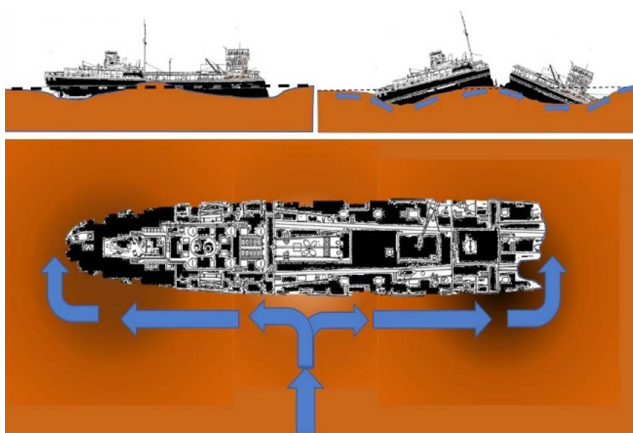
Fig 7. An example of how the wreck is destroyed by strong currents washing out the hull (source: own information).

The analysis of wreck sonograms indicates that its present state is bad. The stern is heavily destroyed and is slowly sinking into the bottom, as a result of being covered by underwater dunes created by water currents around the underwater objects found at the sea bottom in this part of the Gdańsk Bay. Wrecks are most often destroyed by long-term stay at the sea bottom in the area of strong bottom currents, which cause very strong movements of bottom sediments, composed of sand and small gravel, that wash out around the hull. In consequence, natural decomposition of the wreck is caused by collapsing and covering by sand. The process of natural decomposition of wrecks at the sea bottom is shown on the photographs (Figure 7 and Figure 8).

Sediments washed away from the considerably heavy bow section (the weight of the Franken might amount to approx. 8,000 tons) cause very strong tensions resulting in breakage of the hull. Further washing away of the bottom below the stern section creates tensions leading to further breaks in the hull and a total collapse of the wreck

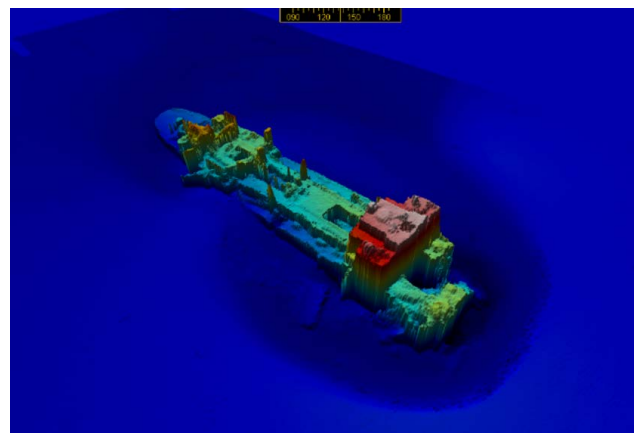
Fig 8. Distribution of the depth around the Franken wreck, visualization of data obtained by MBES (source: own information).

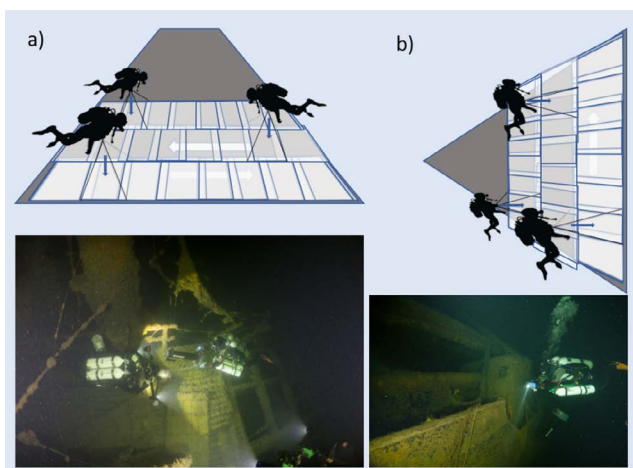
Fig 9. A scheme for photographing the mosaic of the main deck. The photographer should move along the profiles, so that subsequent strips overlap (source: 2018 expedition).

1. Executing photographic documentation for the film.
2. Executing photographic documentation for a documentary mosaic (Figure 9).
3. Inspecting the part of the wreck with tanks.
4. Placing containers for oil sampling.

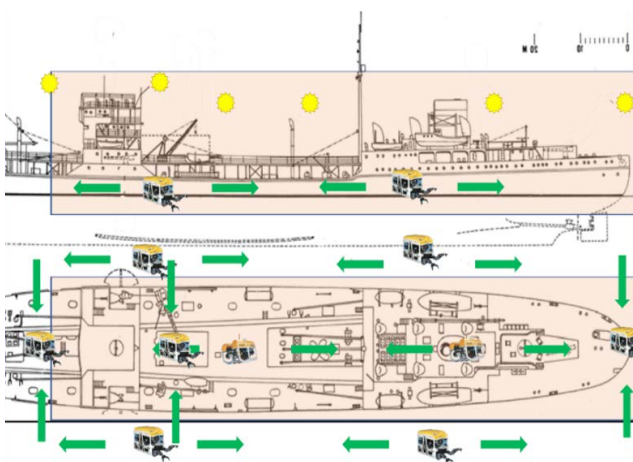
Fig10. Documentation scheme of the Franken using an acoustic camera (own source).

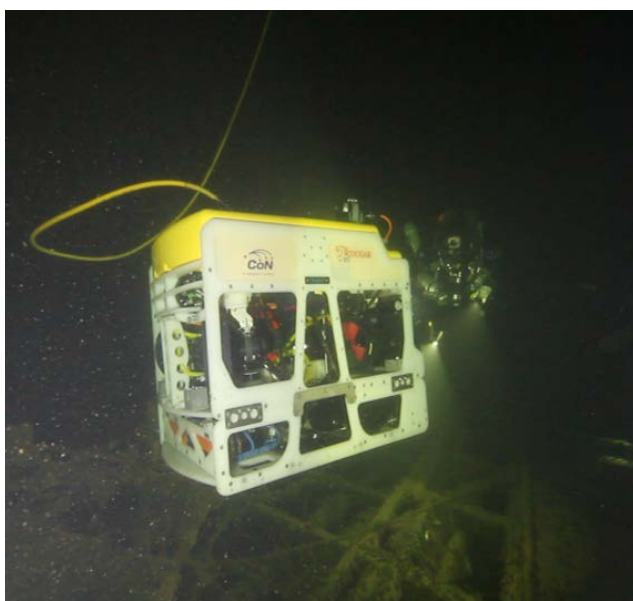
Fig11. Work class ROV Cougar XT (source: 2018 expedition, © S. Pačko).
