# EVALUATION OF FAILURE FREQUENCY AND WATER LOSSES IN MUNICIPAL WATER SUPPLY NETWORK ON THE EXAMPLE OF Z CITY IN THE YEARS 2012-2017

**Summary:** In 2017, the analysed enterprise ZPWik (Zabrzeńskie Enterprise of Water Supply Network and Sewage System) operated the water supply network of 486.3 km length, constructed mainly (in 76.3%) from PE-DH (polyethylene of high density). The age of as much as 85% of the network is up to 20 years old. The most of failures in water supply network is caused by a corrosion of steel pipelines and the conducted constructional work. It is followed from the studies that the failure frequency is systematically decreasing: from 2.33 failures/km in 2012, to 1.76 failures /km in 2017. The majority of the occurring failures are removed during up to 8 hours but we may observe that since 2015, the number of more difficult failures, being removed during longer period than 13 hours, has been successively increased.

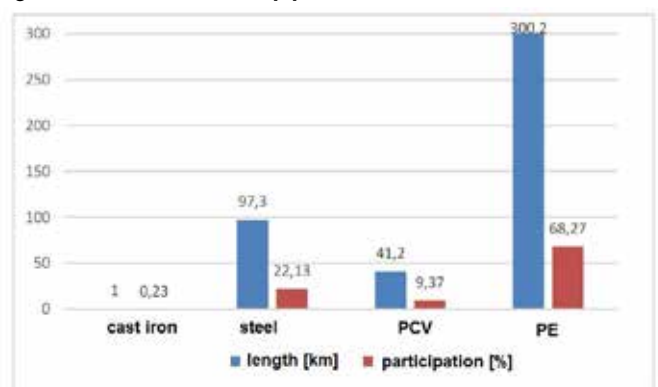
Fig. 1. Material structure of pipelines in 2012

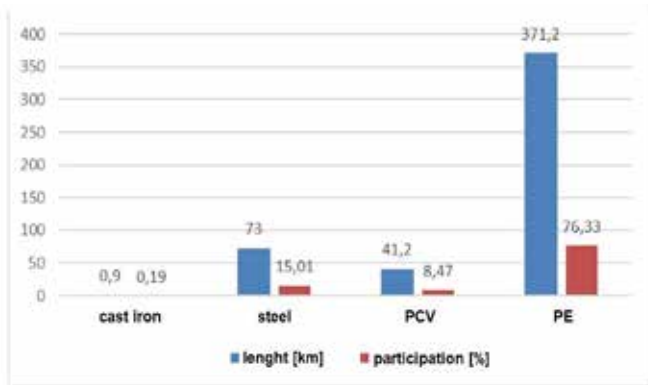
**Fig. 2. Material structure of pipelines in 2017**

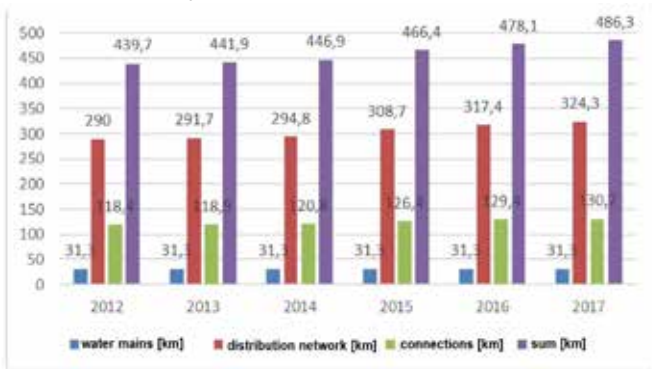
**Fig. 4. The length of the water supply network with the division into the share of the water mains, distribution network and the connections in the years 2012-2017**

In the paper, the range of diameters for water supply connections from  $d=25$  mm to  $d=80$  mm was adopted. The range of diameters from 90 mm to 400 mm will be referred to distributing networks and above  $d=400$  mm, we speak about the water main. As it has been shown in Fig.4, the length of distribution networks in the city

is systematically increasing and consequently, the length of the connections. It is connected with the development of the city.

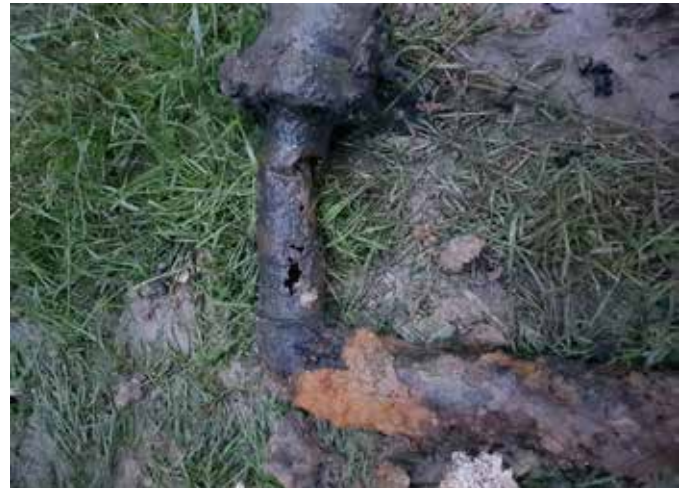
**Fot. 1. Point corrosion of water pipeline connection**

As it can be seen, the most of the failures in water supply networks are caused by corrosion of the pipelines (Fot. 1 – 3). The successive reason for failure occurrence is connected with geological conditions – what can be perfectly seen in Fot.4: how the movements of ground masses have caused the deformation of the

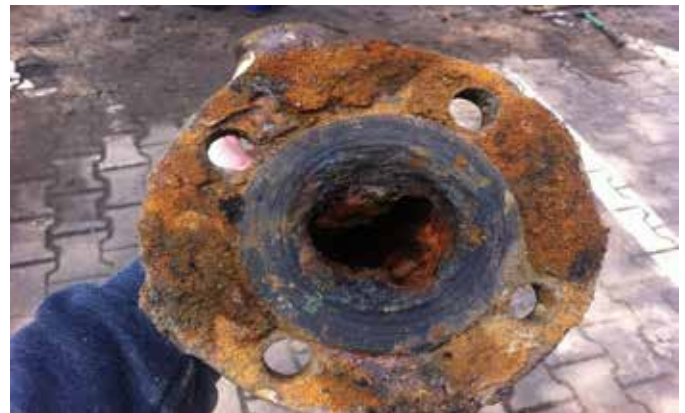
**Fot. 2. Image of corrosion inside the steel pipeline**

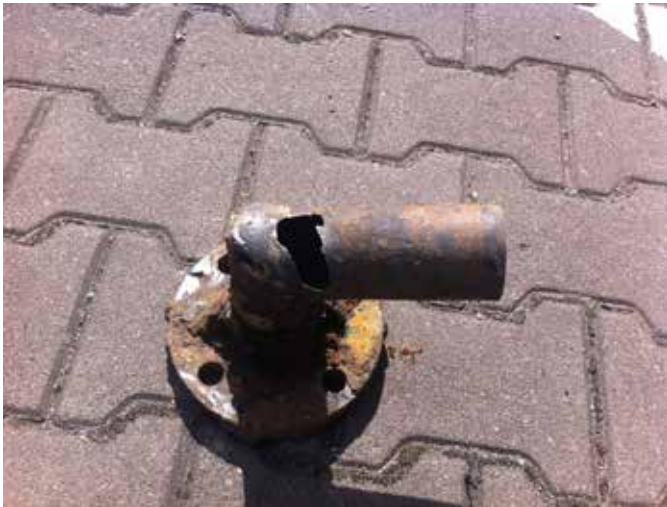
**Fot. 3. Image of point corrosion**

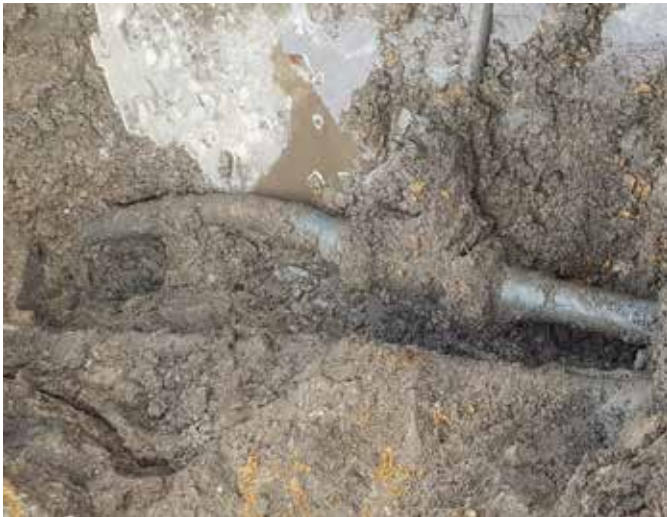
**Fot. 4. Rupture in the area of tee joint in the distribution PVC network**

pipe and, in consequence, damage of pipe socket at the tee. One of the more frequently occurring causes of failure includes damages, generated during the performance of ground work such as drilling, jacking etc. The damage of water supply connection, as illustrated in Fig.5, is a model example of such situation.

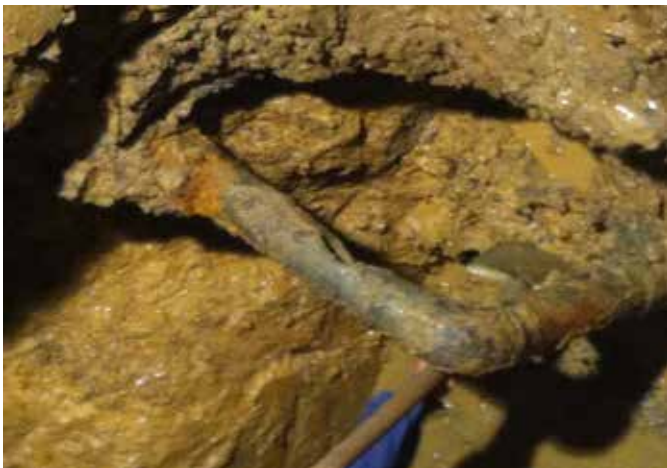
**Fot. 5. Damage of steel connection during performance of jacking**

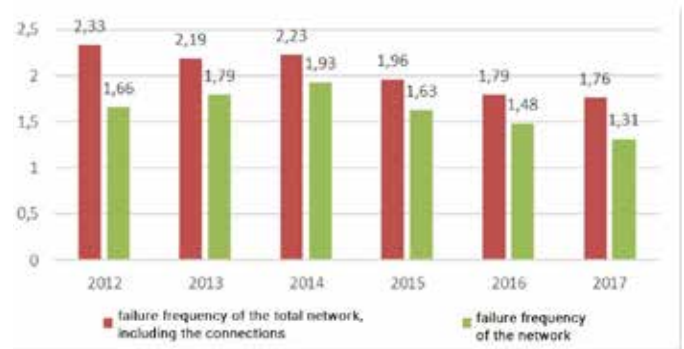
The unitary intensiveness of failures, determining the number of damages per unit of length of the pipeline (most often 1 km) and time unit (most often 1 year) is one of the major indicators of the evaluation of technical state of water supply pipeline network. Fot.5 shows the indicators of the intensiveness of failures. It may be observed that since 2015 until now, the discussed parameter has been decreasing in the networks as well as in connections.

Compared to the indicators given in literature, the analysed network may be classified as being in a very bad technical condition  $> 0.5$  failures /km/year [2]. The index of failure frequency in water supply network of the discussed enterprise, with the connections or without, is high and it would indicate the necessity of undertaking the quick repair measures.

**Fig. 5. Indicators of failure for the whole city [failures/km/year]**

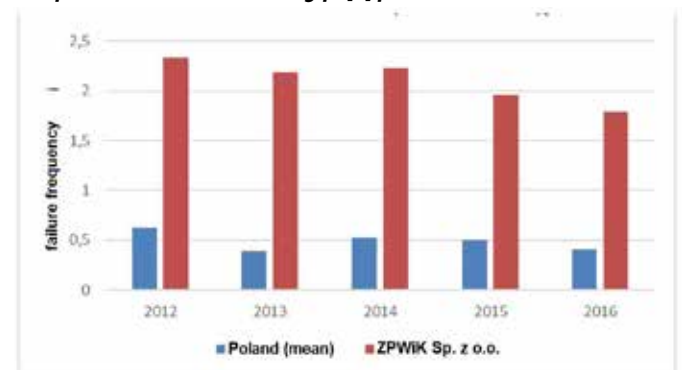
In the light of the data available for water pipeline systems at the territory of the whole country, ZPWik is not “distinguished” in the respect of the current calculated data on the intensity of damages in the water supply network. The data on the failure frequency in the network contained in the Benchmarking 2016 Report, published by IGWP [3] are given in Fig.6.

**Fig. 6. Index of failure frequency in the water supply network – the comparison. Source: IGWP.org.pl [3] plus own data**

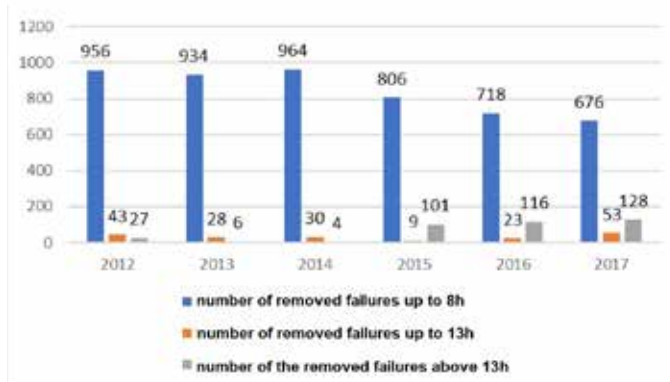
It may be also seen (Fig. 7) that in the years 2015 – 2017, the increase in the number of failures, removed during more than 13 h since the moment of reporting, had place 911-15%). In the case of the discussed enterprise, it is connected with the fact that after the

**Fig. 7. Time of failure removal**

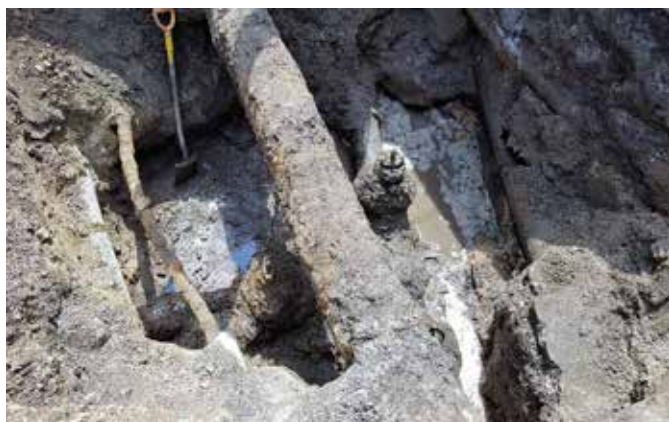
**Fot. 6. Gate tee, prepared to be replaced (over and next to the tee, the pipelines of rain sewage and, also, telecommunication cables in protection tubes are visible)**

period of network infrastructure development, connected with the stage I and stage II of the project for improvement the water and sewage management, the period of more complicated repairs was commenced; it included such operations as replacement of tees, two-port networks and locks in the central part of the city, what is connected with a high complication of work in respect of logistics (development of plan of respective marking during the period of

operations, appropriate reporting to the public administration authorities in connection with occupying the traffic lane) (Fot. 6-8).

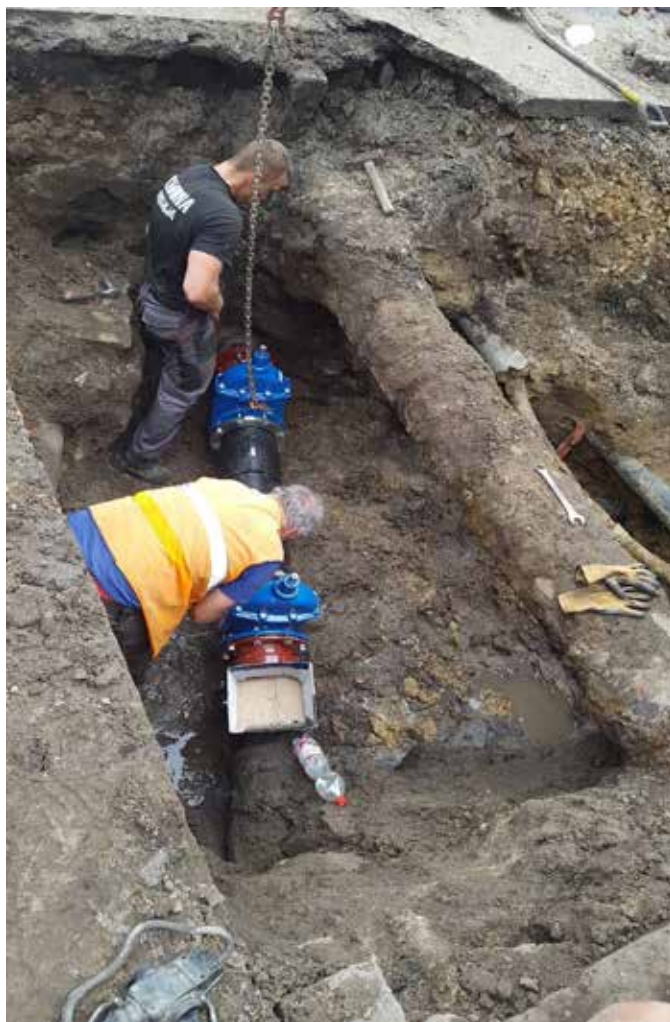
**Fot. 7. The successive stage of gate tee replacement**

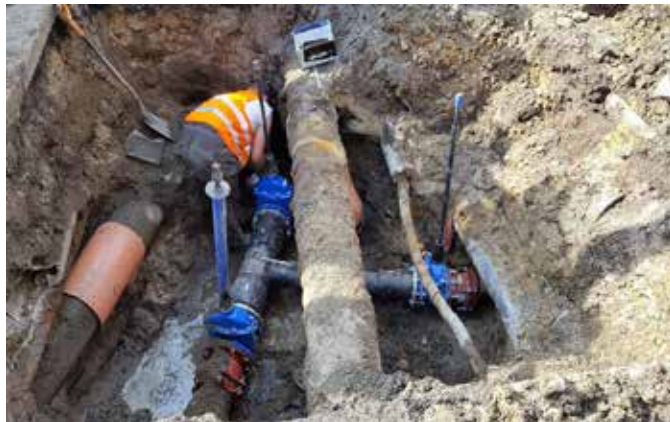
**Fot. 8. The replaced gate tee (before recovery of the correct water flow, the worker visible in the photo, is checking the force of tightening the screws)**

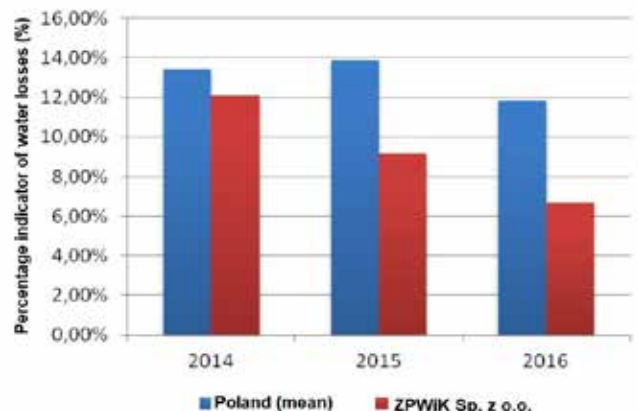
When analyzing the data of water losses at ZPWik and comparing them with the data contained in Benchmarking 2016 Report, published by IGWP (which also contains the references to the mean data of 2014 and 2015) [3], it may be observed that despite the relatively high indicator of network failures, water losses are found on the level below the mean values, indicated in the IGWP report (Fig. 10).

**Fig. 10. The percentage indicator of water losses – comparison of the data: IGWP.org.pl [3] and the own data**
