Research paper

Strengthening of RC slabs against punching shear in theory and practice

Abstract: In the paper the problem of strengthening of flat slabs against punching shear was discussed. Selected methods verified on the basis of experimental tests such as increasing size of the support, applying post-installed shear reinforcement or increasing the main reinforcement by installing additional steel flat bars, were presented. The previous studies demonstrated, that the last method allows for an increase in punching shear resistance of up to 90%, depending on the longitudinal reinforcement ratio. The example of the application of such strengthening technique in the real structure was described. The use of steel flat bars located in the vicinity of the columns and additionally anchored to the slab made possible to compensate for the load capacity deficiencies that occurred due to execution errors (lowering of the main reinforcement within the support zones).

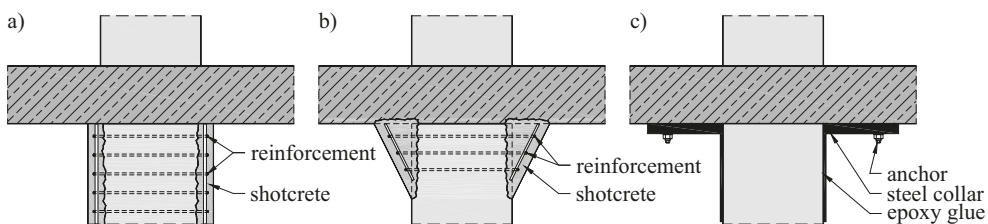
Fig. 1. Methods for increasing the transverse dimensions of columns proposed in paper [9]

The need to strengthen existing slabs may be caused by errors at the design or construction stage. It can result also from a change in use of a building, as well as the occurrence of the accidental actions (e.g., fire) or operating wear resulting from many years of use. One possibility is increasing of the dimensions of the support. This procedure requires access from the bottom surface of slab. The authors of the paper [9] suggest three possibilities of increasing support area, see Figure 1: increasing diameter of column at the whole height of the storey using shotcrete (a), enlarging the column head using shotcrete (b) and using steel supporting structure (c). In the paper [9] the experimental verification of the second method was presented.

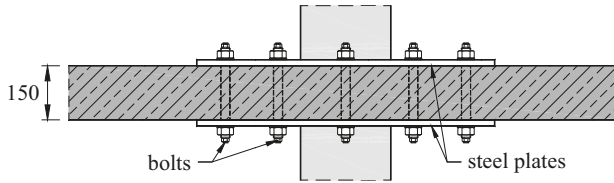
Fig. 2. Cross section of element tested by Ebead and Marzouk [4]

The other possibility of increasing punching shear resistance is described in papers [3, 4]. Effect of this type of strengthening is similar to increasing area of support. In Figure 2 steel plates and bolts used to increase load carrying capacity are presented. The steel plates (6.35 mm thick) were bonded to concrete by epoxy resin and connected by 8÷16 bolts (diameter 19 mm). For the elements, which were strengthened by two steel welded L-shaped plates at each surface, an increase in punching shear capacity of about 50% was observed. Using four separate steel plates resulted in 36% higher load capacity.

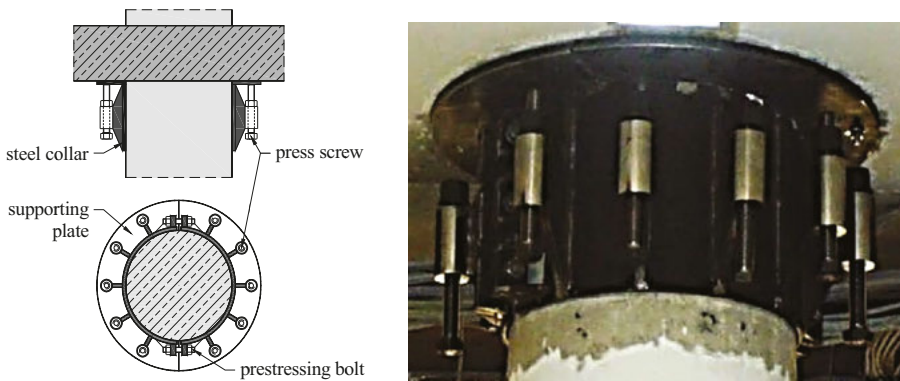
Fig. 3. Strengthening of the support zone applied by Noakowski [12]

Steel collar was used by Noakowski [12] in order to strengthen the flat slab in an office building. Details of the strengthening are shown in Figure 3. The strengthening was realized in the following stages:

- preparing of concrete surface of the column and the slab,
- bonding of steel collar to bottom surface of the slab,
- bonding of steel accessories to column and tightening to column by prestressing bolts,
- installing vertical bolts and tightening them to the steel plates bonded to the slab.

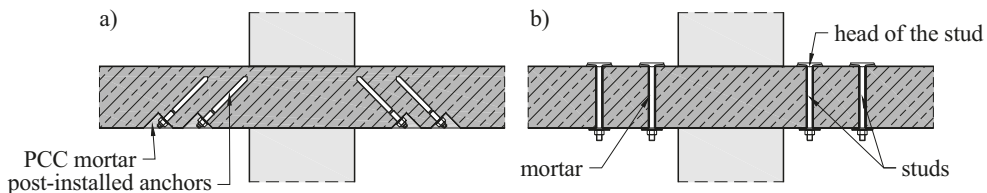
Fig. 4. Strengthening of the punching zone with additional transverse reinforcement, according to [1,9,11]

The other option is to install shear reinforcement in the existing slab. Depending on the method of applying the reinforcement, anchoring can be performed by the adhesive forces (Fig. 4a) or mechanically, by stud's head and nut (Fig. 4b). The authors of the paper [9] were the first who applied this method. In the paper [11] a similar approach (see Fig. 4a) is presented. In case of the slabs with the main reinforcement ratio of 1.5%, a strengthening ratio of about 30÷70% was obtained compared to the element without transverse reinforcement.

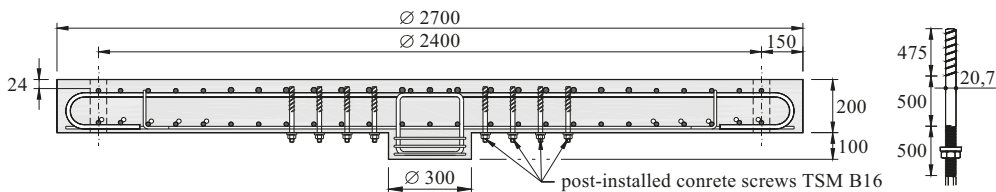
Fig. 5. Cross-section of the slab strengthened with TSM B16 bolts in tests [6]

Feix et al. [6, 19], strengthened 200 mm thick slabs with a reinforcement ratio of $\rho_l = 2.24\%$ (see Fig. 5). By using 32 special threaded bolts, evenly spaced on 8 circumferences, they obtained strengthening ratio $29\div 53\%$, depending on the diameter of the bolts, as well as whether they were screwed directly into the concrete or additionally installed with a special mortar.

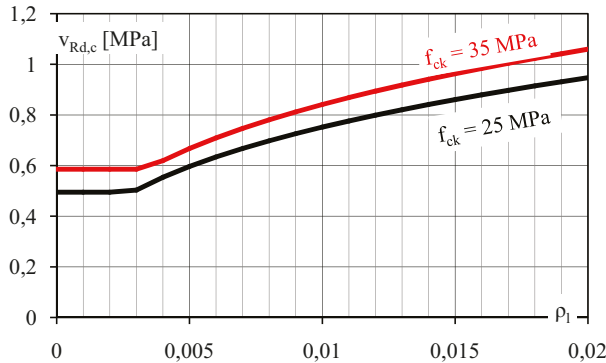
Fig. 6. The effect of the slab reinforcement ratio on the shear stress in the basic control perimeter u_1 [5]

Figure 6 shows the effect of the main reinforcement ratio within the support area on the punching shear resistance for the two commonly used concrete strengths $f_{ck} = 25$ and 35 MPa. By increasing the reinforcement ratio from 0.5% to 2.0% an increase in shear resistance of 60% can be observed.

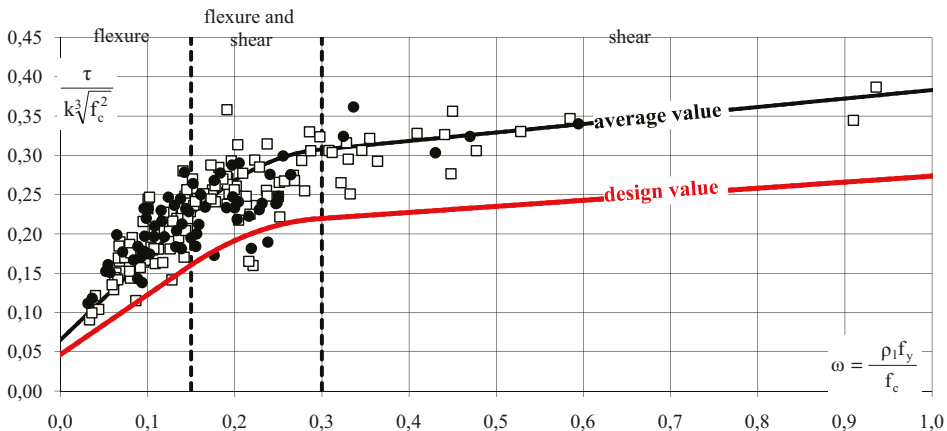
Fig. 7. Standardized critical stresses on the control perimeter at a distance $0.5d$ from the edge of the column as a function of the mechanical reinforcement ratio according to [15]

- flexure for $\rho_l f_{yk} / f_{ck} \leq 0.15$,
- combined flexure and shear for $0.15 < \rho_l f_{yk} / f_{ck} \leq 0.3$,
- shear for $\rho_l f_{yk} / f_{ck} > 0.3$.

The flexure mechanism is characterized by yielding of the main reinforcement in a large area close to the support, which is accompanied by a considerable opening of the cracks. The ultimate limit state is clearly signaled. In the compression zone of the slab close to column edge, concrete strains are significant and as a result crushing can be observed. At the high mechanical reinforcement ratios (above 0.3) approaching of punching shear capacity is a result of pure shear, without yielding of the main reinforcement. Failure is not signaled

by any significant increase in the crack widths. This mechanism is characteristic for high reinforcement ratios and steel with a high yield strength. It can also take place in slabs with average reinforcement ratios (0.5÷1.0%), made from low strength concrete. Such situations may also occur during the disassembly of the formwork, when the concrete has not yet reached its full design strength.

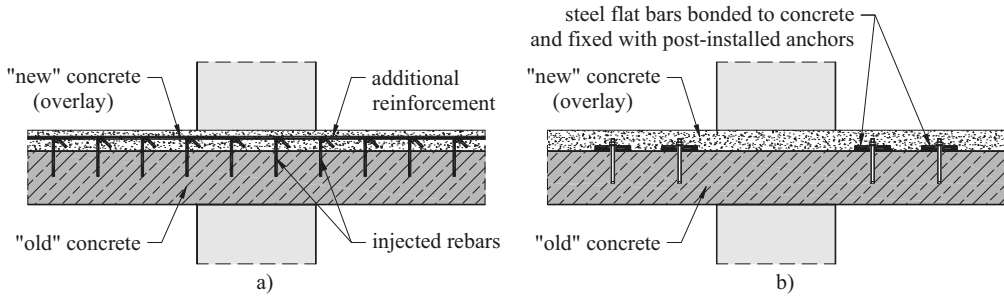
Fig. 8. Strengthening of the support zone with: a) external reinforcement placed in the additional top layer of concrete, b) bonded flat bars anchored with bonded screws

The methods of increasing the longitudinal reinforcement are shown in Fig. 8. The strengthening with flat bars (without concrete overlay) was experimentally tested in the laboratory of the Department of Concrete Structures at the Lodz University of Technology. Figure 9 shows one of the tested specimens after installing the flat bars and before the test. In the Figure 10 the saw-cut along the side of the column after the test was presented.

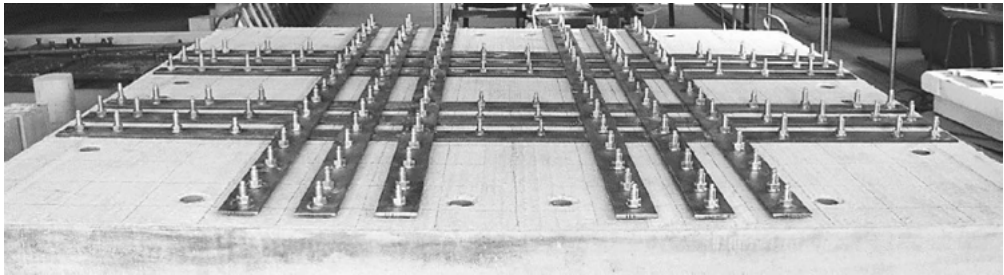
Fig. 9. An example of a slab strengthened with steel flat bars tested at the Department of Concrete Structures at the Lodz University of Technology [17]

zones the additional problem of decrease in punching shear resistance can occur. In order to verify the possibility of repairing such type of errors, experimental tests were carried out on models of the support zones. All of the specimens were made from concrete from the same batch. Two of them were control elements – the S-3 model with a nominal cover equal to 20 mm, while the S-4 – with a cover increased to 50 mm. The other two slabs, in which the upper main reinforcement was also lowered, were strengthened with steel flat bars (8 pieces

for each slab) in order to compensate for losses in load capacity resulting from increasing the concrete cover. The flat bars were bonded to concrete over the entire contact surface and additionally tightened with screws. One of the models (WPSK-8') was strengthened before the load was applied, while the other one (WPSK-8'') was strengthened under load. The mean concrete strengths were determined on cubes (with 150 mm side length) and cylinders (with a diameter of 150 mm and height of 300 mm) and were equal to 46.1 MPa and 39.8 MPa, respectively. The main reinforcement, with an average yield strength of 573.2 MPa, was made in the form of an orthogonal mesh of $\varnothing 12$ mm bars at 150 mm in both directions. As a result, the reinforcement ratio was 0.51% for the slab with the nominal cover and 0.64% for the reference model with lowered main reinforcement. Steel flat bars with a cross-section of 80×8 mm, from steel of an average yield strength of 316 MPa (S235 grade steel) were used to strengthen the test specimens. The results of these tests are summarized in Table 1. It was found that the displacement of the top reinforcement by 30 mm from the nominal location, which meant an increase in cover of 250%, resulted in decrease in the punching shear resistance by over 20%. The use of external reinforcement in the form of steel flat bars allowed to compensate the error resulting from the reduction in the effective depth. The increase in load capacity in relation to the control specimen S-3 was 47% for the WPSK-8' and 42% for the WPSK-8'' element. The detailed results of these studies are presented in the paper [18].

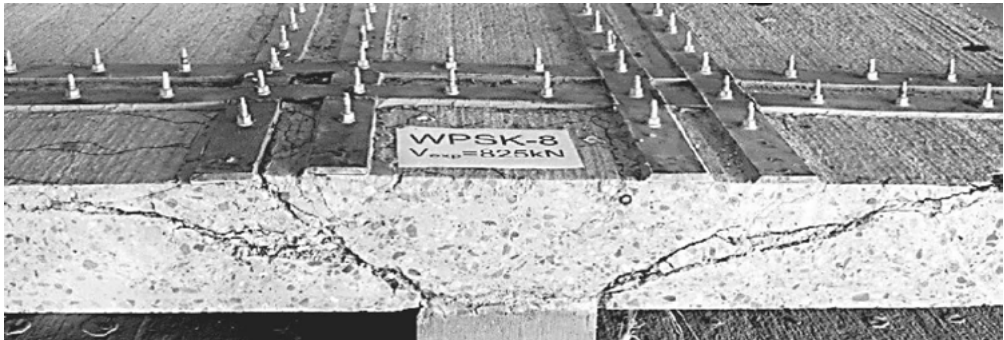
Fig. 10. View of the saw-cut of the specimen after failure [17]

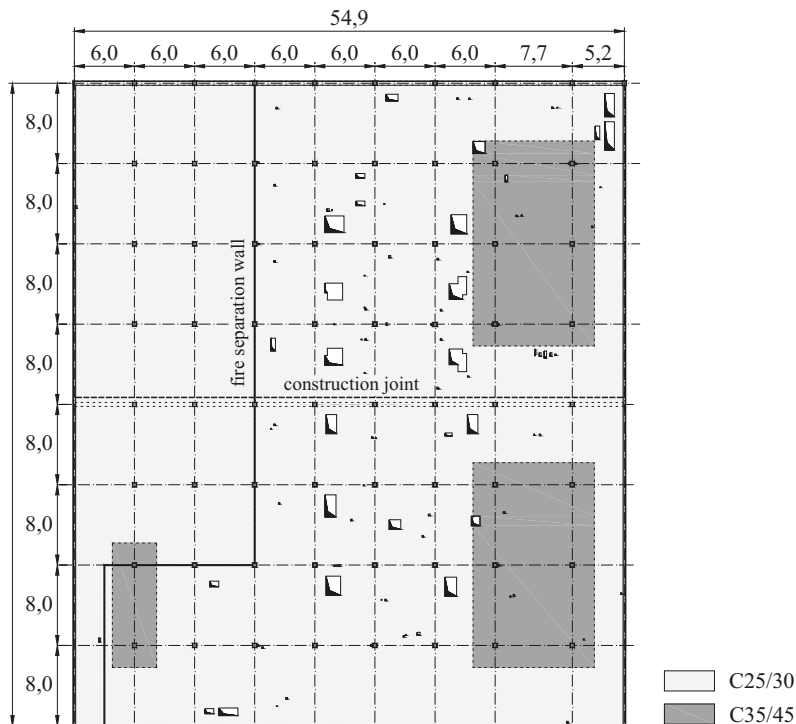
Fig. 11. Floor plan

The presented case concerns a 280 mm thick reinforced concrete composite floor (consisted of 220 mm thick in-situ concrete cast on filigree precast slabs), in a two-story production facility with dimensions 55 × 64 m in plane – see Fig. 11.

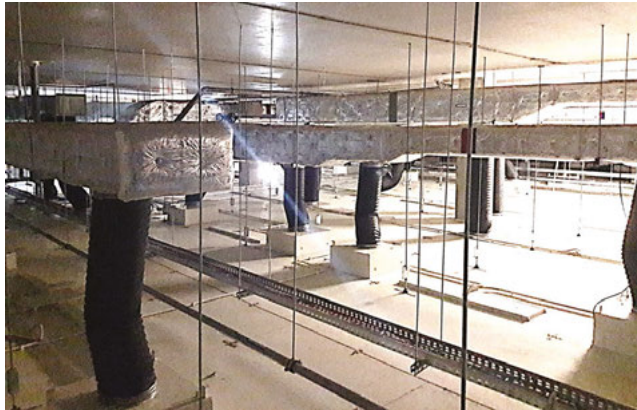
Fig. 12. View of the space between the floor slab and a suspended ceiling with technical equipment

The structure was designed as column-and-slab system, supported on 400×400 mm internal columns and 240 mm thick external wall from silicate blocks on a cement-lime mortar. A regular grid of columns was adopted with an axial spacing of 6.0/7.7 m × 8.0 m. In the middle of the building, a construction joint was designed. The connection of the two separated parts of floor slab was made by means of Halfen CRET shear dowels. A technical ceiling was suspended to the floor slab, in order to create a space of about 2 m for technical installations and equipment – see Fig. 12.

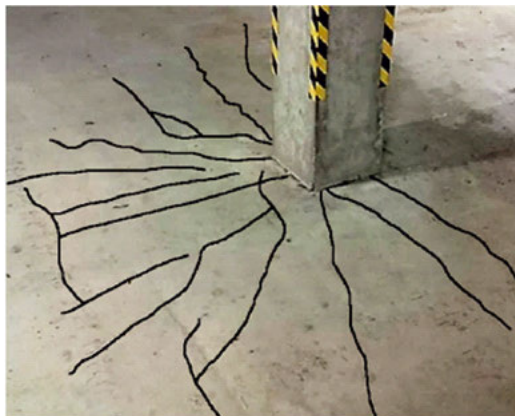
Fig. 13. Crack pattern in the upper surface of the floor slab close to column

During the inspection, numerous cracks were found on the upper surface of the slab. The cracks with a width of 0.3 ÷ 0.4 mm, occurred mainly in the vicinity of almost all of the internal columns (Fig. 13) and in the span area where their widths were greater and reached up to

1.5 mm. The location of cracks in the span section coincided with location of the shrinkage reinforcement (rebar mesh with a size of 150×150 mm was used). Most of the cracks were injected with a resin some months before visit of the authors as a result of the recommendations of other experts performing technical inspection.

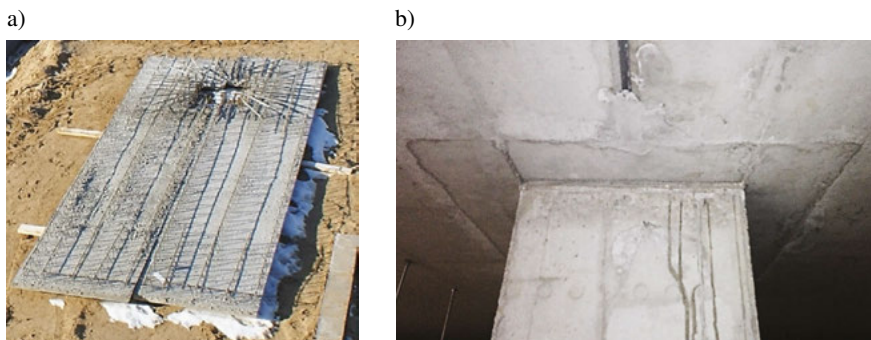
Fig. 14. Precast Filigree slabs: a) elements provided to cast within support strip, b) bottom view of the support zone with a monolithic insert of the width of 150 mm around the column

While analyzing the documents of the investment process stage, significant changes in the detailed design in relation to the construction design were found. The construction design provided for a monolithic 380 mm thick flat slabs with polystyrene void formers. During the construction stage the solution of the ceiling was changed to a RC composite, 280 mm thick slab. The replacement design provided for a 60 mm thick precast filigree slabs made from concrete of C25/30 strength class. The structural overlay was designed from two types of concrete: C25/30 on most of the ceiling and C35/45 within selected area (marked with dark grey in Fig. 11), where higher internal forces were expected. The design provided for a nominal cover of the reinforcement equal to 25 mm (from the bottom) and 20 mm (from the top). The on-site inspection showed a certain difference between the realized slab and the design assumptions, consisting in the division of the precast slabs in the support strips – see Fig. 14.

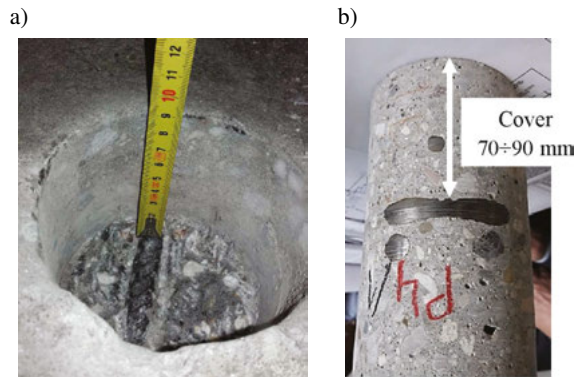
Fig. 15. Uncover of the main reinforcement in the supports area: a) hole after drilling core with visible rebar, b) concrete core with cut top reinforcement

Tests on cores taken from the structure after about nine years of completion have shown that the concrete can be assigned to strength class C30/37, however, significant differences in strength of individual samples were found (characterized by the coefficient of variation of about 20.2%). The test results did not indicate that concrete of two different strength classes was built in, as it was assumed in the detailed design. Based on the inspection of the collected cores, it was possible to determine the actual position of the top reinforcement in the floor slab, which was shown in Fig. 15. It was found that the assumed cover of the upper reinforcement ($c_{\text{nom}} = 20$ mm) was exceeded several times.

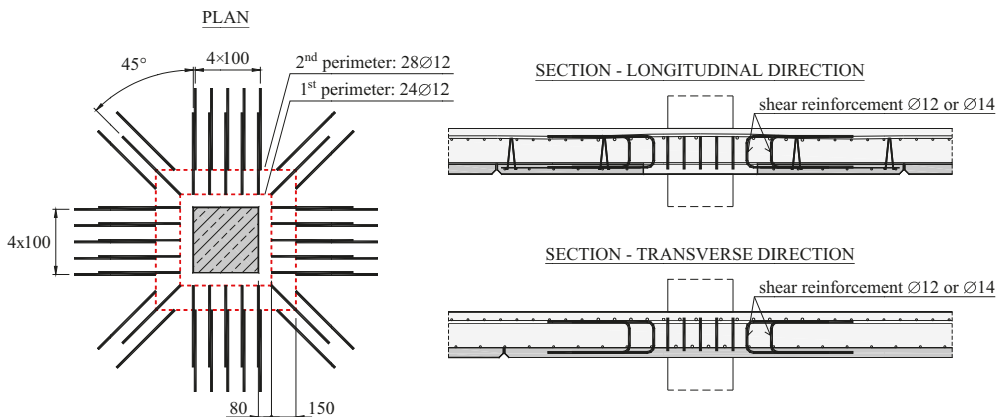
Fig. 16. Assumed location of the punching shear reinforcement according to the as-built documentation

The design provided for punching shear reinforcement in the support zones. According to the design and as-built documentation, the shear reinforcement consisted of C-shaped inserts embedded in the precast slabs, made of $\varnothing 12$ or $\varnothing 14$ rebars. The executive drawings did not contain any sections through the slab, therefore location of the reinforcement, presented in Fig. 16, should be regarded as a presumed. In order to meet the requirements regarding to minimum concrete cover, the C-type bars would have to be placed above the main reinforcement of the precast slabs. It does not follow from the design documentation that additional longitudinal bars were placed in the bent-ups of the inserts.

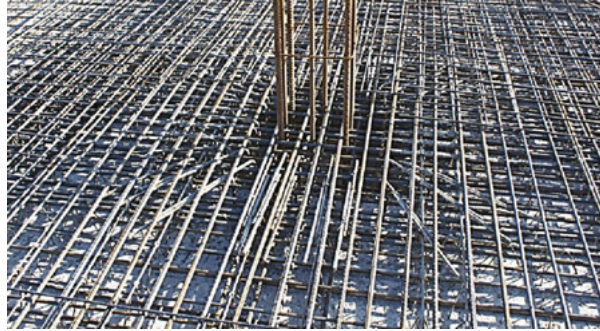
Fig. 17. Detail of the reinforcement in the vicinity of support

An analysis of the photographic documentation from the construction stage, provided by the customer, clearly showed that the main longitudinal reinforcement was tied outside of the C-shaped inserts (see Fig. 17). No additional bars were placed in the corners which means that the requirements [5, 10, 14] for anchoring of the shear reinforcement in the form of links, which should enclose the longitudinal reinforcement, were not met.

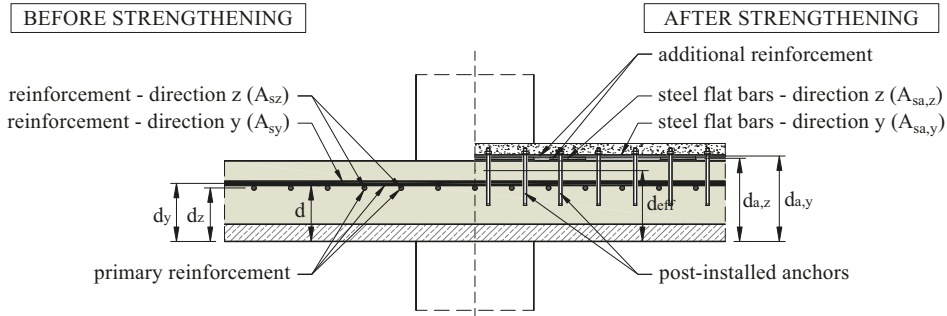
Fig. 18. Concept of strengthening of the floor slab by means of flat bars

By introducing the external reinforcement in form of 4 or 6 flat bars in each direction, the increase of design punching shear resistance of the support zones from 42 to 94% compared to the existing situation was achieved. In order to provide effective strengthening the additional reinforcement had to be located as close to the column as possible, taking into account possible obstacles in form of openings as well as the location of the existing reinforcement (to avoid possible collisions of post-installed anchors with the existing reinforcement). The length of the flat bars was designed in such a way that they extend beyond the area of the radial bending moments i.e. about 1/5 of the floor span with respect to the support axis. The number of flat bars in each direction depended on the identified deficit of the load-carrying capacity. When selecting the cross-section of the flat bars, the assembling considerations were taken into

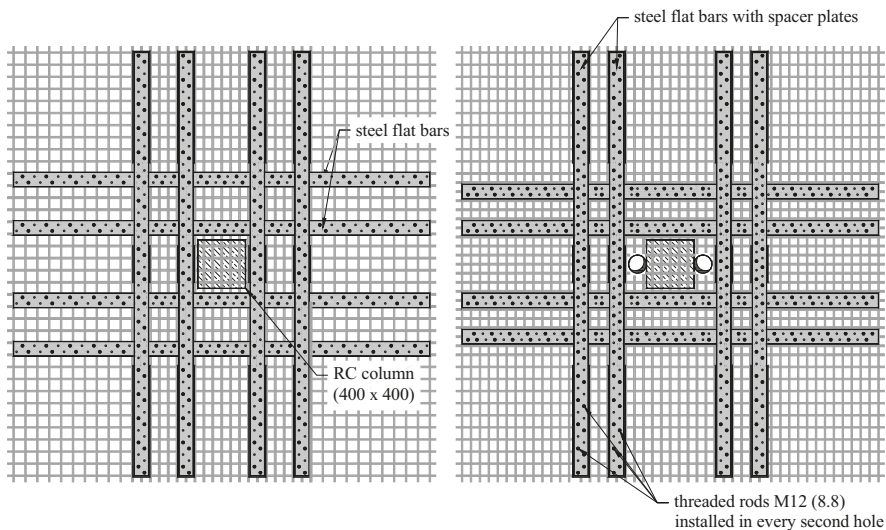
Fig. 19. Exemplary location of flat bars in the vicinity of the columns

account therefore, it was allowed to apply no more than 6 flat bars in each direction. Finally, flat bars with a cross-section of 120×8 mm made of S355 grade steel were designed. Due to the different support reactions as well as the number and location of openings, 4 to 6 flat bars in each direction were needed. It was proposed to fix the flat bars to the upper surface of the ceiling with Sikadur-30, a solvent-free, thixotropic, two-component adhesive based on epoxy resin and filler. In order to limit the undesirable failure mode, consisting in detaching the flat bars, additional anchoring with post-installed M12 threaded rods, injected with Hilti 200A adhesive were used. Figure 19 shows the examples of flat bars arrangement.

The cruciform arrangement of flat bars required use of additional spacer plates, connected to the flat bars with fillet welds (in case of flat bars of the upper layer). As part of the manufactory preparations, in all of the elements holes were drilled, which number was twice as high as the number of anchor bolts. The decision to increase the perforation was due to concerns about

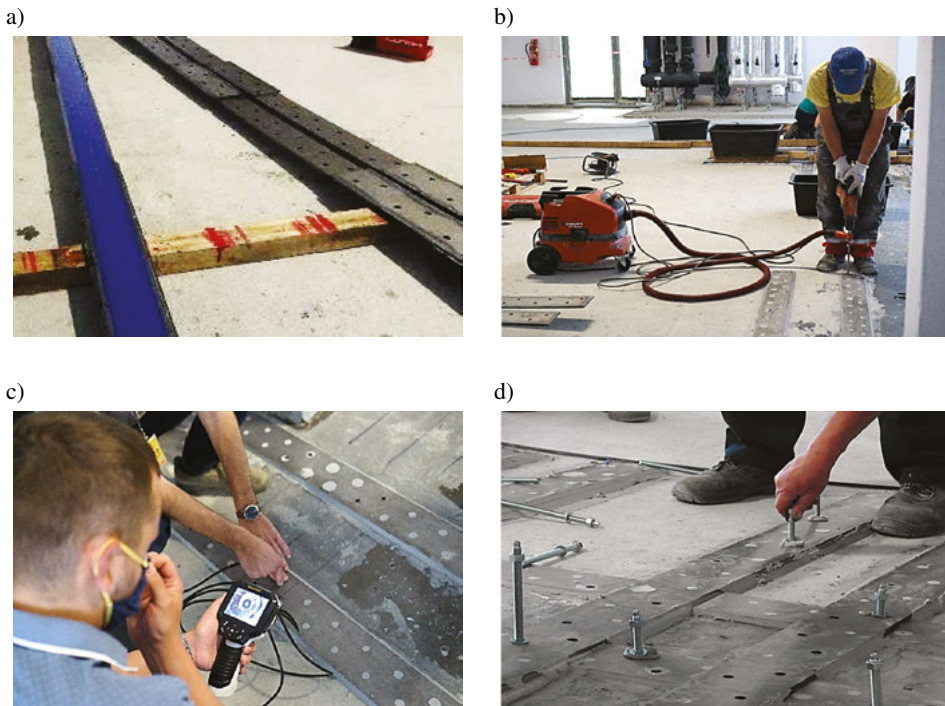
Fig. 20. Subsequent steps during the execution of the trial strengthening: a) preparation of flat bars for assembly (visible protection with tape), b) drilling the holes, c) inspection of holes using an endoscope camera, d) installing the anchors

- 2) preparation of flat bars by cleaning the bonded surface and degreasing immediately before applying the resin and sticking the holes in the flat bars with tape to prevent flowing out the adhesive – see Fig. 20a;

- 5) pressing the flat bars with weights and leaving for the setting time;
- 6) drilling holes in the floor slab (Fig. 20b); after the adhesive had hardened, the holes were drilled (after removing the masking tape); drilling was performed in stages – at each stage about 25% of the total number of holes provided were drilled; in case of

encountering obstacle, drilling was stopped and an inspection with an endoscope camera (see Fig. 20c) was carried out – if a rebar was visible, drilling was interrupted and moved to the adjacent hole;

- 7) cleaning holes with compressed air and injecting threaded anchors (see Fig. 20d); the adhesive was applied to the holes filling about half of their volume and the anchors were installed in a rotary motion; after cross-linking of the resin, which lasted about 30÷60 minutes, the next holes were drilled and the remaining anchors were installed (the steps described in points 6 and 7);
- 8) installing of the second layer of flat bars (the steps described in points 6 and 7);
- 9) tightening of nuts and shortening of excessively protruding bolts.

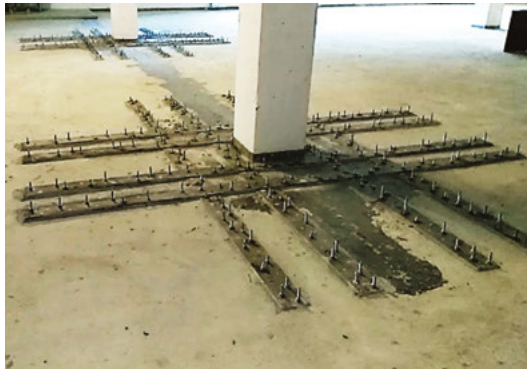
Fig. 21. View of the strengthened support zone

Figure 21 shows the support zones after completion of the strengthening. Taking into account the experience from the trial realization, the owner decided to strengthen the ceiling in stages, depending on the current needs and technical possibilities, without intervention within interceiling space. In the first stage, documentation covering the area intended for offices was prepared. The authors pointed to the need to secure steel flat bars with 60 mm thick reinforced concrete plinths. This solution resulted from the need of anti-corrosion and fire protection. In order to ensure an even surface in the room, it was proposed to build a raised (technical) floor, supported on the existing ceiling. The floor consisting of ready-made gypsum fiber tiles will be supported on steel pedestals with adjustable height. Such solution allows for a free arrangement of the necessary installations – see Fig. 22.

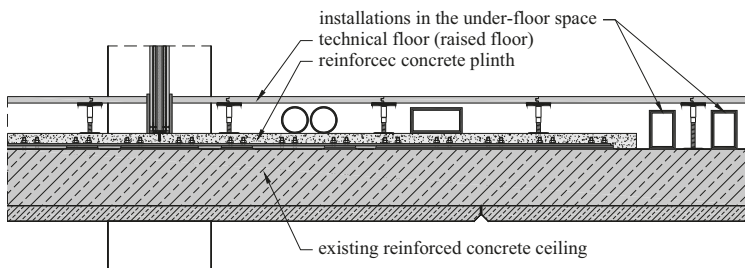
Fig. 22. Protection the external reinforcement with a concrete plinth and leveling the levels with a technical floor
