# Thermal Analysis of Pavement for the East Bielsko-Biala Bypass

## ABSTRACT

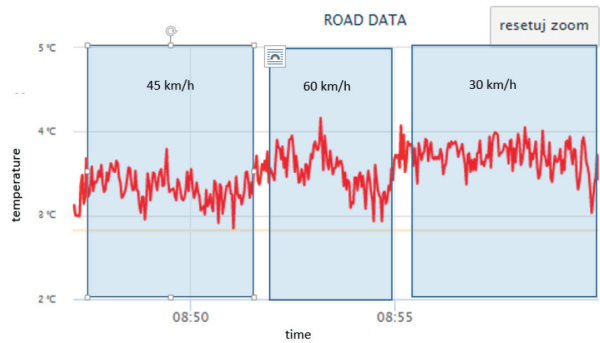
Fig. 4. Road Surface temperature fluctuations at various speed [own study]

In order to determine speed impact relevance three test runs were performed. Test drives were realised in daylight conditions at speeds respectively: 30, 45 and 60 km/h. During the measurements the air temperature fluctuated around 2 °C, no precipitation was observed. Fig. 4 presents road surface temperature registered during the variable speed test drives. The introduced results are slightly effected by increasing air temperature registered during the tests. As a consequence, the average surface temperatures for the first, second and third drive were as follows: 2.33 °C, 3.52 °C and 3.68 °C. As the first test run has been realised with a speed of 45 km/h, second with a speed of 60 km/h and the third 30 km/h, it stands to a reason that the average temperature growth was caused by raising air temperature, not by the vehicle speed.

The test vehicle speed change in a range of 30 ÷ 60 km/h did not resulted in a significant impact on the road surface temperature measurement. Obtained temperature discrepancies has not been greater than variability during the stationary tests. As mentioned in [3] authors point out that MARWIS may be used as basic measuring device for local meteorological shield system development on the bypass.

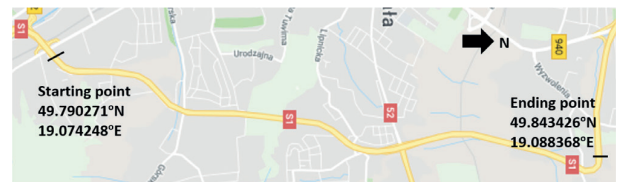
Fig. 5. The test route on a bypass, cartography based on Google Maps [own study]

The road test analysed in this article had been carried out on dual carriageway road section which is a part of eastern bypass of Bielsko-Biala city. Due to the fact that the bypass is situated in mountainous terrain and there are bridge structures and flyovers, the significant local pavement temperature variabilities may be expected. As the result in the autumn and winter time black ice may occur locally, which dramatically decreases the safety of road users. The selected route was about 6.25 km long - see Fig. 5 with marked starting and ending point.

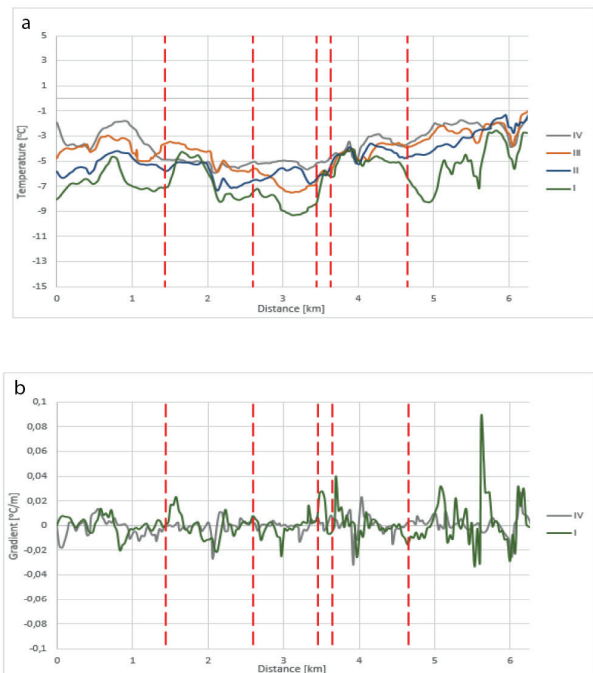
**Fig. 6. Drives I-IV measurement results [own study]**

traffic lanes with as short as possible time gap (necessary for i.a. changing the movement direction). The measurement results for selected test runs are presented in the figures. The drives were performed in the same day and in similar weather conditions. The results summary are presented as follows: test runs I-IV (Fig. 6), IX and X (Fig. 7), XI and XII (Fig. 8). Fig. 6a), 7a) and 8a) illustrate road surface temperature variability, while Fig. 6b), 7b) and 8b) concerns temperature gradient variation. To ensure facilitate readability of Fig. 6b), authors decided to illustrate only data regarding I and IV test runs. Those are test runs for which time gap was the longest and exceeded one hour. The horizontal lines in the figures indicate the location of bridge structures (given in Table 3).

The most significant conclusions that can be formulated based on presented results (Fig. 6 – Fig. 8) are as follows:

- results of measurement from test drives performed in comparable weather conditions are similar, especially with regard to road temperature gradient, which is very important for traffic safety,
- the road surface temperature discrepancies regarding drives I-IV are highly determined by condition changes caused by significant time gap between the drives performed partly in mid-morning hours and changeable sun exposure,
- also comparing test runs XI and XII, the significant influence of rapid air temperature rise and sunlight exposure is clearly noticeable,
- in most cases the road sections with the highest road surface temperature variation do not cover with the location of bridge structures.

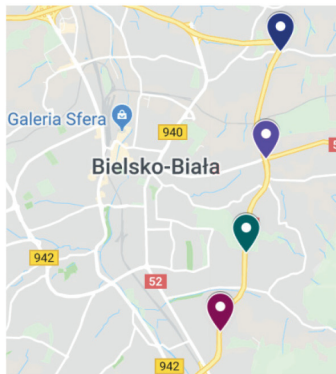
**Fig. 13. Areas showing high thermal volatilities based on different test runs, cartography based on Google Maps [own study]**

On the basis of geolocation data in Fig. 13 the areas showing high thermal variability has been indicated. In marked points significant fluctuations of the road surface temperature has been registered during most of the test runs (see Fig. 10 and Fig. 11). In all cases, the bypass runs beneath the viaduct structures of other local roads.
