## STRESS CORROSION CRACKING PROPERTIES OF STEAM GENERATOR TUBING ALLOYS IN CREVICE ENVIRONMENT

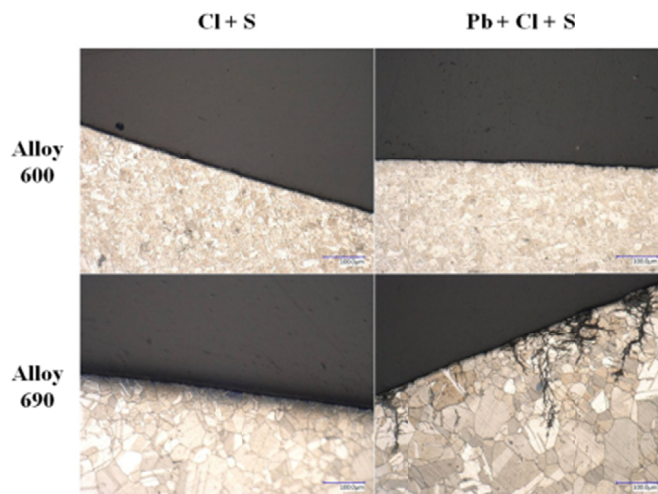
Fig. 1. Optical microscope images of Alloy 600 and 690 in Cl + S and Pb + Cl + S solutions

Optical microscope observation results are shown in Fig. 1 for the Pb + Cl + S group and Cl + S group. As shown in Fig. 1, the largest cracks were found for Alloy 690 in a solution containing Pb while no cracks were found for Alloy 690 in a solution without Pb. The shape of the cracks was complex, and most of the cracks were observed to be transgranular, similarly to other reports [8]. Unlike Alloy 690, cracks were found for Alloy 600 in all conditions. However, the cracks for Alloy 600 were significantly shorter than those for Alloy 690 in the solution containing Pb. It is presumed that the shape and existence of the surface oxide film can affect the SCC.

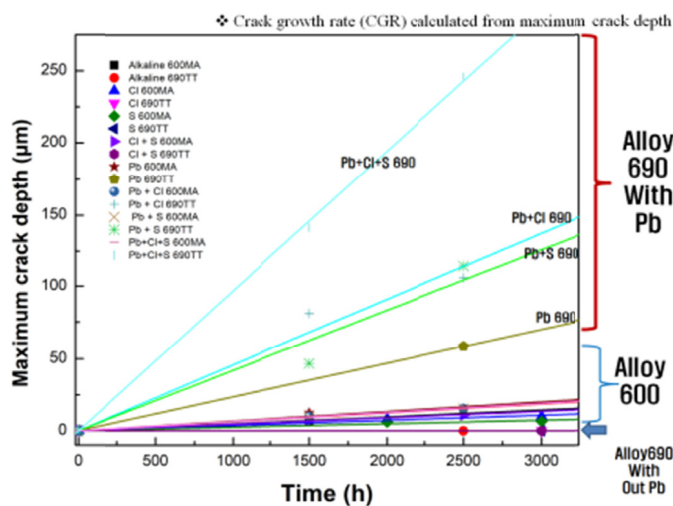
Fig. 2. Crack depth with immersion time for Alloy 600 and Alloy 690 in solutions containing different impurities

Fig. 2 displays the results of the experiments conducted in various environments. No cracks were observed for the Alloy 690 in the solution without Pb while cracks were found for Alloy 600 regardless of the presence of Pb. The crack growth rate for Alloy 690 in the solution containing Pb was higher than that for Alloy 600. Moreover SCC rate in leaded solution was increased with chlorine indicating that chlorine shows synergistic effect on SCC rate. Chlorine showed a greater effect on SCC than sulfur in the solution containing Pb. When sulfur, chlorine, and lead were added together, the SCC rate was the highest.

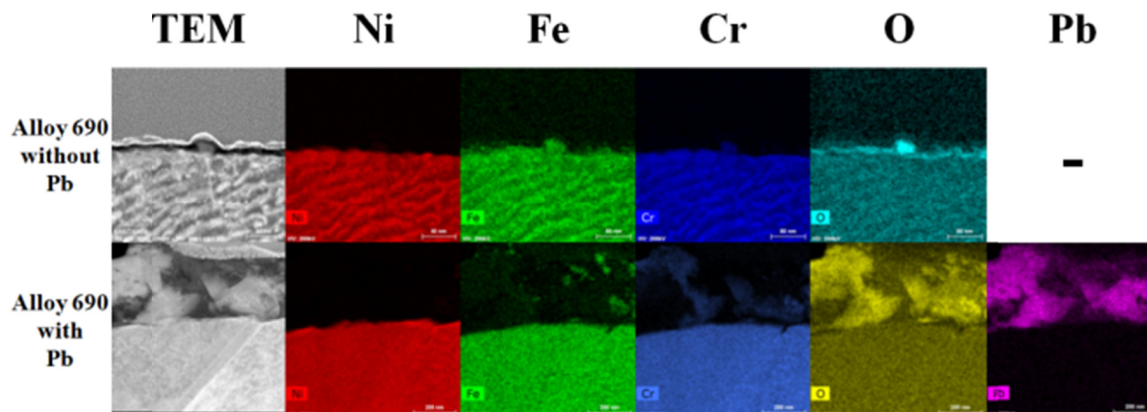
Fig. 3. STEM-HAADF images and EDX elemental maps obtained from the apex of Alloy 690 both with and without Pb

Fig. 3 shows the results of TEM for the surface oxide layer of Alloy 690. Alloy 690 had a uniform oxide film on the surface in the solution without Pb. However, the Pb oxide was detected and a uniform oxide was degraded on the surface of Alloy 690

when Pb was added to solution. It is expected that the shape and existence of the uniform oxide film affected the SCC in Alloy 690 considering that surface oxide plays a significant role in SCC behavior [9].
