## ACOUSTIC EMISSION AS A TOOL FACILITATING TECHNICAL CONDITION INSPECTIONS OF TANKERS CARGO TANKS

*This article discusses several attempts at using AE as a diagnostic signal and a method facilitating technical condition inspections of tankers cargo tanks.*

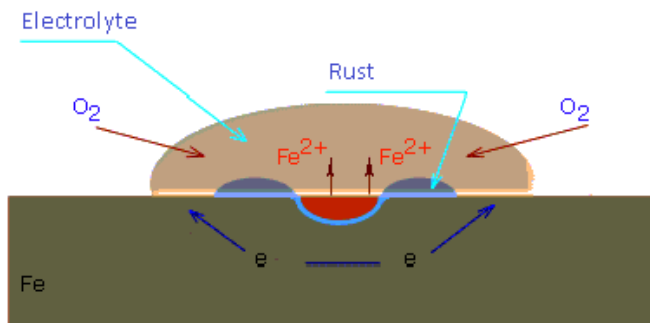
*Fig. 1 Course of electrochemical corrosion of iron in an electrolyte drop due to aeration [3]*

The course of a corrosion process may be represented schematically, as shown in Figure 1 below.

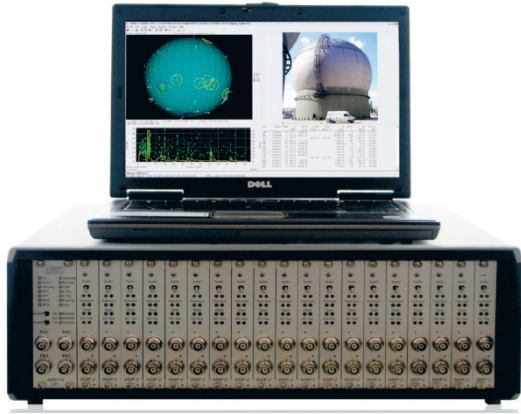
Fig. 4 AMSY5 equipment

The AMSY5 system is a multi-sensor AE system comprising parallel measurement channels. Each channel is connected to an analogue measurement section, digital signal processing.

A complete AMSY5 system includes:

- main unit (MC2, MC6, MC15, etc.),
- one or more AE channels,
- basic software package – SWAT or SWBN. [6]

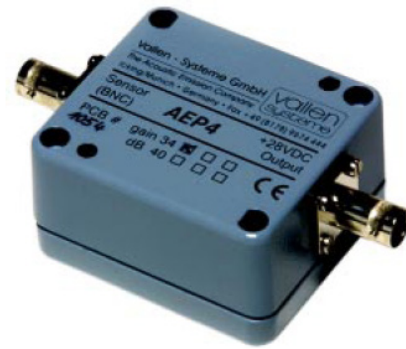
Fig. 7 AEP4 preamplifier (gain up to 34dB).

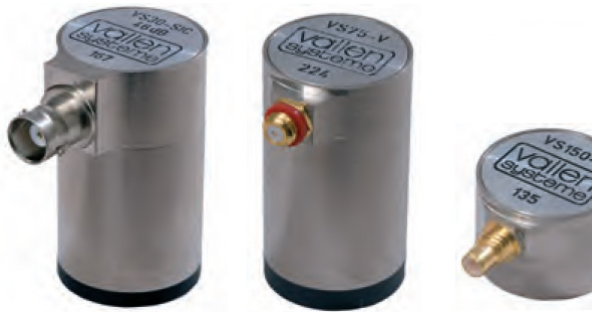
Fig. 5 Sensors for tests

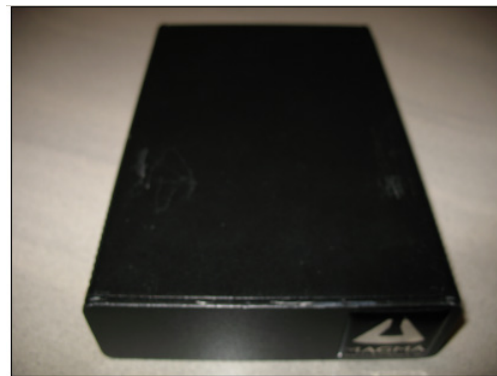
Fig. 8 MAGMA logger.

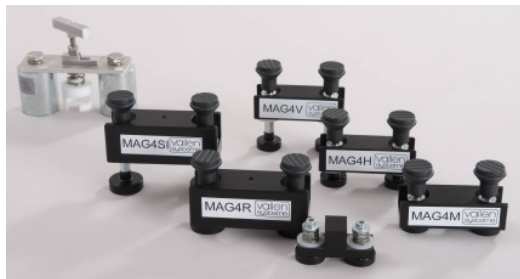
Fig. 6 Magnetic holders

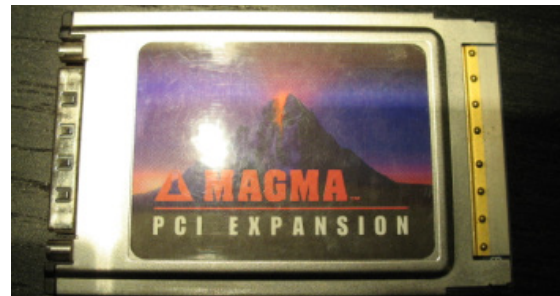
Fig. 9 MAGMA PCMCIA processing unit.

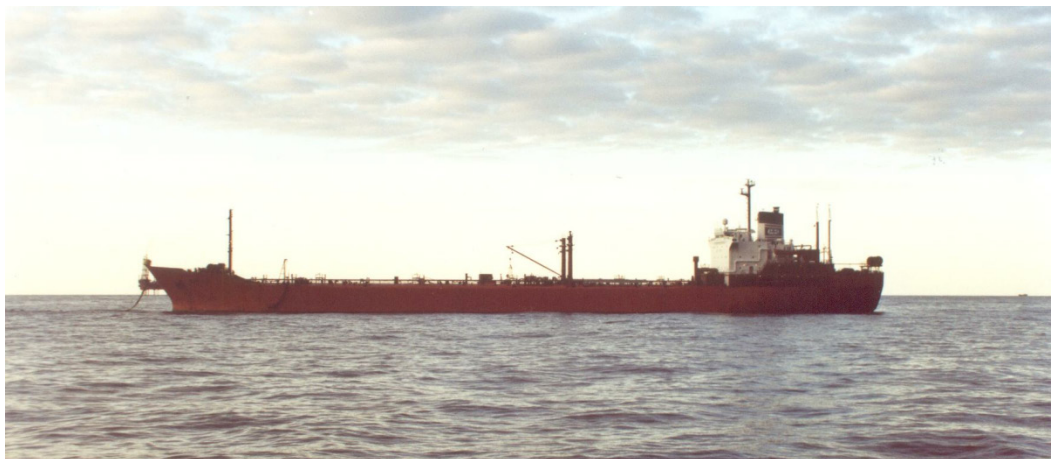
*Fig. 10 M/T IKARUS II at sea.*

M/T IKARUS II was constructed in 1975 in Japan by KANASASHI SHIP-BUILDING. The ship is currently being used as a resource base for the production centre located on the "Baltic Beta" platform and as a carrier for oil extracted from the B-J deposit to the port in Gdańsk.

Capacity – GRT – 21 576;	Main engine type	- Kawasaki M.A.N K
Capacity – DWT – 36 194;	7SZ 70/125,	
Total length – Lc = 182.03 [m],	Main engine power	- M = 79 650 [kW],
Length on waterline – Lwp = 171 [m],	Speed	- 10 [Mm/h] at 145
Width	[RPM],	
Draught		
- B = 27 [m],		
- T = 17 [17],

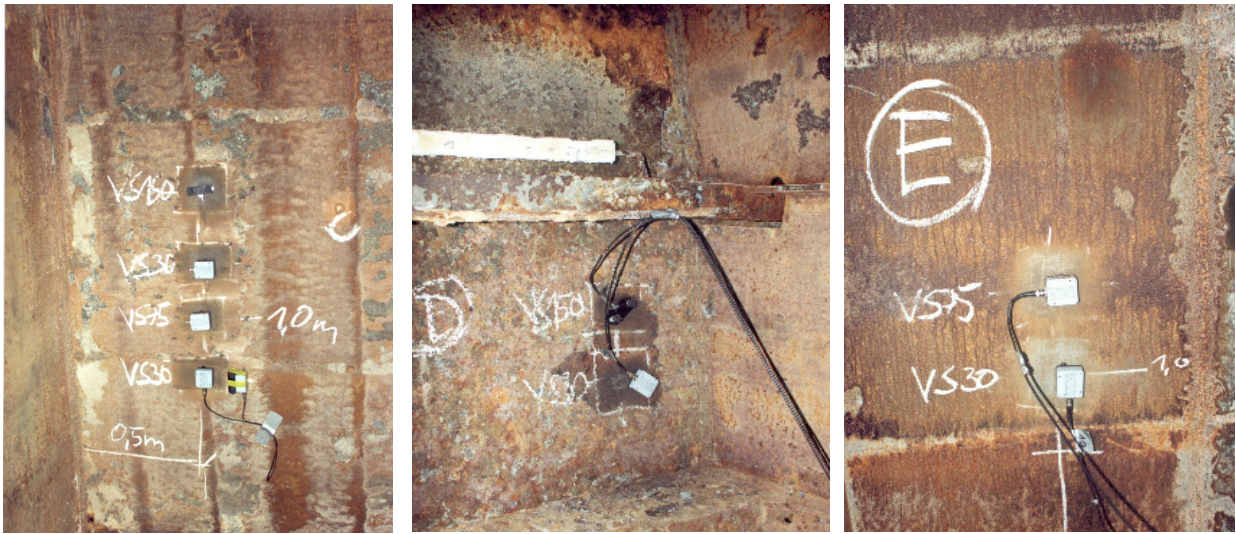
*Fig.11 Marked and cleaned areas for fitting sensors at "C" measurement point and marking of sensor types and numbers on the surface of a wing tank bulkhead*

- VS 30-V and VS 150 RIC sensors with measurement cables at "D" measurement point on the surface of the ship sides plating
- VS 30-V and VS 75-V RIC sensors with measurement cables at "E" measurement point on the surface of the central tank bulkhead

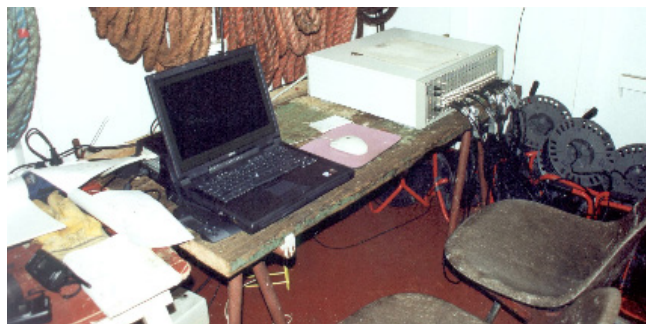
*Fig. 12 16-channel measurement system and a docking station with a laptop in a bow room.*

An assembly by Vallen, type AMSY5, was used for the measurement of the acoustic background, containing:

- 16-channel measurement system;
- laptop docking station;
- laptop;
- 8 VS 30-V sensors with a preamplifier and magnetic holders;
- 4 VS 75-V sensors with a preamplifier and magnetic holders;
- 4 nagar magnetic holders;
- 16 BMC measurement cables of the length of 125 m.

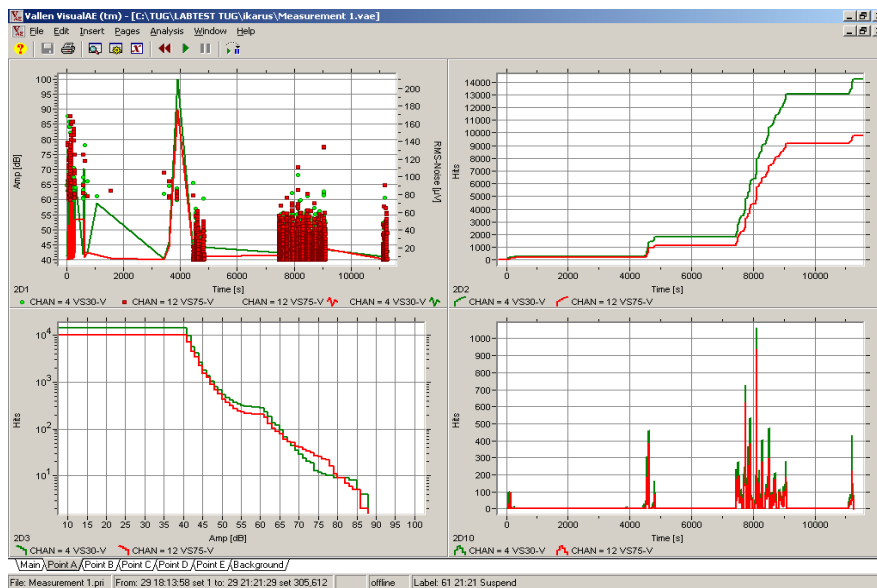
Fig. 13 Sample results of signals deriving from corrosion are presented below.

Sample results of background tests are presented below.

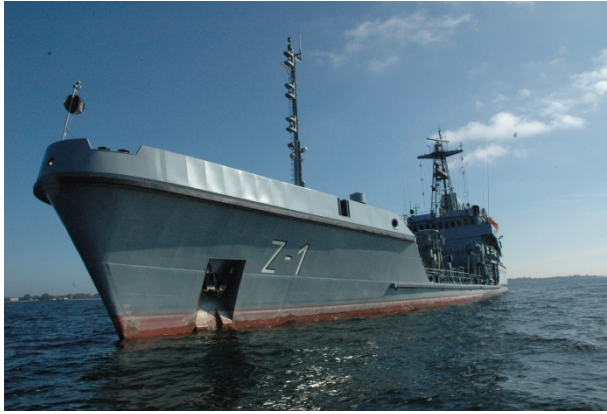
ORP "Bałtyk" was constructed in the shipyard of the Polish Navy in Gdynia Oksywie. Its task was to provide fuel, oils and fresh water, as well as collect fuel and waste.

Tab ORP Bałtyk's technical data

Displacement	D = 2984 t
Load carrying capacity	1276 t
Length	L = 84.75m
Width	B = 13.07 m
Draught	T = 4.80 m
Engines power	N = 2×1480 kW
Speed	V = 15 Mm/h

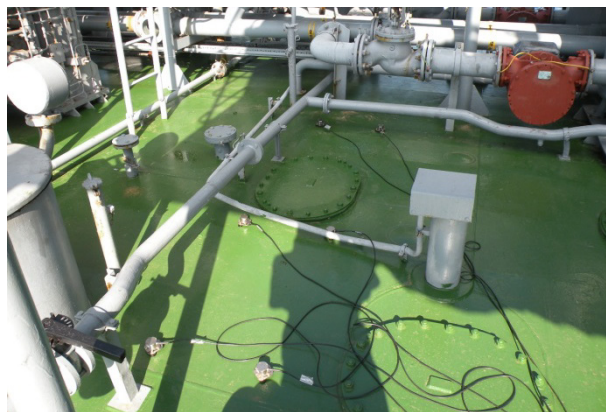
Fig. 16 Cargo deck of ORP Bałtyk'with sensors arranged for tests.

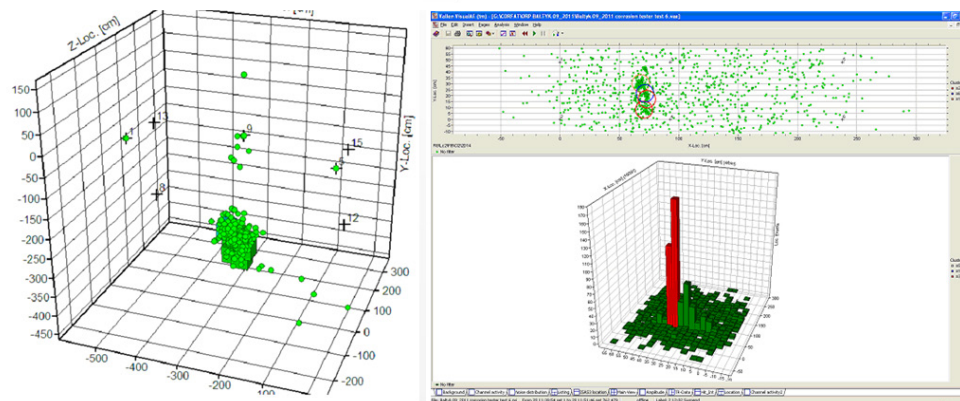
Fig. 17 Visualization of tests results. Visible signal of corrosion. [10].

The conducted tests were successful. Corrosion sources were recorded and located, without having to empty the tested tanks. The use of acoustic emission as a diagnostic signal supplements the currently used methods.

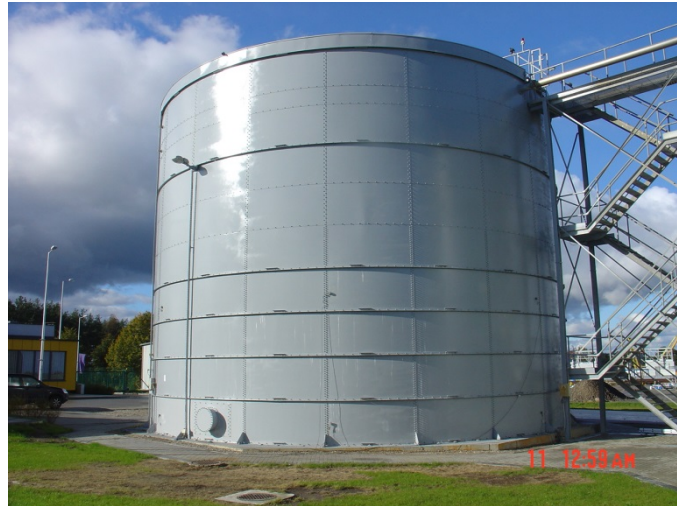
*Fig. 18 Brine tank ( $V = 2000 \text{ m}^3$ )*

One of the overground objects covered by the tests was a brine tank in a lye facility in Kosakowo. The aim of the tests was to record AE signals in the tank structure side surface during its operation.

- The tested brine tank is tight (no leaks), and its side walls (cylinder side walls) are devoid of active corrosion centres.
- Energy of the collected AE signals emitted during the tests is relatively low due to very strong attenuation by individual layers on the tank (paint, membrane).
- The obtained results of AE signals analysis (using the Visual AE module in the Vallen software) enable the correct assessment of the processes taking place and the proper verification of the condition of the tested tank structure.

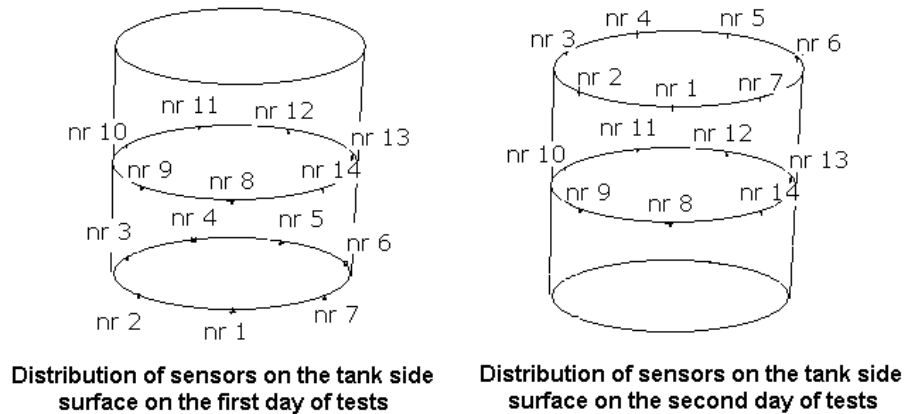
Fig. 19 Arrangement of sensors

1. The first 7 VS30-V sensors were evenly distributed every  $L1 = 6.88 \text{ m}$  along the circumference, at the distance of  $h1 = 0.6 \text{ m}$  from the tank base. Sensors from 1 to 7 were numbered (clockwise).
2. Another 7 VS75-V sensors were evenly distributed every  $L1 = 6.88 \text{ m}$  along the circumference, at the distance of  $h2 = 4.1 \text{ m}$  from the tank base. Sensors from 8 to 14 were numbered (clockwise).
3. Sensors were installed with AEP4 preamplifiers in the designated places on the tank plating using magnetic holders. Then they were connected using cables with AMSY-5 instrumentation.

Arrangement of sensors on the first and second day of measurements

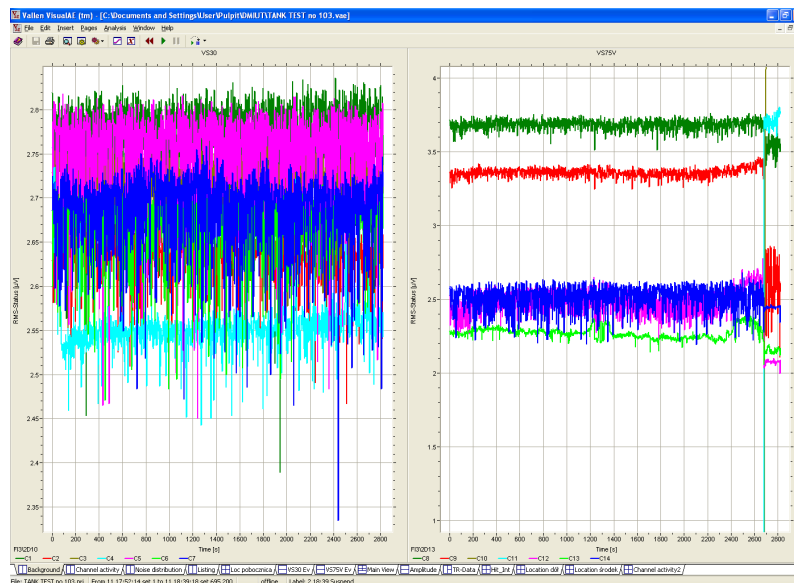
Fig. 20 Acoustic background

The level of acoustic background specified for the measurements on the first day of tests equalled 22 dB. This value remained unchanged for the second day of tests. Weather was changeable with rainfall spells during the preliminary works on the first day.

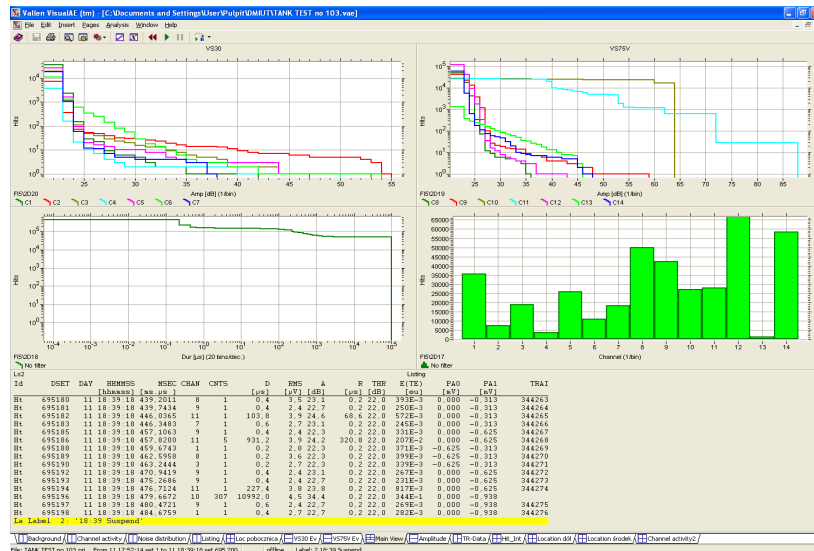
Fig. 21 Activity of individual channels

Representative results of the AE signals tests in the tank and on its side surface – during normal operation and with water and brine inflow and drainage systems in an off state – are presented below.
