## Analysis of energetic system failures of Polish fishing fleet vessels and their impact on the environment

Cezary Behrendt<sup>✉</sup>, Przemysław Rajewski

Maritime University of Szczecin, Mechanical Faculty, Institute of Marine Propulsion Plants Operation  
1–2 Wały Chrobrego St., 70-500 Szczecin, Poland,  
e-mail: {c.behrendt; p.rajewski}@am.szczecin.pl  
<sup>✉</sup> corresponding author

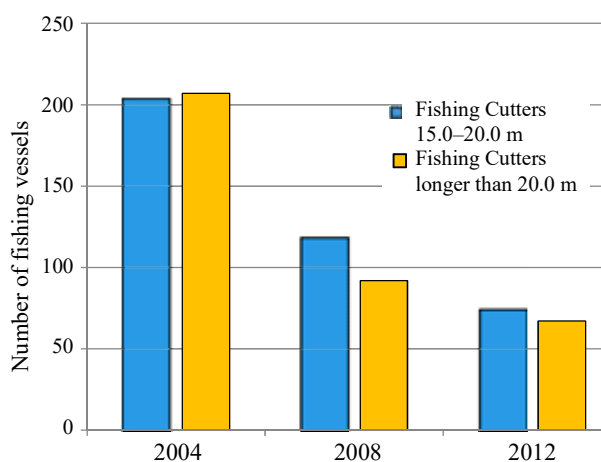
A particularly large number of fishing cutters of the Polish fishing fleet have been reduced, that is vessels whose length exceeds 15 m. Figure 1 presents the number of fishing cutters since the accession of Poland to the European Union divided into

Figure 1. Number of fishing cutters of the Polish Baltic fishing fleet from 2004 to 2012 (Rajewski & Behrendt, 2008; Behrendt, 2013)

two groups according to the length of the ship's hull: fishing cutters of length from 15 to 20 m and those exceeding 20 m.

As it appears from the analysis carried out using the results presented in Figures 1 and 2, major reductions in the number of fishing cutters occurred in the segment with length exceeding 20 m. Out of the fishing cutters group, the length of which equals from 15 to 20 m, 95% were constructed in 1955–1970. The newest vessels in the amount of 3 units were constructed in 1991–1992 in Odra Shipyard in Szczecin (Rajewski & Behrendt, 2008; Behrendt, 2013). The situation is slightly better in the case of fishing cutters of length exceeding 20 m. Having analyzed the fleet size in 2012, in that group of the fishing cutters, 50% of the vessels have been in operation for more than 25 years (Rajewski & Behrendt, 2008; Behrendt, 2013).

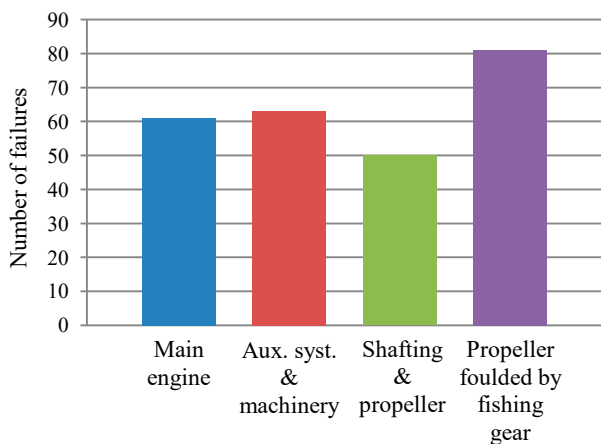
The figures in Table 1 are illustrated in the bar chart below (Figure 4).

**Figure 4. Number of energetic system failures in fishing cutters**

Among the fishing cutters, the greatest number of failures occurred to the main engine counted together with auxiliary systems and machinery serving the main engine. These two types of failure combined made up over 48% of all failures reported by fishing cutters in the years 1999–2012. Propeller fouling by fishing gear – nets and lines – was most significant in this class of fishing vessels. In total, 81 failures corresponded to nearly 32% of all failures in that period.

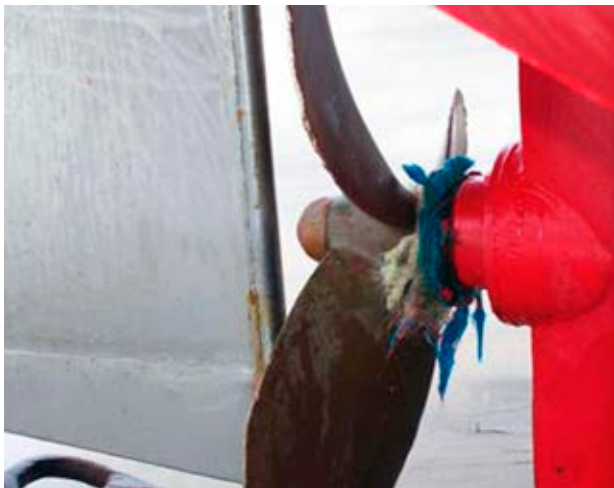
In the years 1999–2012 there were reports on as many as 255 failures in fishing cutters operating in the Baltic Sea from Polish ports. Among the four examined types, or groups, of failures relating to the energetic systems of fishing cutters, the fouling of the propeller by fishing gear is the most frequent reason. Figure 6 presents an example of the damage to the propulsion system of a fishing vessel

**Figure 6. Therope wound on a line of shafts**

which limits operation of the vessel. The damage was caused by a rope wound on a line of shafts.

The damage presented in Figure 6 resulted in the need to haul the vessel to a port by a second cutter fishing nearby. A fishing line screwed into the stern tube seal of the fishing vessel is presented in Figure 7. Oil spillage was a result of the situation.

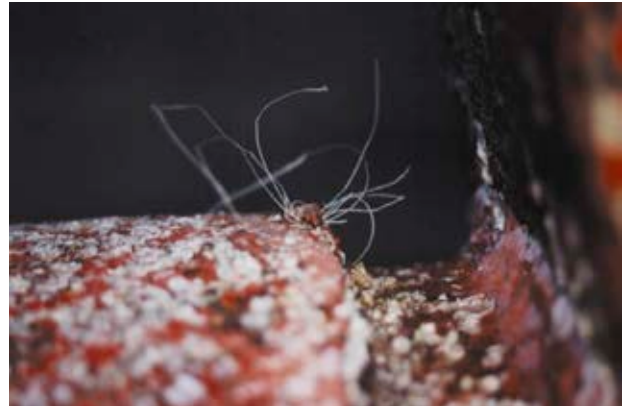
**Figure 7. Nylon fishing line of a fishing net line screwed into the stern tube seal**

A total of 81 such failures make up over 32% of all failures. 11 cases of marine environment pollution were reported to have been caused by oil spillage. The direct reason was either a leak of the stern tube or due to the controllable pitch propeller blades mounted to the hub, line or net fouling the propeller. The two fishing craft sinking incidents reported also caused oil spills. The substantial share of failures caused due to a propeller fouled by lines or nets results from the specific character of fishing cutter operation connected with running out and hauling in fishing gear while sailing at slow speed or a drift, often at high seas.
