## SELECTED ASPECTS RELATED TO THE APPLIED LOADS CONTROL DURING FATIGUE TESTS OF A METALLIC AIRFRAME

*Service life of the PZL M28 is computed based on the results of the full-scale fatigue tests of the structure [1]. As the PZL M28 is a commuter category airplane according to the 14 CFR Part 23 and CS-23 regulations, the test objects are: (1) wing and wing load carry-through structure, (2) empennage and attached fuselage structure. Additionally, there are fatigue tests carried out for the landing gear and other selected elements including control system elements. The aircraft load carry-through structure is metallic and the cabin is unpressurized. The fatigue tests are conducted stage-by-stage. As tests progress, it is possible to extend the aircraft target service life, applying the safe life philosophy with reference to the primary components of the load carry-through structure.*

*The article brings into attention the issue of the applied loads control in conducting fatigue tests of the metallic airframe.*

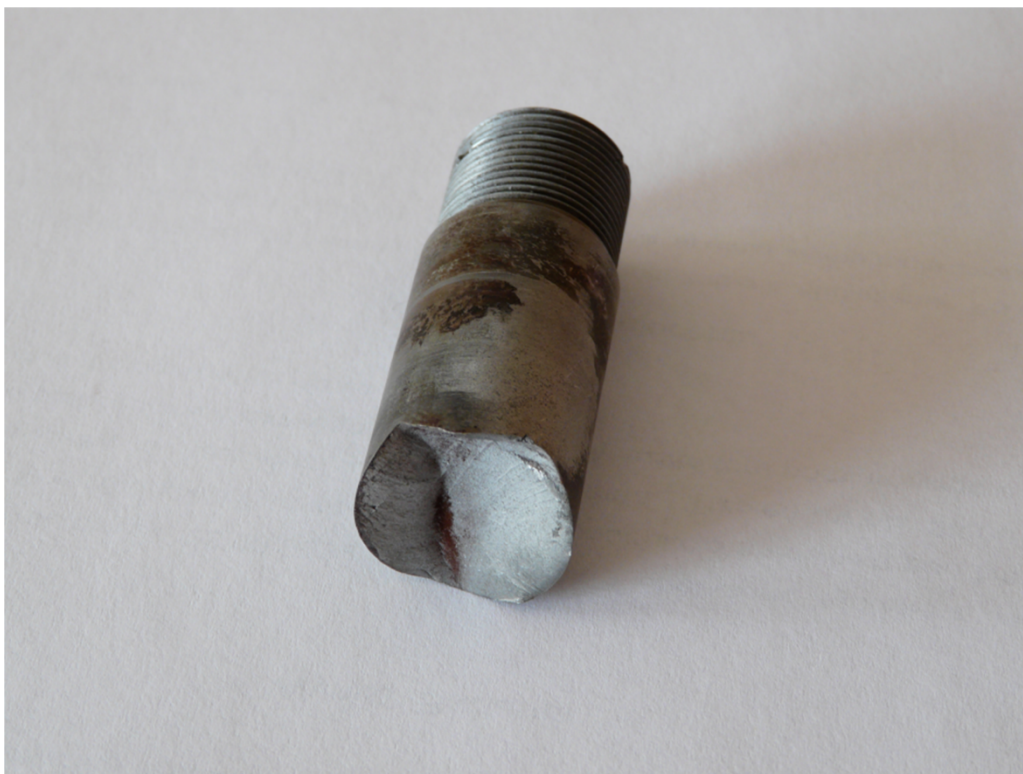
**Fig. 3. Fatigue test of the PZL M28 05's wing and wing load carry-through structure. A fatigue- damaged bolt of the test fixture.**

Some goals of the fatigue tests conducted are to find the critical elements in the aerostructure, determine its service life and to develop maintenance activities plan of the aircraft fleet in service. So, the test should be run until a fatigue damage occurs as the sole fatigue analysis is not a reliable tool to predict fatigue life. This aspect imposes great responsibility on the test team who need to watch for early symptoms of developing damage and observe fatigue crack propagation. Of course, many provisions are set to help, e.g. strain gauges in predicted critical areas. Nevertheless the system should be capable of a rapid reaction to the damage occurrence so as not to introduce random loads, which are uncontrolled and likely to be excessive. The system's behavior during one of the test events (damage of one test fixture element) is shown in Fig. 2. The system detected a failure and commanded a slow decrease in forces in the actuators. At the same time another provision was activated – the hydraulic pressure was automatically discharged. All parameters during the event were automatically recorded. In the effect, no damage was introduced to the tested article. Figure 3 shows a fatigue-damaged bolt of the test fixture as an example of a potential source of the tested article damage.

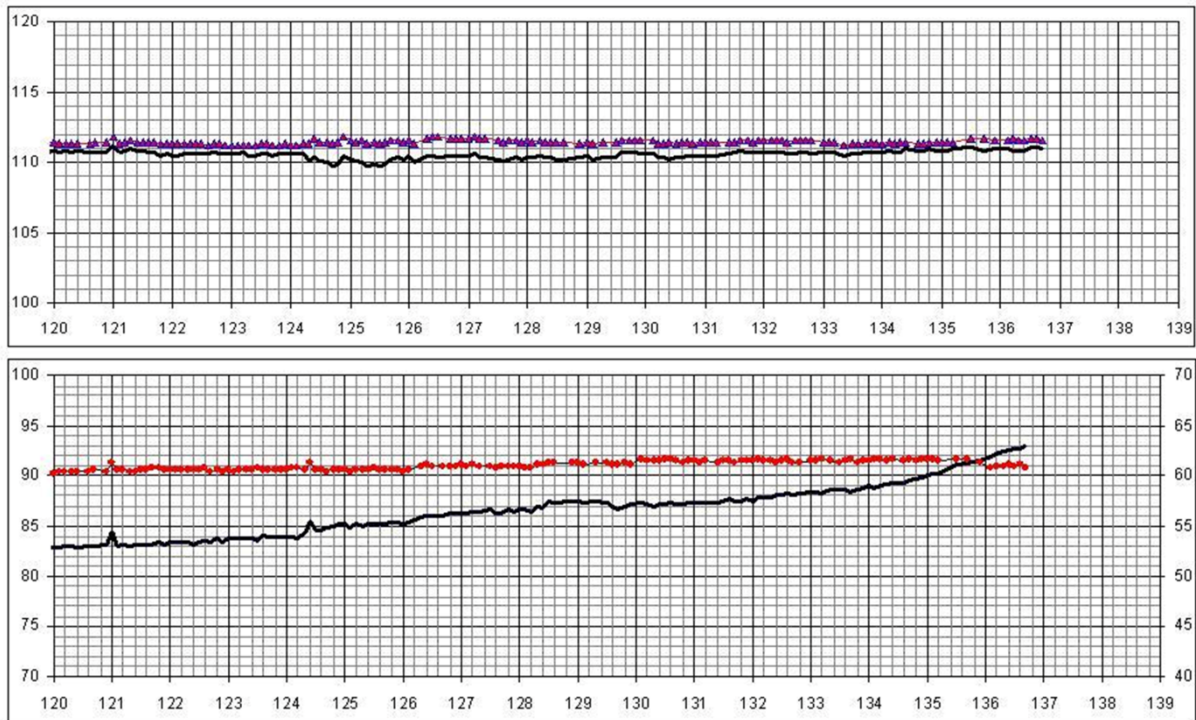
**Fig. 4. Fatigue test of the PZL M28 05's wing and wing load carry-through structure. Strain gauges maximum values recorded at each of 100 flights: (upper) no changes detected within the period shown; (lower) one gauge indicates monotonous change (possibly caused by damage development of the tested article or a strain gauge; in the case of doubts, additional strain gauges were applied).**

*Note some random excesses, but falling within the 2% error limit.*

As mentioned above, strain gauges offer convenient cues to monitor critical areas of a tested article during test. Sample records of strain gauges maximums in each of 100 flights are shown in Fig. 4 and 5. Four strain gauges records are shown in Fig. 4. No actions were initiated due to changes indicated in the bottom part of the figure as no visible damage in the affected area was observed. A different situation is shown in Fig. 5. One of two almost symmetrically located strain gauges (B2-3/P and B2-3/L) indicated a permanent growth. Local damage in its vicinity was detected. Repair was performed and a new strain gauge was installed in approximately the same position. The growth of B2-3/L was a warning signal for the test team who did not introduce any additional damages until the test article was repaired.

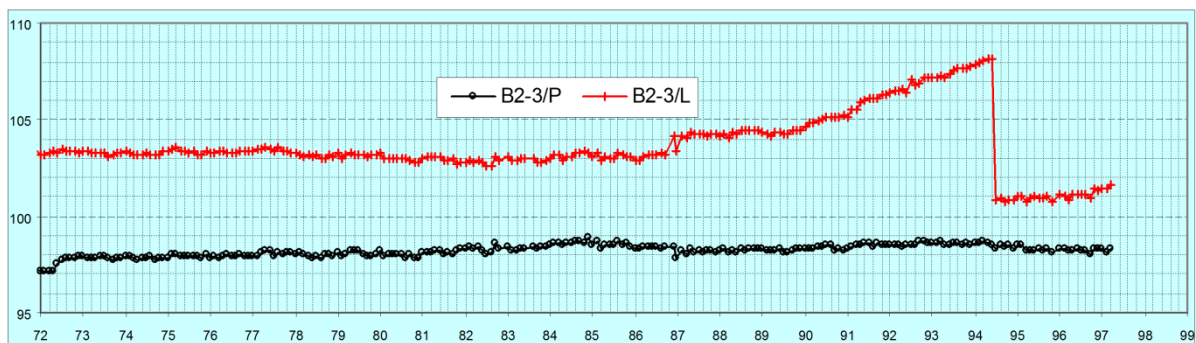
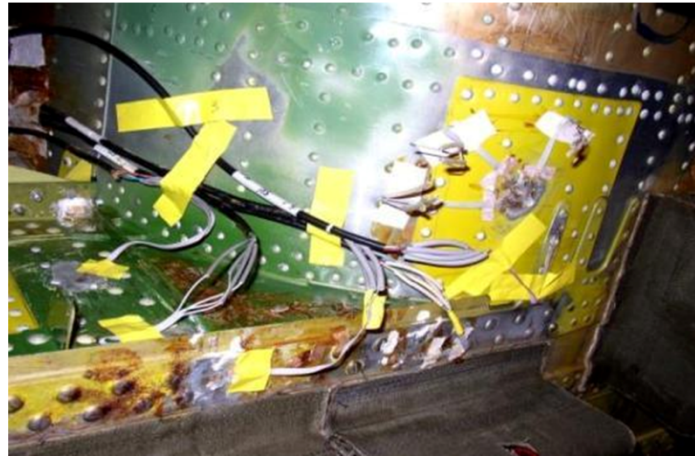
**Fig. 5. Fatigue test of the PZL M28 05's wing and wing load carry-through structure. Two almost symmetrically located strain gauges on the tested article, B2-3/P and B2-3/L maximum values recorded at each of 100 flights are shown. B2-3/L indicated rising up to local damage of the tested article (see the red arrow). Repair was performed and the strain gauge was glued in approximately the same position. B2-3/P is at the undamaged side in this event (its location is shown by the yellow arrow).**
