Analysis of Riverbank Stability Due to Bamboo Vegetation in Walanae River, South Sulawesi, Indonesia

ABSTRACT

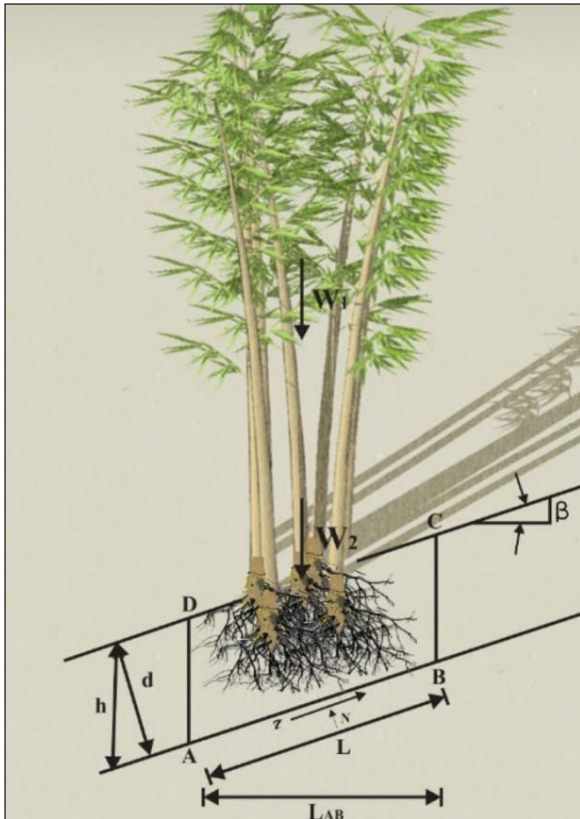
Figure 1. Description of plant weight on cliff stability

The decrease in cliff stabilization on the riverbank was caused by the weight of bamboo plants (W1) and soil mass (W2). The combination of plant and soil mass is described in Figure 1. On the basis of this combination, this research was divided into two objectives. The first objective was to find the weight of bamboo estimated by the diameter of poles. The secondary aim of the study is the risk of collapse. In the slope stabilization study, the mass failure was assessed based on the value of safety factors, which indicates cliff collapse when greater than 1.25 [WSDOT, 2005].

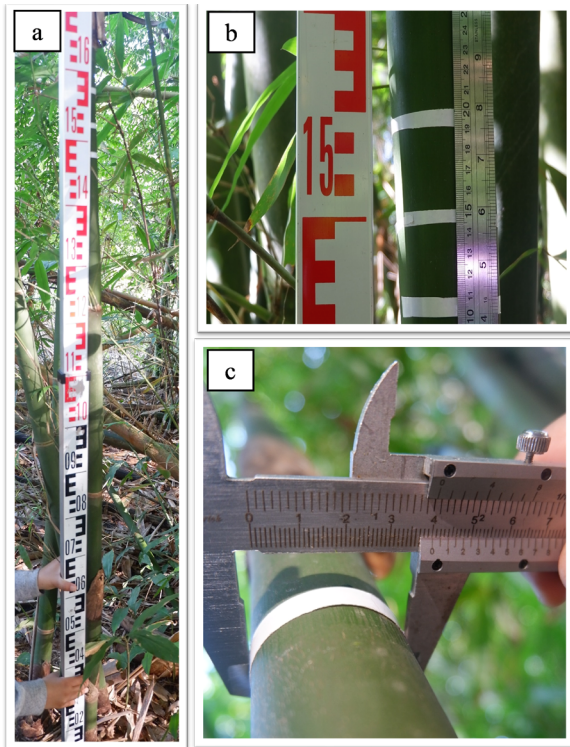
Figure 3. The Measurement of pole diameter

The measurement of bamboo characteristics was carried out in January 2020 – March 2020. The middle area of the Walanae River was chosen as the sampling location with a river length of 42.4 km. There were 46 clumps of parring bamboo (*Gigantochloa atter*) that became the research sample. As one of the endemic species in Indonesia, bamboo grows in the riverbank of the Walanae River. Figure 3 describes the measurement of pole diameter. It started with the determination of observation points (Fig. 3a). Furthermore, Figure 3b shows the point in the stem height of 150 ± 5 cm [Yuen et al., T. 2017]. Figure 3c shows the measurement of pole diameter using a caliper.

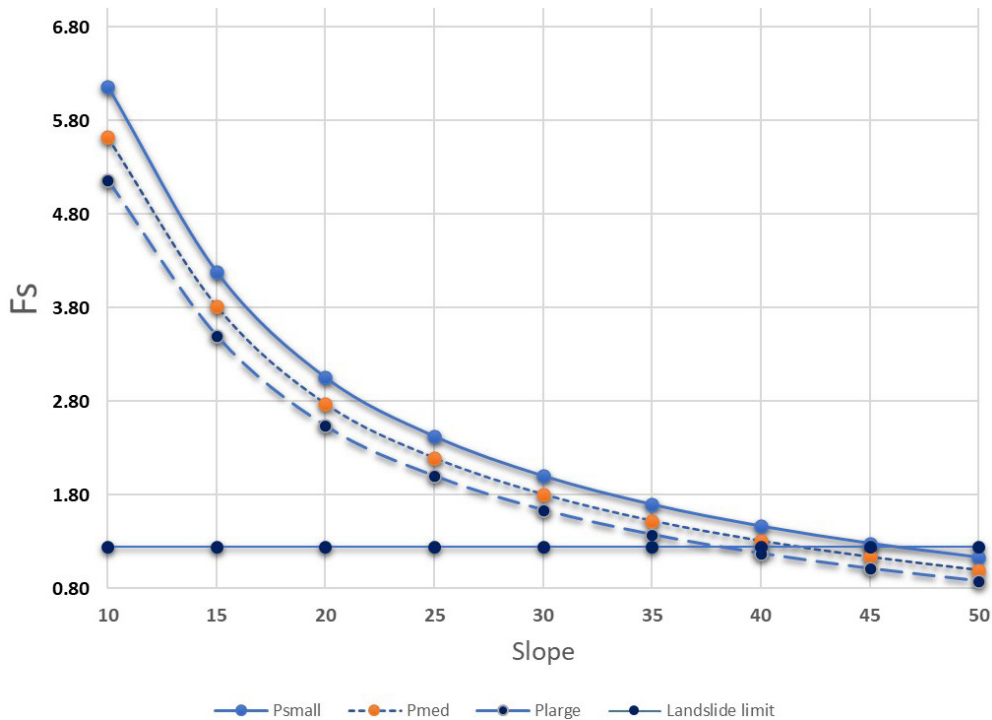
Figure 4. Estimated safety factor due to the weight of bamboo

The results of the safety factor analysis on three bamboo groups with various slopes are presented in Figure 4.

Figure 4 shows the decrease of the safety factor value due to an increase in the slope angle. It proves that the larger the slope angle caused, the more extensive the risk of collapse. Psmall gives the most significant Fs value or indicates a small landslide risk in the bamboo with an average weight of 46.538 kg. If the growth of bamboo

reaches a greater condition, then the chance of landslides is also higher. The increase in the number of bamboo sticks with a large diameter is a sign of an increased risk of landslides.

At a slope angle of 40° , the presence of plarge bamboo causes landslides. Even worse conditions occur at 45° and 50° angles, and bamboo vegetation causes sliding in the riverbank. This indicates that the slope angle of 40° is not feasible to use bamboo as reinforcement for the cliff.
