A NEW APPROACH OF COASTAL CLIFF MONITORING USING MOBILE LASER SCANNING

Rafał Ossowski

Gdańsk University of Technology, Poland

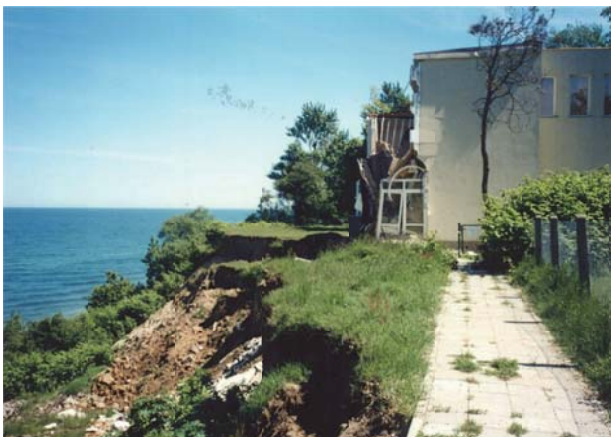
Fig. 2. The leisure centre “Horyzont” situated on the edge of an active cliff and damaged in 2002.
(photo courtesy of W. Subotowicz)

The landslide hazard of the Jastrzebia Gora cliff has been known for several decades. The interest of the society and local self-government in this part of the coast increased in 1988 when the created landslide endangered the leisure centre “Horyzont” (Fig. 2). The average multiannual cliff abrasion rate in this region is approximately equal to 1m/year [1].

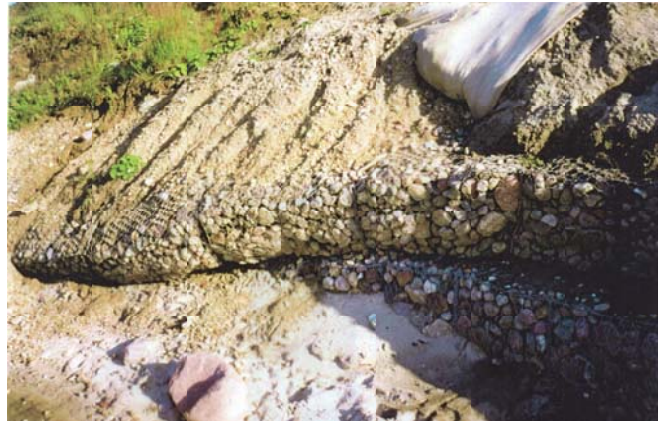
Fig. 3. Gabions composing the seawall in the region of “Bałtyk”, damaged in 1998
(photo courtesy of W. Subotowicz)

In years 1994-1997, a retaining structure was built at the foot of the cliff as a protection for the major part of the

abovementioned cliff segment at Jastrzebia Gora. It had the form of a seawall consisting of gabions. At first, it was built along the eastern cliff part, of 200 m in length, where the partially damaged leisure centre “Horyzont” was situated. Unfortunately, first damages of this seawall were already observed as early as in 1998 (Fig. 3).

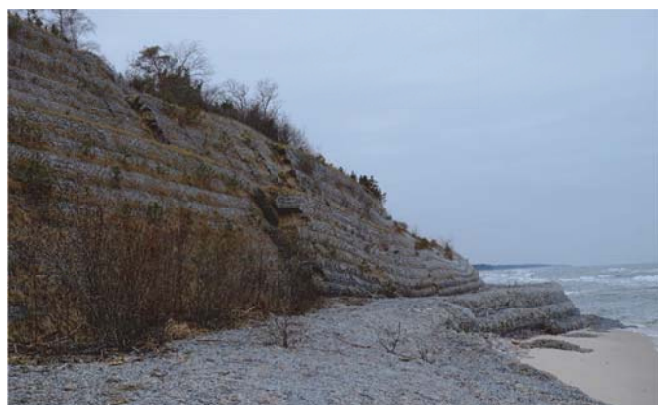
Fig.4. Degradation of reinforced cliff part at Jastrzebia Gora – situation of January 2017.

In 2000, a cliff segment of 200 m in length was protected using reinforced soil. This reinforcement consisted in reconstructing the cliff using dense sand reinforced with geogrids. Unfortunately, after 10 years this structure was also damaged. It was difficult to decide whether that failure was caused by execution errors (incorrect soil densification, for instance [7]), or design errors (ill-suited drainage, etc.). The fact is that the slope with reinforced soil deformed in both: vertical and horizontal direction. According to the terrestrial measurements performed at the beginning of 2011, the displacement of the artificial cliff slope towards the sea was about 1 m, while the settlement already exceeded 1 m [4]. Details concerning the history of attempts made to protect the Jastrzebia Gora cliff are included in [8].

A general conclusion from the above situation is that all past protection measures revealed low durability (see Fig. 4). Consequently, permanent monitoring of the cliff is indispensable for the safety of tourists and residents.
