EXPERIMENTAL RESEARCH ON INSUFFICIENT WATER LUBRICATION OF MARINE STERN TUBE JOURNAL BEARING WITH ELASTIC POLYMER BUSH

Agnieszka Barszczewska
Gdańsk University of Technology, Poland

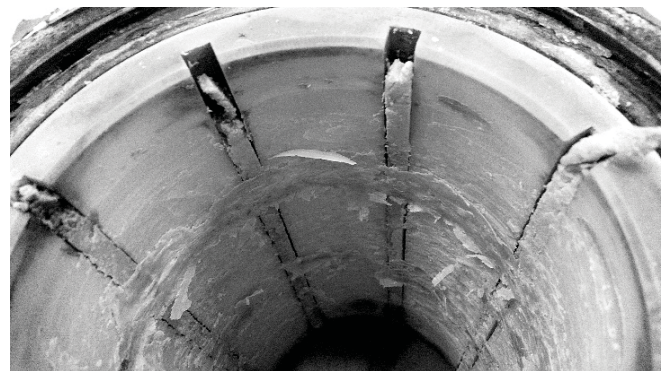
Fig. 1. Elastomer bush melted during the laboratory test. Test conditions: load: 0.2 MPa, speed 10 rev/s, water flow 0 L/min.

When the bearing and the shaft are not capable of transferring out the heat from the friction zone, local contact between the surfaces of the bush and the journal occurs. If water flow is not resumed, seizure and rapid wear of the bush along its entire length occurs [19]. An example of a damaged polymer bush due to limited lubricating water flow is shown in Fig. 1.

The tested bearing was able to work properly for established time at marginal water flows, but probably not without any wear. Both tested bushes had undergone melting and hydrolysis (Fig. 1). The deep cracks in the sliding surface, characteristic of the hydrolysis process, indicates that the bushes had been subjected to the long-term exposure to water at a temperature of at least 50°C. Thus, the process of hydrolytic degradation of the bushes could have already occurred during tests at the water flows greater than 0 L/min.

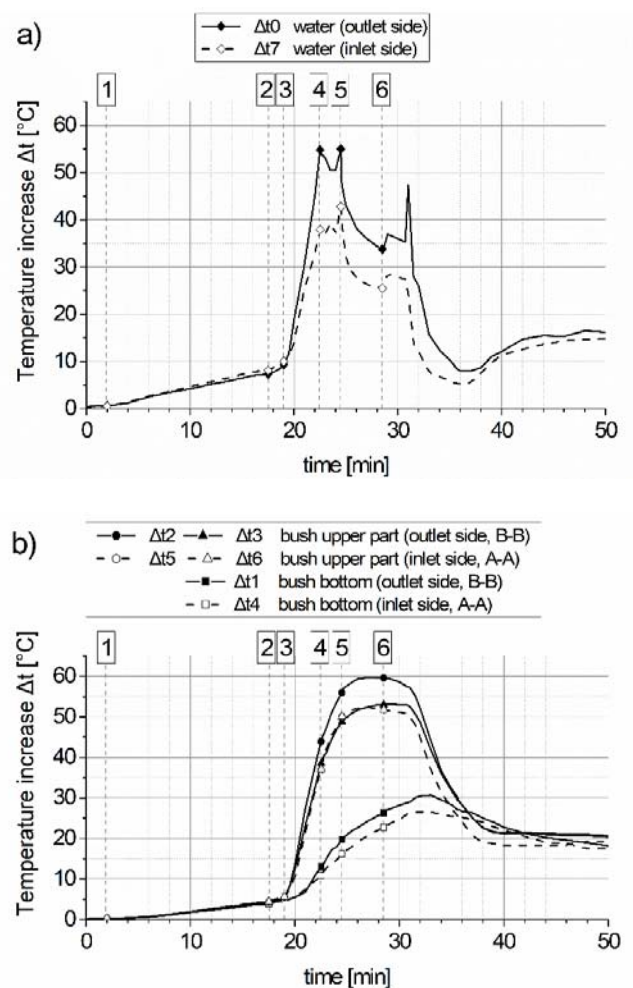
Fig. 5. Temperature and friction torque increase diagrams for bearing with elastic polymer bush. Test conditions: pressure=0.2 MPa, shaft revolution speed =10 rev/s, water flow=0 L/min. a) Water temperature increase diagram, b) Bush temperature increase diagram, c) Friction torque increase diagram, 1 - turning off the water flow, 2 - sudden increase in motion resistance, 3 - limiting shaft revolution speed to 100 rev/s and attempting to turn on the water flow, 4 - another attempt to turn on the water flow, 5 - stopping electric motor, 6 - momentary activation of the electric motor.

The process of simulating a malfunction was initiated by closing off the water flow through the bearing (1). Shutting off the water flow (1) resulted in a temperature increase of the water and the bush. The water temperatures on the inlet and outlet sides of the bearing were increasing at the same rate, and from the moment of closing the valve they were slightly higher than the bush temperatures (measured 3 mm underneath the sliding surface).

When motion resistance had increased (2), the author decided to continue testing, since the water temperature increased by only 8°C from the simulation start and did not exceed assumed 30°C. In less than two minutes temperature differentiation in the bearing was observed (3) and at this moment the valves were opened, the pump transporting water to the bearing was activated, and the revolution speed of the motor reduced from 10 to 1.7 rev/s (100 rev/min). The motion resistance started to decrease, but unfortunately no-water flow through the bush was observed and the bush and the water temperatures were increasing at a very rapid pace (segment 3-4).

According to the author, the flow of water through the bearing was impossible (3), since there was no clearance between the bush and the journal, and the lubrication grooves were blocked by the melted polymer. Additionally, inlet water temperature sensor did not indicate any inflow of fresh water (lack of temperature drop). Water flow was observed after second attempt at activation of the pump (4), resulting in a momentary drop of the water temperatures. The electric motor was turned off at (5) and turned on for a moment at (6).

During the test conducted at the load of 0.2 MPa and no-water flow, bush damage due to overheating took place (Fig. 5). The presumption of the author was to terminate the test if the temperature in the bearing exceeded 50°C, meaning a temperature increase not greater than 30°C or if a concerning increase in the motion resistance was observed. The results of that test are presented in Fig. 5.

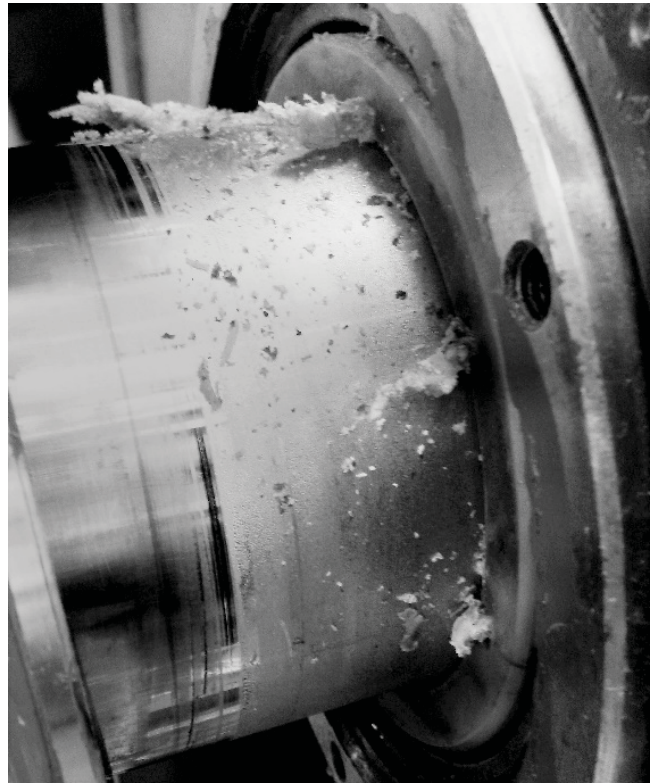
Fig. 6. Disassembly of bearing's cover: lubricating grooves clogged with wear particles. Test conditions: pressure=0.2 MPa, shaft revolution speed =10 rev/s, water flow=0 L/min.

After disassembling the bearing's covers, the melted bush was visible on both sides of the bearing (Fig. 6).

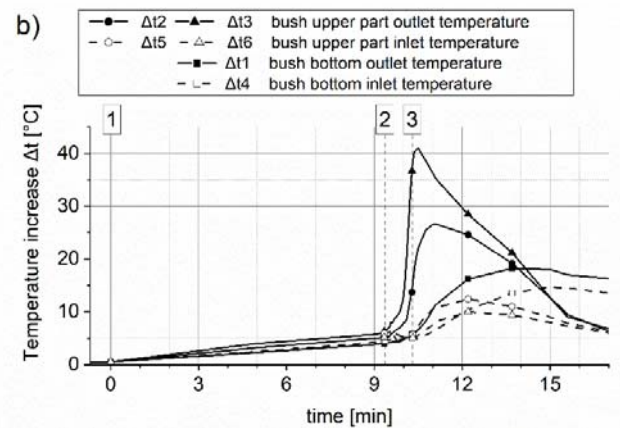
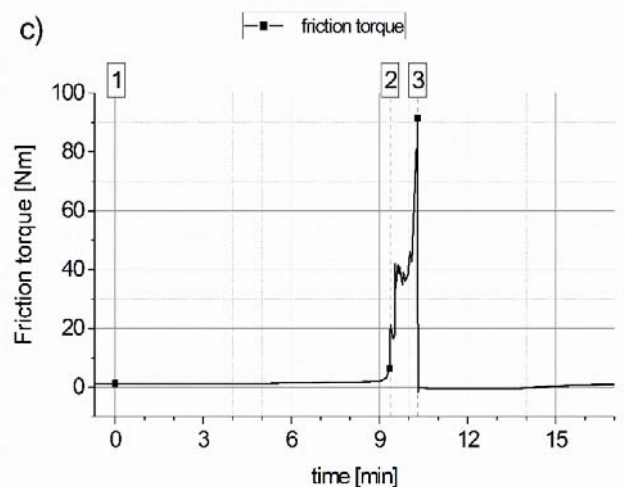
Fig. 8. Temperature and friction torque increase diagrams for bearing with elastic polymer bush. Test conditions: pressure=0.3 MPa, shaft revolution speed =10 rev/s, water flow=0 L/min. a) Water temperature increase diagram, b) Bush temperature increase diagram, c) Friction torque increase diagram, 1 - closing the water flow, 2 - sudden increase in the resistance of motion, 3 - stopping motor's operation.

Following the closing of the water flow (1), the temperatures of the water and the bush rise at a similar rate. After approx. 9 minutes into the test, a sudden rise in the resistance of motion occurs (2), thus the valves are being opened and the water pump turned on. This resulted in bringing down the temperatures on the inlet side of the bearing (Δt_5 , Δt_6 , Δt_7), but also in a sudden increase of the temperatures at the outlet (Δt_0 , Δt_2 , Δt_3). These temperature changes concerns the water and the upper part of the bearing, where lubricating grooves are placed. The outlet temperatures increase is a result of pushing out the hot water from the bearing and it might be additionally affected by water backflow phenomenon [49]. The opening of the fresh water flow did not affect the temperatures at the bottom of the bush (Δt_1 , Δt_4), since water mainly flowed through the lubrication grooves.

The results of the test conducted at 0.3 MPa in the conditions of no-water flow are presented in Fig. 8.

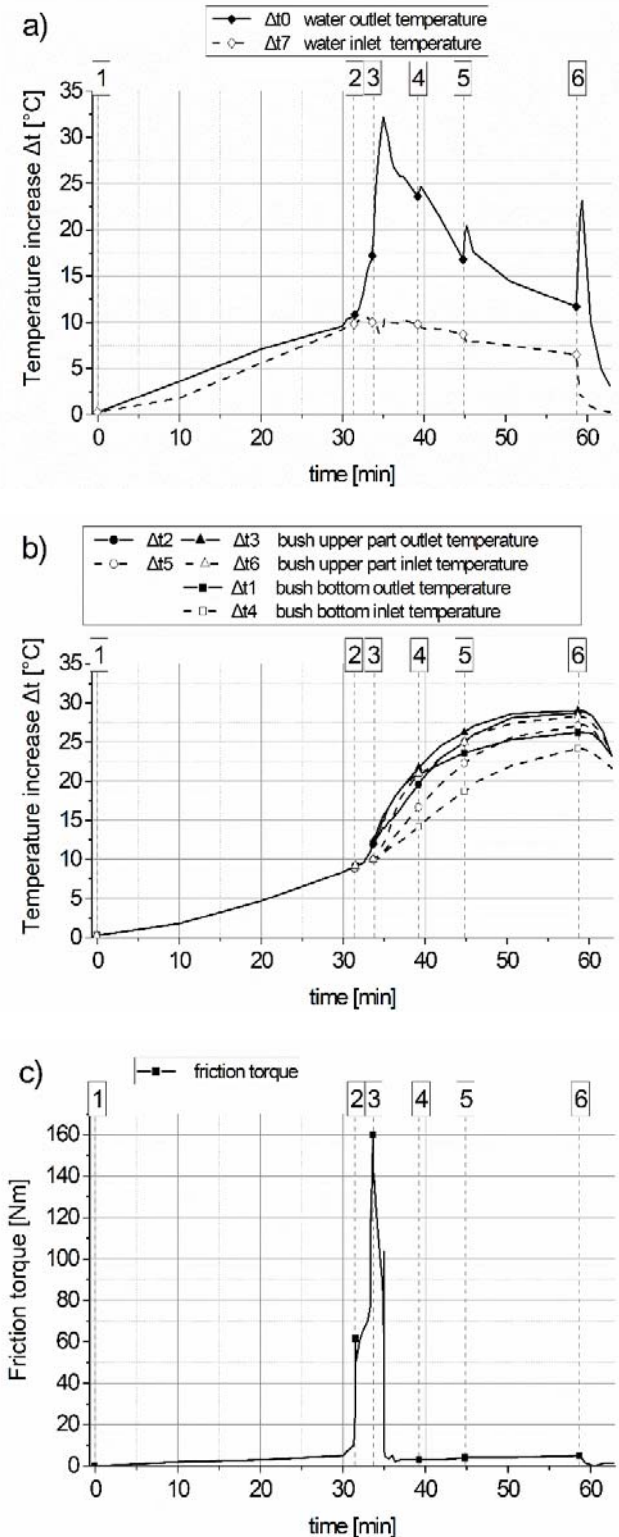
From the moment of closing the water flow through the bearing (1) the water temperature was growing faster than the bearing temperature. After 30 minutes of the bearing's operation at 0.4 MPa sudden increase in the resistance of motion was observed (2). At this point, the valves were opened and the water pump was turned on. Just a few seconds later the cover sealing was pushed out (on the outlet side) by steaming water (2). The steaming water began to leak out and, despite activating the pump, no-water flow through the bearing was observed. A moment later the motor was turned off (3). After switching the electric motor off, several attempts were made to activate the water pump (4,5). It was only after about 30

minutes from the moment of pushing the sealing out that the water flow through the bearing finally took place (6).

Fig. 10. Temperature and friction torque increase diagrams for bearing with elastic polymer bush. Test conditions: pressure=0.4 MPa, shaft revolution speed =10 rev/s, water flow=0 L/min. a) Water temperature increase diagram, b) Bush temperature increase diagram, c) Friction torque increase diagram, 1 - closing the water flow, 2 - sudden increase in the resistance of motion, turning the pump on, pushing out of the cover sealing by steaming water, 3 - stopping the motor, 4, 5, 6 - attempts at turning the water flow on.

The final test consisted of investigating the bearing's behaviour at loads of 0.4 MPa and conditions of no-water flow (Fig. 10).

The test demonstrates that the temperature of the water inside the bearing must have been 100°C, despite the fact that the outlet water temperature sensor indicated only 33°C just a moment before the sealing was pushed out.
