**SELECTED PRACTICAL AND METHODOLOGICAL ASPECTS  
OF RENOVATIONS AND ADAPTATIONS OF MODERNIST  
BUILDINGS FROM THE AFTER-WAR PERIOD  
IN UPPER SILESIA**

Tomasz WAGNER\*, Ryszard NAKONIECZNY  
Faculty of Architecture, Silesian University of Technology, Gliwice

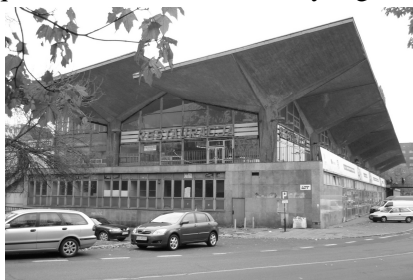
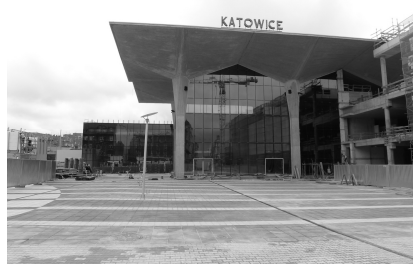
Fig. 1-2. The negating attitude - Katowice Railway Station, designer Waclaw Kłyszewski, George Mokrzyński, Eugeniusz Wierzbicki, Waclaw Zalewski, 1959 - 1972, state of 2010 (photo on the left), demolished in 2011, the renovation of a part of the "cone" structure in the "railway station gallery" - new shopping centre formed in place of the railway and bus stations, 2012 (photo on the right).

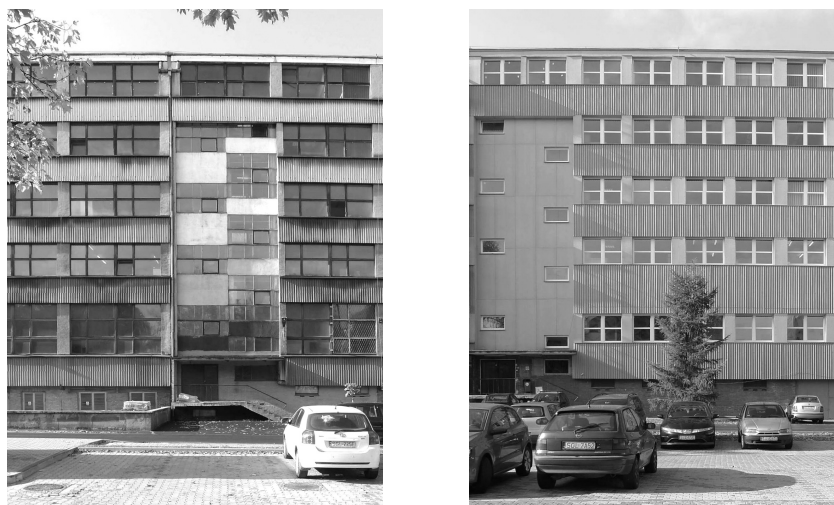
Fig. 5-6. The attitude of the partial acceptance - the Department of Civil Engineering Laboratory, Silesian University of Technology. Designed by Professor T. Teodorowicz-Todorowski (1973), Elevation before and after thermal insulation in 2012. Its project, completely obliterating the original features of the building, although obtaining a building permit, the attorney of the Academic District, Dr. G. Nawrot, protested thanks to which the building has partially retained some features characteristic for modernism. Unfortunately, the elevations have lost their original avant-garde character. Photo by R. Nakonieczny 2012.

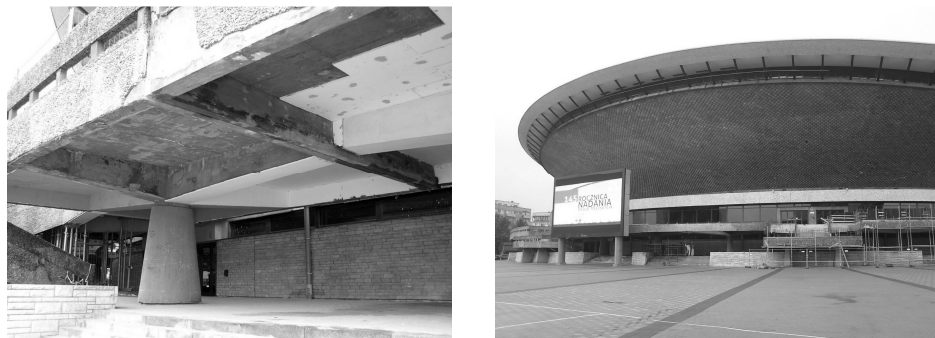
Fig. 7-8. The attitude of full acceptance – a sports hall "Spodek" in Katowice, designer M.Gintowt, M.Krasiński, A.Żórawski, A.Włodarz, W.Zalewski, 1960-1972. At the end of March 2011, modernization work was commenced (Figure on the left). The first project was commissioned by MOSiR and was rejected after the intervention of the Chamber of Architects and the provincial authorities who intended to favour projects which would preserve the historically well-established form of the building. In Figure on the left – the commence of the work, which resulted in protests – in this case: cladding the exterior terrace with a layer of polystyrene (!) designed in the „béton brut” aesthetics.

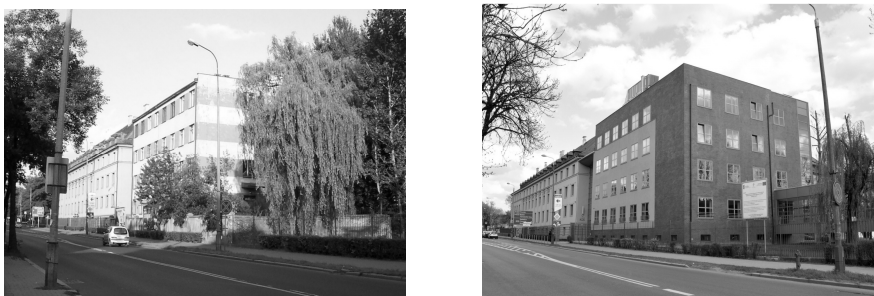
Fig. 13-14. The attitude of creative continuation – the reconstruction and extension of the Department of Organization and Management at Roosevelta Street 32 in Zabrze (former Military Command Replenishment). The design of the building sygn.1973 WBP, reconstruction 2006-2011, the authors of the project J.Witeczek, G.Nawrot, T.Wagner. The state before (2005) and reconstructed (2011)<sup>II</sup>. Photo by T. Wagner.

<sup>II</sup> The facility was granted an award in “The best public Space in Silesian Voivodship (13<sup>th</sup> edition of the competition)”.
