The role of the tenement housing development in the urban structure of Western and Central Ukraine during the Secession era

Keywords: Secession, tenement housing development, Western and Central Ukraine, House with Chimaeras

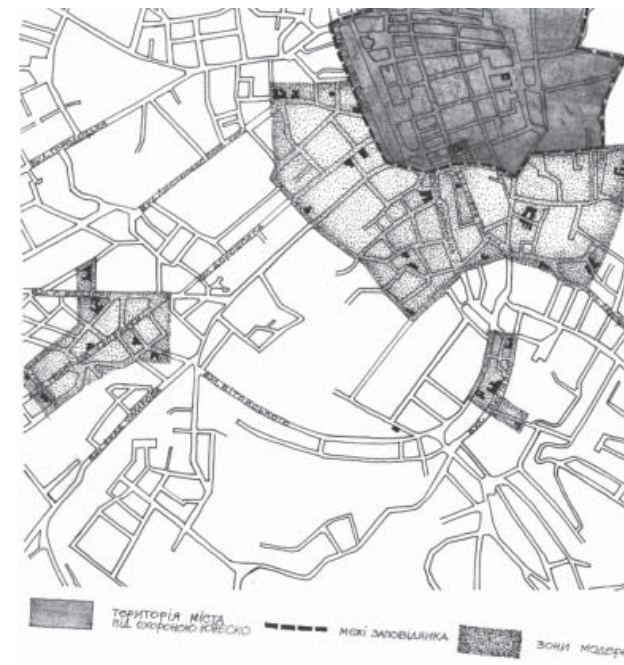
Ill. 1. The location of the Secession zones on the plan of Lviv (Scheme of Yu. Ivashko)

The formation of neighbourhoods of concentrated Secession tenement buildings in Lviv, outside the medieval city, occurred directly under the influence of the then large-scale urban-planning activities. They laid new streets and boulevards, increased the area of private residential lots in comparison with the medieval center. The built-up density and the number of stories in buildings increased as well. (Ill. 1).

The specificity of Lviv tenement housing development in the Secession era is the integrity of the architectural ensemble and using of one style, especially that often the whole street was built up by the same architectural bureau or architect (the ensemble of Asnyk Street (Acad. Bogomolets St.) and the ensemble of Domagalych Street (Acad. Pavlov St.), ensembles along Hlynianska Street (D. Dontsov St.), Friedrich Street (Martovych St.), Yablonski Street (Shota Rustaveli St.), Bonifratry Street (M. Kravchuk St.), Lenartovych Street (Nechui-Levytskyi St.) (Ill.1).

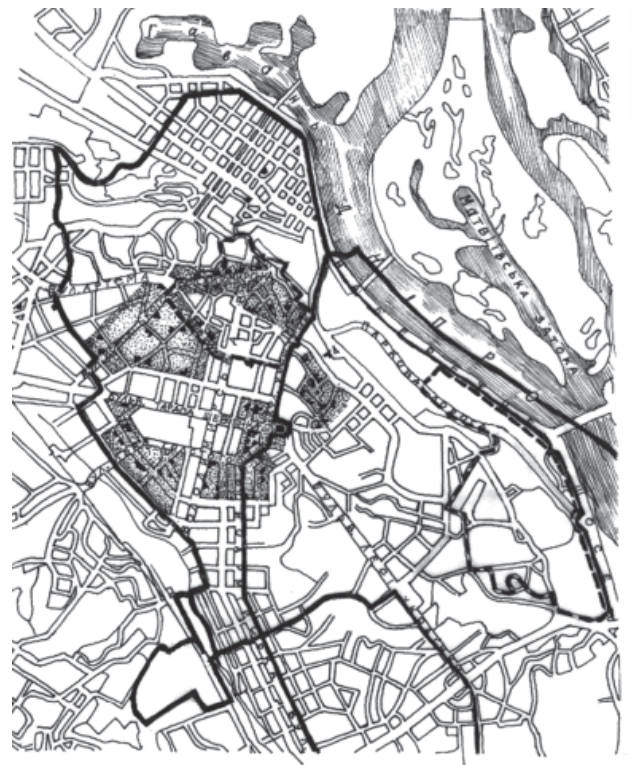
III. 2. The location of the Secession zones on the plan of Kyiv (Scheme of Yu. Ivashko)

Considering that the Secession city development required much more funds than, for instance, typical residential building of the period of historicism-eclecticism; this led to the fact that tenement houses in the Secession style, constructed on the streets and squares of the first and second level, should be brick, and had no less than two floors, should be built on individual projects and approved in the City Duma with the supervision of construction (III. 2).

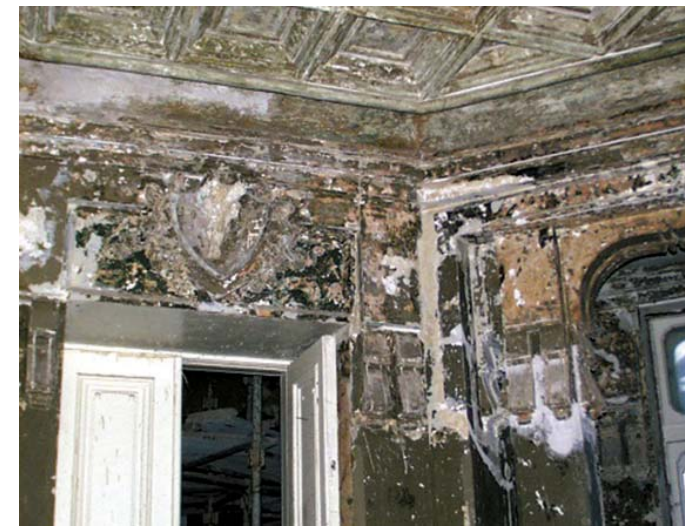
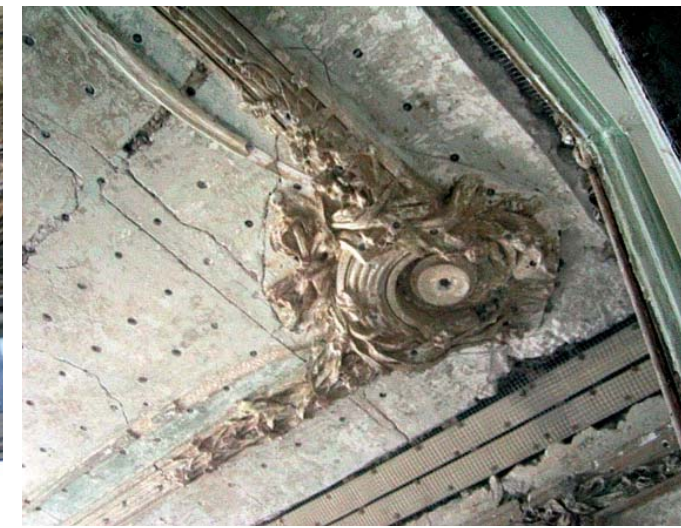
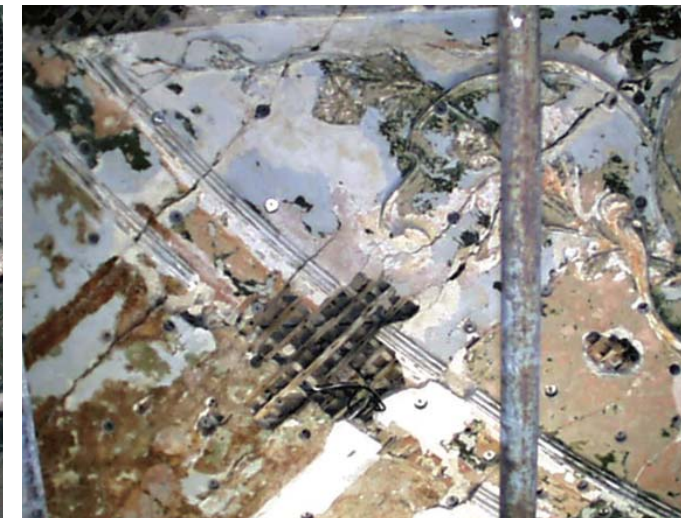
III. 3. The house at 10Bankova Street.Condition of interiors before restoration. Photo: Ukrrestavratsiia corporation,2001-2003

served; the easel painting and "alfresco marble" of the main staircase, required restoration (III. 3). The issues of restoration of the Kachkovskiy clinic building at 33 Honchar Street were associated with a change in the authentic appearance of the main facade as a result of the re-painting during previous repairs and the loss of a part of the décor; the main cause of damage was the influence of atmospheric factors, which caused wetting of structures, biological damage of wetted areas, corrosion of metal fittings of sculptures and chips of surfaces.

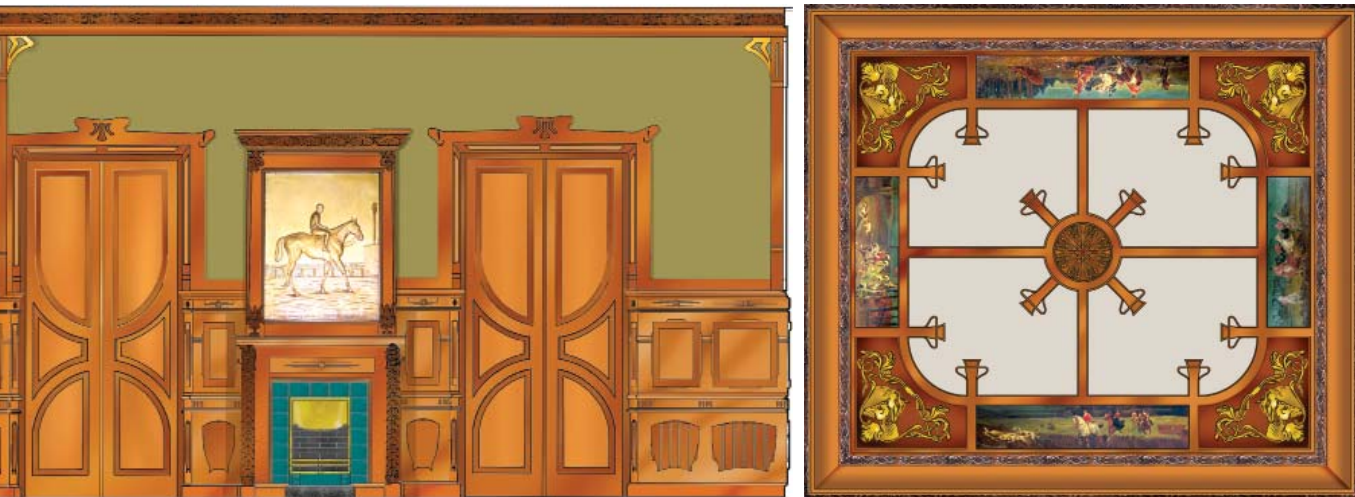
III. 4. The project of the English study in the apartment of L. Rodzianko. (Development of the Ukrproektresvratsia Scientific Institute).
a. The balcony before the restoration, b. The gable after the restoration

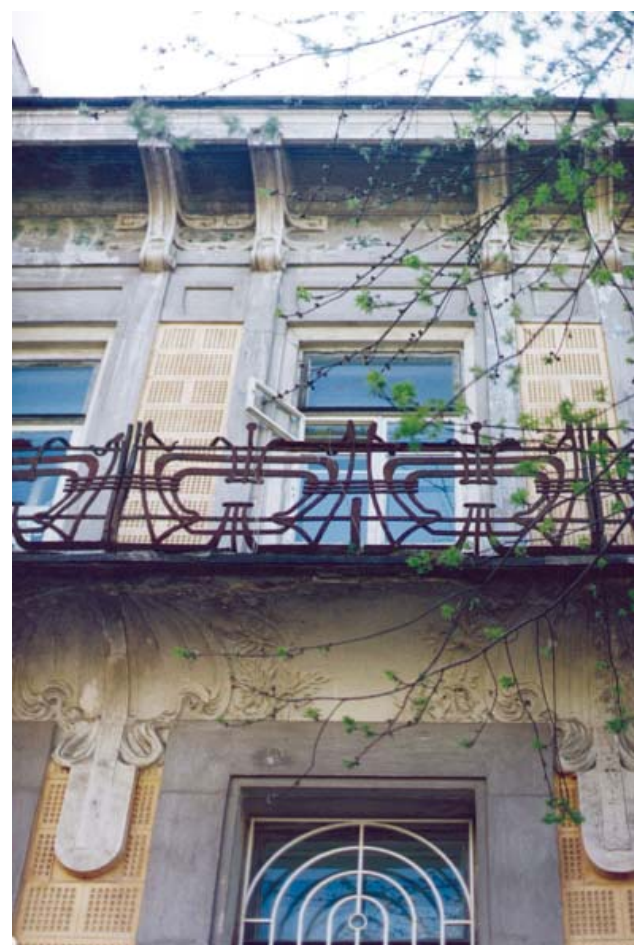
III. 5. The Kachkovskiy clinic. Photo: Yu.Ivashko, 2009.
a. The emergency condition – cracks from 32 to 38 cm,
b. The scheme of bored piles

The main facade of the building was covered with cracks; it was necessary to replace the waterproofing of the balcony and terrace, a part of the crowned metal elements and to eliminate salt efflorescence. The unsatisfactory technical condition was fixed at the top of the cornice, brackets, decor, decorative ceramic and glass inserts, decorative pedestals of the basement, and sculpture of the main facade. Corrosion of metal fittings inside cement sculptures of sirens and a lion led to their splitting into separate fragments and the loss of some parts with exposure of internal fittings; corrosion of metal fittings caused an emergency condition of the left balcony, floors of the terrace and structures of the passage to the courtyard (Ill. 5).

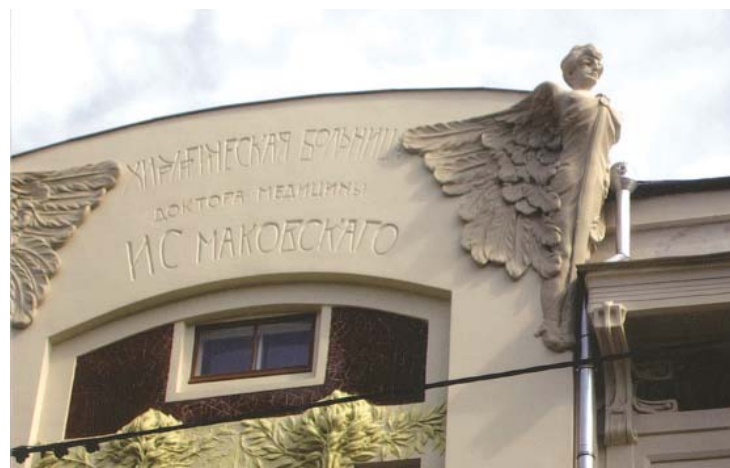
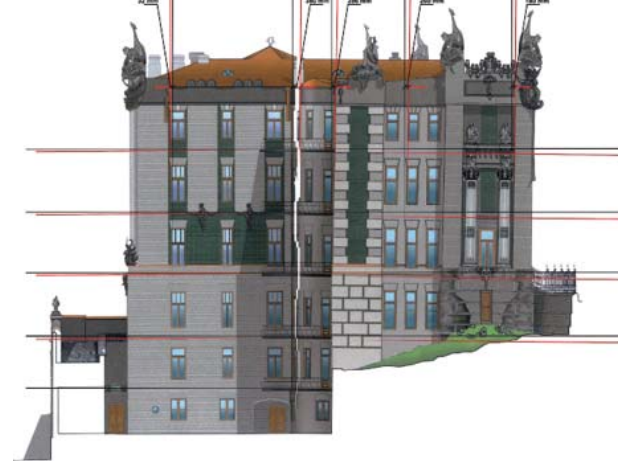
III. 6. Materials of Ukrrestavratsiia corporation, 2001-2003

The greatest number of issues arose during the restoration of the house at 10 Bankova Street. The main problem was connected with the combination of two different foundation systems without contraction joints (strip foundations from the side of Bankova Street, and from the side of the slope foundation on bored piles (first used by an engineer A.E. Strauss), which led to uneven building subsidence – as a result the house split into two parts and the walls were inclined from the vertical by 38 cm. This caused the appearance of numerous cracks, deformation of the floors (Figure 6).

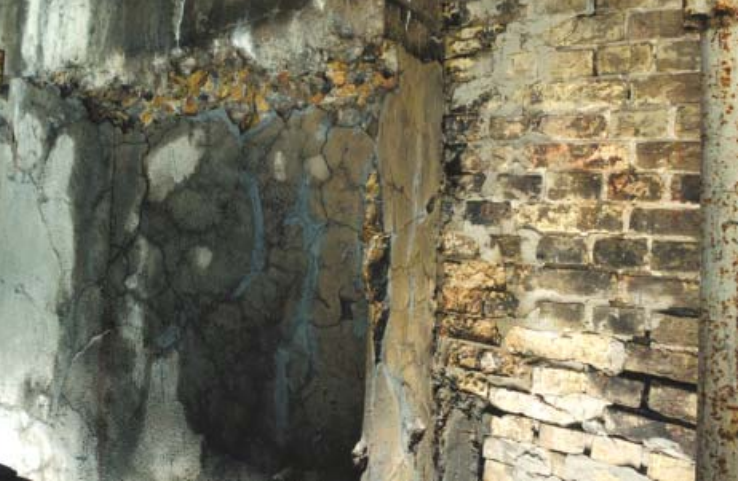
Ill. 7. The house at 10 Bankova Street. The façade before the restoration
Photo: Ukrrestavrtsiia corporation, 2001

Like in the building of the Kachkovskiy clinic, the emergency condition of the balconies of the southern facade of the house of W. Horodecki at 10 Bankova Street, with the destruction of concrete, corrosion of the internal reinforcement of the monolithic reinforced concrete balcony slab and decorative balustrade, was caused by wetting through atmospheric humidification, in this case, the emergency condition of the zinc covering of the roof, wetting of wooden roof structures and floor due to biological damage of the beams. Humidification of walls masonry and, consequently, penetration of atmospheric moisture into the thickness of rustic through the surface cracks and pores and metal corrosion inside the rustics led to an emergency condition the basement cement mortar rustications with imitation under the clumps of natural crushed stone, with the appearance of through cracks, loss of cement sandy mortar and seasonal biological damage. Humidification and sedimentary processes led to the destruction of the cement decor of the facades, the appearance of cracks, erosion and biological damage. Atmospheric and groundwater moistening resulted in the loss of a decorative overlay dark gray cement roller for joints pointing in masonry on almost all facades (Ill. 7).

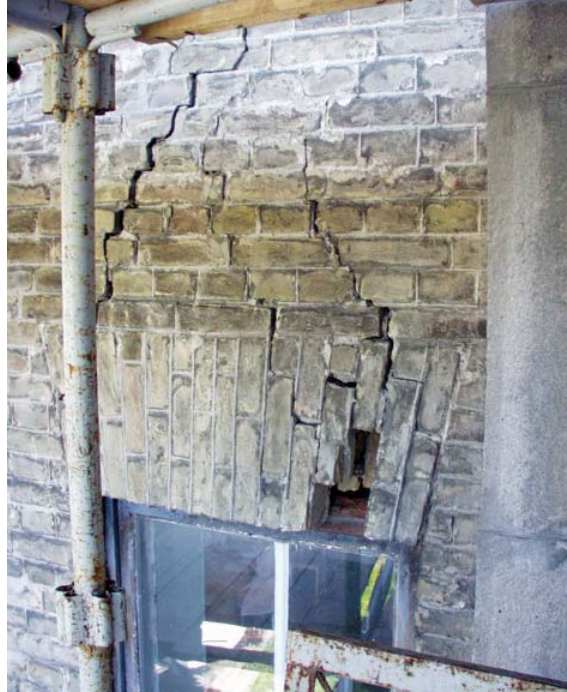
One more issue that was fixed and in the houses at 14b Yaroslaviv Val Street and at 33 Honchar Street was associated with wetting, but in the case of the house at 10 Bankova Street, it was continuous significant soil moistening of the footing under foundations, which led to uneven subsidence of the foundations and walls, chipping of the surface of the front masonry, biological damage of all surfaces of the northern facade and basement floor and disruption of the paint layer.

The subsidence phenomena caused the activation of cracks mainly on the north and south facades with a tendency for further disclosure, including masonry disturbances and bricks falling out.

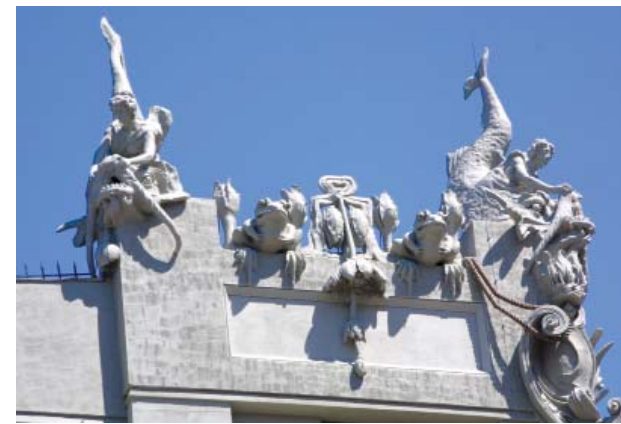
Ill. 8. The house at 10 Bankova Street.
a-b. The condition of the sculptures of façade before the restoration.
c. The condition of the sculptures of façade after the restoration
Materials of Ukrrestavrtsiia corporation, 2001-2003

The cause of the emergency state of the cement-sand facade decoration of the house at 10 Bankova Street, as well as of the building of the Kachkovskiy clinic, was the corrosion of internal metal reinforcement, which led to the appearance of cracks and loss of fragments of sculptures (Ill. 8).
