ARCHIVES of FOUNDRY ENGINEERING

ISSN (2299-2944)
Volume 17
Issue 1/2017

The Analysis of Foundry Engineering of Copper Alloys Based on the Research of a Metallurgist Settlement in Szczepidło

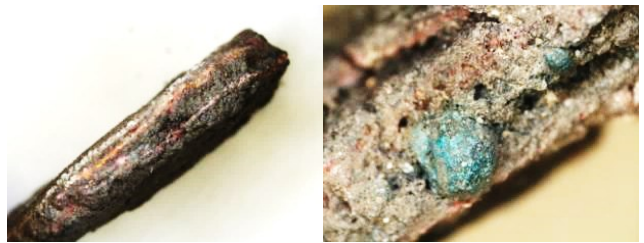
Fig. 1. Part of crucible wall No. Sz-656 with visible drops of alloy

In the group of artefacts linked to the foundry workshop, a set of ceramic objects was assembled. After conducting the observations and analyses, it was confirmed that they served as crucibles in the technological process of copper alloys. The crucibles were made from clay with a significant amount of sand, which allowed the removal of moisture and heat exchange, and it affected the required fire resistance of the ceramics. The following are the chosen results that demonstrate that the ceramics were in contact with the liquid metal. This contact resulted in penetration of metal into the porosity of the crucible walls, which is visible in microscopic photographs as drops of liquid alloy formed in the porosities (Fig. 1).

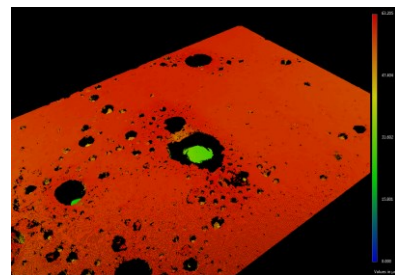
Fig. 2. Topography of the fracture of crucible No. Sz-657, magnification 200x, drops of alloy visible. The scale shows values in μm

The fractures of the crucible walls were investigated using confocal microscopy, which allows obtaining spatial picture where different topography layers of the artefact investigated can be seen (Fig.2). There are significant differences in levels visible in the place where the solidified drops of the alloy were expected.

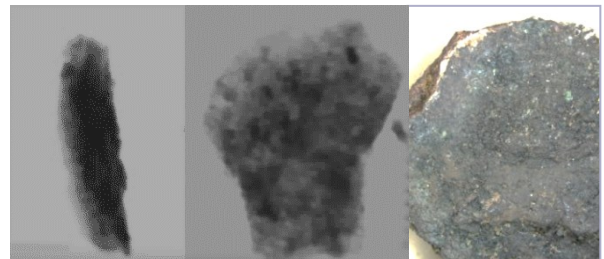
Fig. 3. The result of testing a part of crucible wall No. Sz-14467 by X-ray defectoscopy

The contact of ceramics with molten metal was also shown in radiographic volume tests (Fig. 3).

The pictures of the material structure confirm that the thin crucible walls are saturated with metal. The inside layers of the crucible are shown in dark colour which means that a composite layer of ceramics-metal was created, because of temperature and contact of the ceramics with molten metal. The presence of metallic elements in the walls of the crucible was also confirmed based on X-ray fluorescence spectrometry (Fig. 4, Tab. 1).

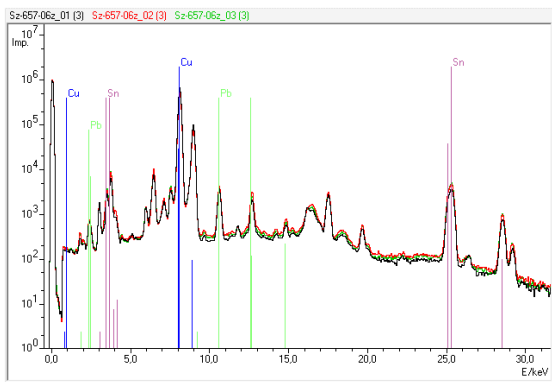
Fig. 4. Graph of fluorescence spectra for crucible No. 657 with marked characteristic elements: copper and alloying tin and lead

The dominant share of copper and the alloying elements of tin and lead was confirmed. Based on analyses, pottery fragments with visible traces of metals need to be regarded as industrial ceramics used for production of tin bronze (crucible No. 662) and tin-lead bronze (crucible No. 657).

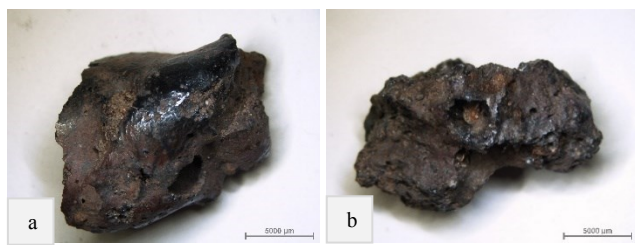
Fig. 5. Macroscopic pictures of slags No. 14060-13.5 (a) and 13.7 (b)

Macro- and microscopic pictures were taken of the slags, as well as defectoscopic pictures (Fig. 6a) and chemical content analysis was performed. The slags contained trace amounts of metallic elements, apart from a few cases where small amounts of copper were observed. The pictures (Figs. 5-6) reveal inhomogeneous structure of the slag. Numerous porosities and voids visible inside point to air bubbles locked in the slag structure, testifying to a significant gassing of the alloy.

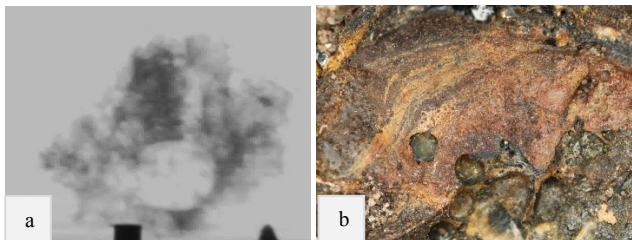
Fig. 6. The result of X-ray defectoscopic tests (a) and microscopic observations, 20x (b) of fragments of No. Sz-14044

The slags should be regarded as remains of a typical bronze melting process, they were collected from the metal surface together with non-metallic impurities present in the metal bath.

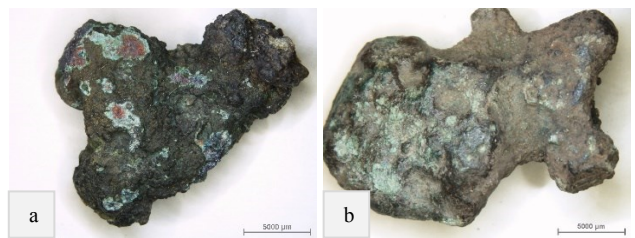
Fig. 7. Semi-products No. 512 (a) and 519 (b)

Within the group of production discards and semi-products, numerous artefacts (Fig. 7) were investigated pointing directly to the foundry activities conducted in the settlement area. Production waste as home scrap was probably used also as raw material in the process of bronze melting.

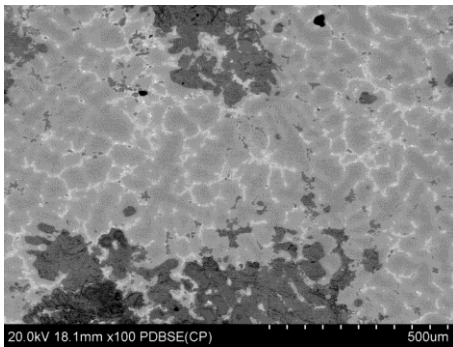
Fig. 8. SEM microstructure No. 506, 100x

The microstructure image of the chosen samples (No. 506 and 634) showed the characteristic dendritic structure of the material. There are copper dendrites visible (α solid solution), while in the interdendritic spaces there are intermetallic phases of Cu-Sn-Pb-As. Also, the presence of copper sulfides Cu_2S was noticed. Near the porosity, oxide precipitates Cu_2O i SnO_2 were documented, as the products of copper and tin corrosion. The presence of big copper dendrites (of variable size) points to the slow solidification in a sand or clay mould (Fig.8). Below the pictures, the results of chemical analysis in microareas are compiled, expressed as weight percentage (Fig.9).

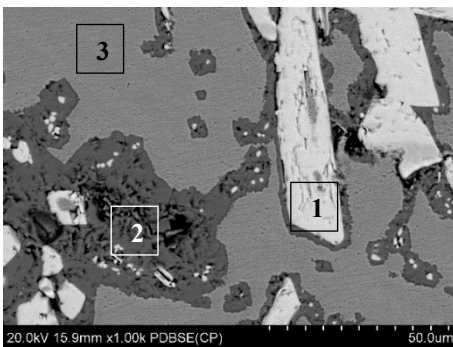
Point/Element	O-K	Ni-K	Cu-K	Sn-L
634 pt1	23.18	0,00	2.36	74.46
634 pt2	10.21	0,00	89.79	0,00
634 pt3	0.50	0.39	99.11	0,00

Fig. 9. Microstructure image and SEM-EDS analysis No. 634

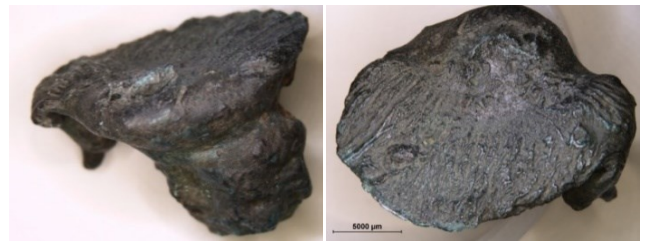
Fig. 10. Pouring cup No. 553

The connection of these artefacts with the foundry workshop is also confirmed by fragments of gating systems, especially the funnel-shaped gates, with the plane of free solidification clearly visible, which is characteristic of casts solidifying in open moulds. There are lines and directions of solidification clearly visible as well as a forming contraction cavity (Figs.10-12). Two of the pouring cups do not show any seams resulting from two-part moulds, so they can be treated because of precision casting by lost-wax method. The shape of the third cup (No 533) however, relates to a two-part mould, which signifies that both technologies were used in the discussed workshop.

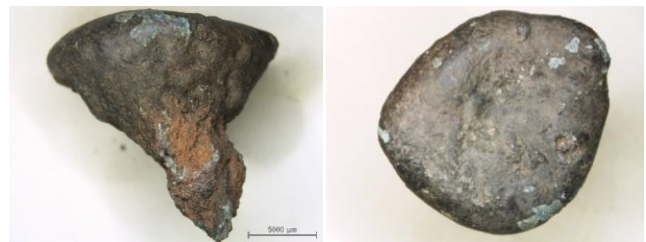
Fig. 11. Pouring cup No. 581

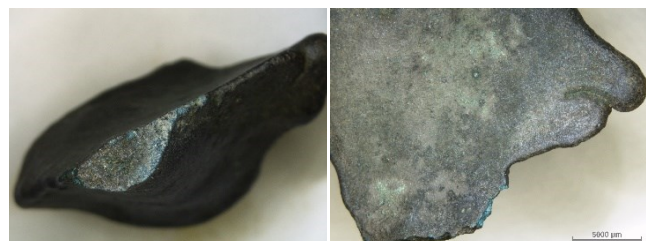
Fig. 12. Pouring cup No. 533

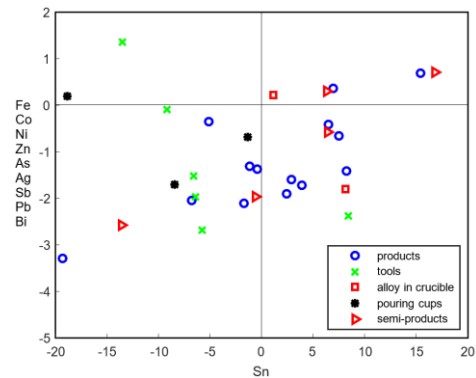
Fig. 13. Principal components analysis of bronze objects: tin, antimony, arsenic, lead, bismuth, nickel, silver, iron and cobalt.

Distance from the average content (wt%). Zero means the average concentration of Sn (x-axis) and the average value of the sum of the other components Fe, Co, Ni, Zn, As, Ag, Sb, Pb, Bi (y-axis). Marked groups: finished products (little arrowheads, pins, bracelets, wires), tools, alloy in crucible, pouring cups, semi-products and production waste. It needs to be acknowledged that the material tested is very inhomogeneous which shows in structure images and the values of chemical content. Because of the great inhomogeneity of chemical content and the presence of tramp elements such as arsenic, antimony, nickel and silver it is difficult to define the properties of the analyzed alloys. The analyses of strength and plastic properties cannot be carried out on the historic material because of the destructive character of these tests.

The compilation of the results is presented in Table 2 and in the graph (Fig. 13).

Principal components analysis of bronze objects: tin, antimony, arsenic, lead, bismuth, nickel, silver, iron and cobalt is presented in the graph (Fig. 13).
