## THE CONSERVATION-RESTORATION OF ARCHITECTURAL STATUARY IN ACCORDANCE WITH THE ETHICAL REQUIREMENTS FOR SCULPTURE AND ARCHITECTURE

DE CLERCQ Camille<sup>1</sup> DE ROY Judy<sup>2</sup>

<sup>1</sup> Stone Sculpture Conservation Studio, Royal Institute for Cultural Heritage (KIK-IRPA), 1 Parc du Cinquanteenaire, 1000 Bruxelles, Belgium; Camille.de.clercq@kikirpa.be

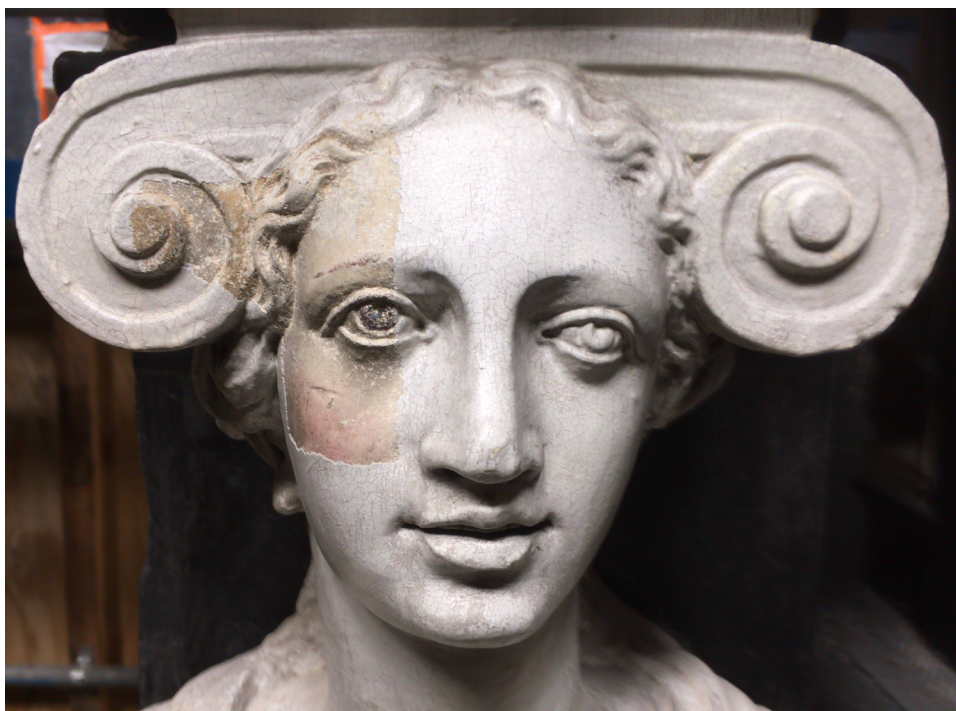
Fig. 1 Eucharistic tower, Hiëronymus Duquesnoy, 1604 (Sint-Martinuskerk, Aalst): detail of a stratigraphic window on the architecture around the sacrarium (southside). Multiple layers of overpaint cover original alabaster imitation (© KIK-IRPA, Brussels, Camille De Clercq)

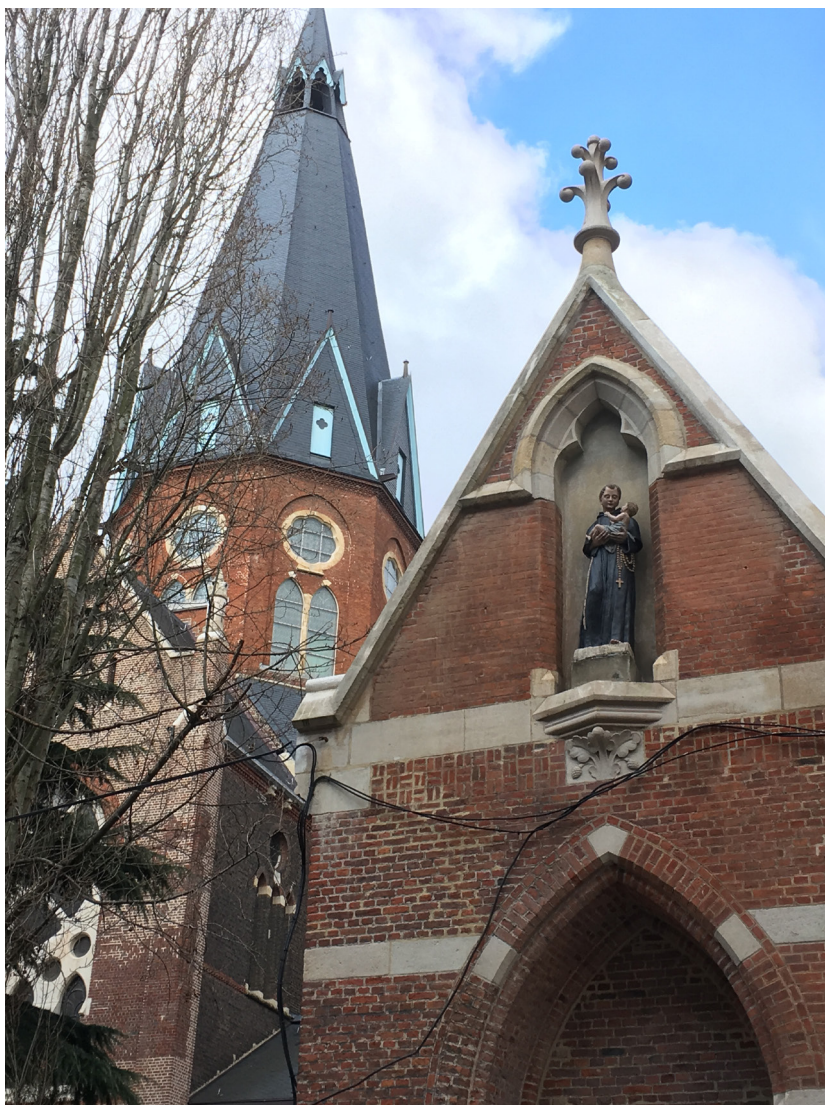
Fig. 2 Statue of Saint Anthony in situ, Georges Houtstont, ca. 1868 (© KIK-IRPA, Brussels, Sam Huysmans). After treatment

The 138-centimetre-tall statue of Saint Anthony is conserved outdoors in its original niche at a height of 8 meters. It makes part of a completely preserved neo-Gothic site in Brussels, consisting of a church and a convent created by architect P.J.H. Cuypers (16 May 1827 – 3 March 1921) in 1868. Saint Anthony, patron of the church community, is represented in a typical way and with his usual attributes. He is wearing the Franciscan habit, with a rope belt and a large rosary hanging from his robe. He holds the Infant Jesus in his hands.

After an outdoor exposure of 150 years, the conservation state of the sculpture was problematic. The most badly weathered parts are situated at the bottom of the right arm and at the base. Infiltration

of rainwater and rising damp in combination with frost action provoked a series of small cracks and delamination resulting in material loss. The terracotta surface of the sculpture was largely unprotected as a large part of the paint layer was missing. Stratigraphic investigation however showed that the sculpture was originally finished with a paint layer. The realistic effect of the statue was emphasized by this elaborate polychromy. The soutane resembled black velvet with a yellow-brown rosary and the Infant Jesus wore a light blue loincloth. The original polychromy is well preserved on the flesh tones but largely disappeared on the robes vestments, especially on the front side. The statue was overpainted twice. First in colours similar to the original polychromy and later with a whitish paint layer. The binding media were not fully identified. However, there is evidence that all the paint layers were bound in an oil medium.

It is obvious that the priority of the conservation treatment is to stabilize the terracotta support. The cracks where rainwater could infiltrate were filled and the statue's partly broken base was consolidated. To keep the intervention to a minimum, broken parts that do not have a supporting function such as the monk's sleeve and the Child's limb have not been restored.

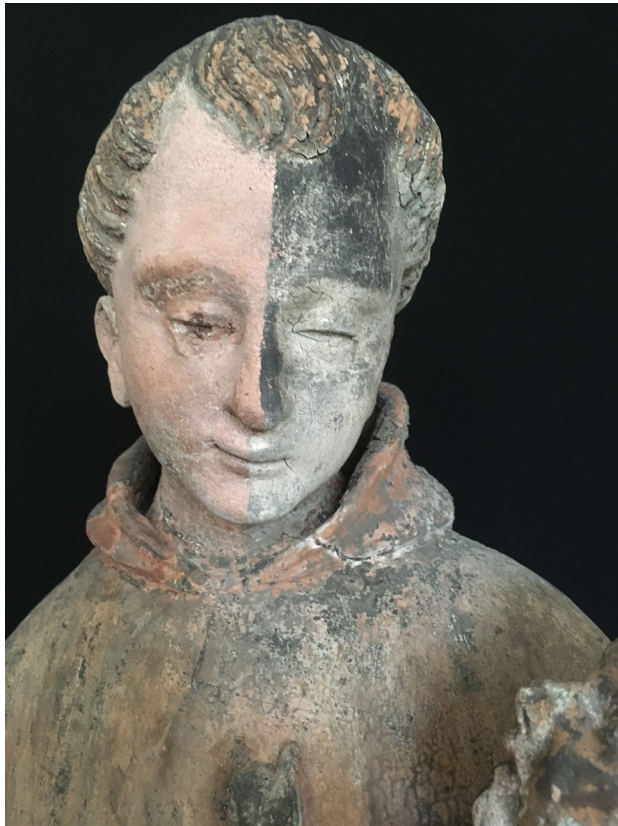
Fig. 3 Statue of Saint Anthony, Georges Houtstont, ca. 1868, polychrome terracotta. The group during the treatment, still covered by greyish overpaint on the right; on the left, the polychromy cleared of the overpaint which weighed down on it (© KIK-IRPA, Brussels, Camille De Clercq)

Since the expression of the face of Saint Anthony was completely lost, we decided to test the possibility of removing the whitish overpaint. The result was aesthetically very satisfying (Fig. 3). Unfortunately, this approach could not be applied on the other parts of the sculpture as the polychromy had largely disappeared. On the front side of Saint Anthony's robe for example, there were hardly any remains of the original paint layer.

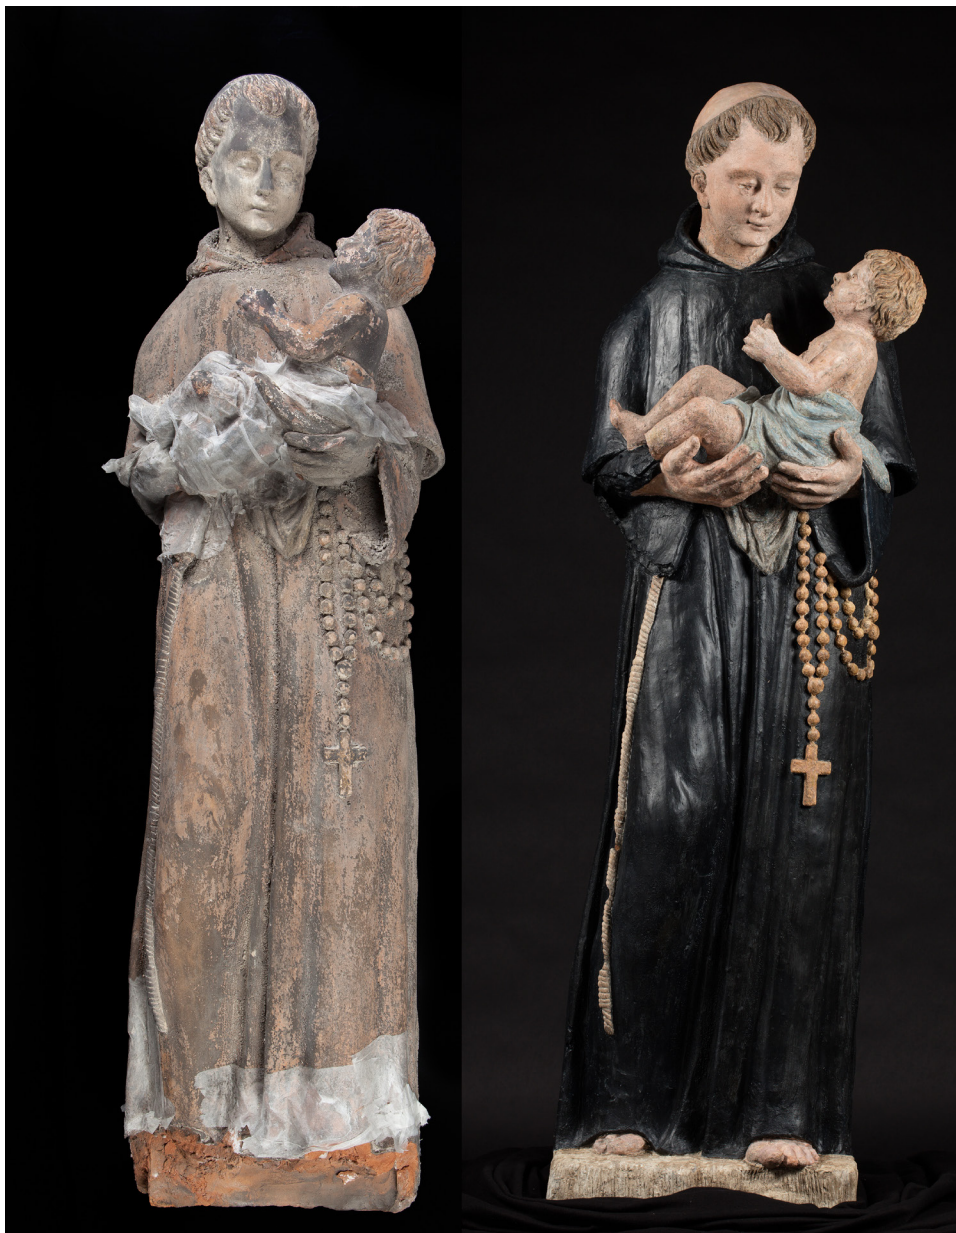
Fig. 4 Statue of Saint Anthony, Georges Houtstont, ca. 1868. Before treatment on the left; on the right after treatment. Partially repaint the statue has, next to an aesthetic and iconographical function, also a very important protective function against the severe weather conditions. (© KIK-IRPA, Brussels)

An important element in the decision-making on the conservation-restoration treatment is the location of the sculpture, as both the owners and the architect were strongly in favour of keeping the sculpture in its original niche. However, because the statue must be replaced outside, a protection of the damaged surface against severe weathering conditions was an absolute necessity. The fragile terracotta support definitely needed a protective coating. Therefore, we decided to remove the whitish overpaint on the flesh tones and recover the vestments with reversible conservation paint products in their original colour scheme (Fig. 4). The remains of the original polychromy were preserved underneath this new layer of paint, as a historical witness. As new painting materials a ground layer ("Gesso", an acrylic coloured ground layer from Golden) and paint (Golden MSA) were used<sup>1</sup>. They have both been tested at the KIK-IRPA during a 10-year period with very good results: good colour, good attachment, no peeling and perfectly reversible.

As a depiction of the patron of the church and the convent, the polychrome statue has a very high religious value. Partially repaint the statue has, next to an aesthetic and iconographical function, also a very important protective function against the severe weather conditions.

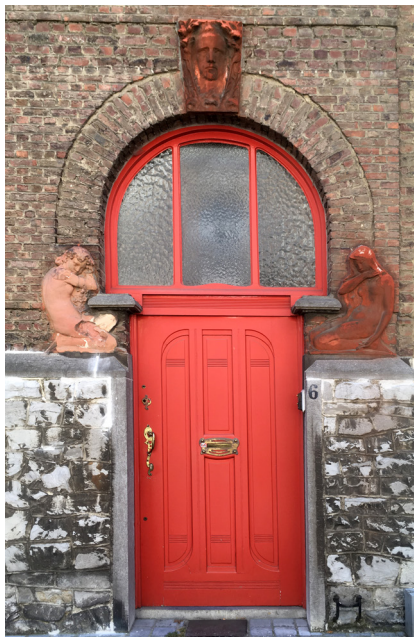
5 6

During our inspection, it appeared that only one of the three reliefs from the façade was still the original made out of red baked terracotta. Apparently, the two others were replaced by replicas in a terracotta-coloured mortar. It was only during our study that the landlords informed us about an unexpected and interesting fact: another copy of the central figure was kept in their garden. After our examination it appeared that the 'garden relief' was not a copy, but the original terracotta representing the portrait of the painter (Fig. 6). So instead of three original terracotta reliefs on the façade, there was only one original on the façade, one original in the garden and furthermore two replicas on the façade. Unfortunately, the original terracotta from the second female figure has disappeared.

Fig. 5 Three reliefs, Pieter Braecke, 1902, from the street façade of the private house of the Symbolist painter Emile Fabry in Woluwe-Saint-Pierre. Only one of the three reliefs, the kneeling female on the left, is still the original made out of red baked terracotta. The two others were replaced by replicas in a terracotta-coloured mortar. (Brussels) (© KIK-IRPA, Brussels, Camille De Clercq)

The deterioration of all four of them was advanced. The deterioration pattern of the two terracotta reliefs is mainly determined by the presence of cracks and delamination resulting in material loss on the entire surface. This damage was, as with the statue of Saint Anthony in our first case study, provoked by the combination of water seepage and frost. The thinner parts, such as the flowers in the hair of the left female character seemed to be very sensitive to this process as they were severely damaged. Furthermore, a lot of previous restorations were aesthetically disturbing. Lacunae were filled with gypsum or cement-based mortars. Apart from the colour difference with the terracotta their composition is inadequate for outdoor use or incompatible with the original material. Concerning the two mortar copies we can say that, despite their formal compatibility with the original sculptures, their state of conservation wasn't satisfactory either. The indefinite mortar was damaged by physical and chemical degradation, resulting in an uneven surface. Furthermore, we could observe black crusts.

It was decided that the original reliefs in terracotta were too fragile to be exposed outside in the future. The old mortar copies wouldn't be re-used either because they are also not suited to be exposed in an outdoor situation.

Therefore, we proposed to make three new replicas with a lime-based mortar<sup>2</sup> in a terracotta colour for the decoration of the façade and preserve the original reliefs in a protective environment. At the moment, the discussion concerning the future place of conservation of the originals is still ongoing. In fact, two options have been suggested. Firstly, as the reliefs were especially specifically designed for this house, conserving them inside this house could be a possibility. Another option would be to display the reliefs in a public space. The originals could be exhibited in the town hall of Woluwe-Saint-Pierre or at the museum of the CIVA foundation in Brussels, specialized in architecture.

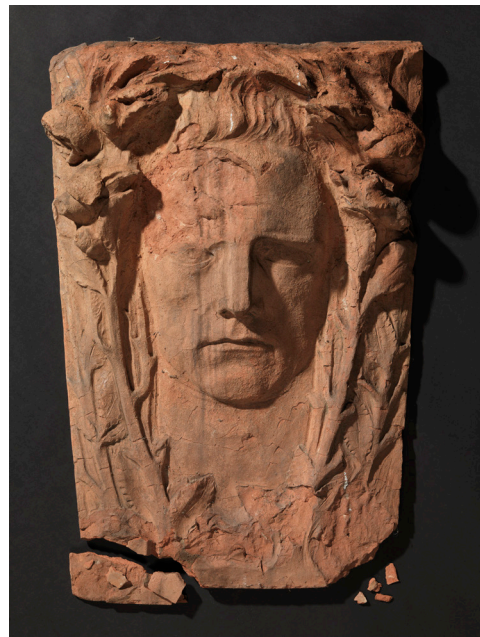
Fig. 6 The original terracotta relief representing the portrait of the painter, for years kept in the garden of the landlords, FIGcliché x108851 (© KIK-IRPA, Brussels)
